## Central Texas Turnpike System 2002 Project

# Annual Inspection Report Fiscal Year 2012

# Annual Inspection Report

For the fiscal Year ending August 31, 2012

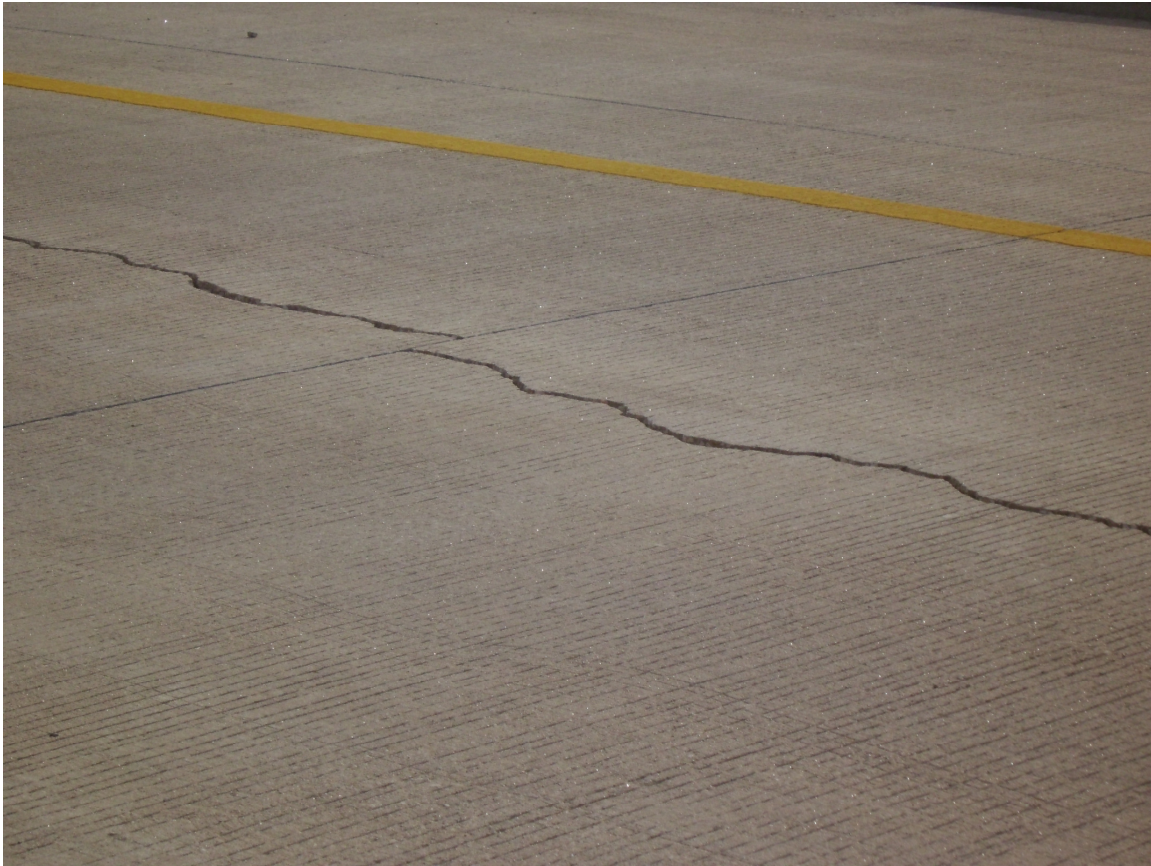
**Figure 4 – Pavement Crack on Loop 1**

As noted in prior year's report, the pavement north of the ML 1 toll plaza on Loop 1 was in need of repair. These repairs were made during calendar year 2011 by the TxDOT Austin District Maintenance Office. This section of roadway is continually monitored by the District and there is sufficient funding to make repairs as necessary.

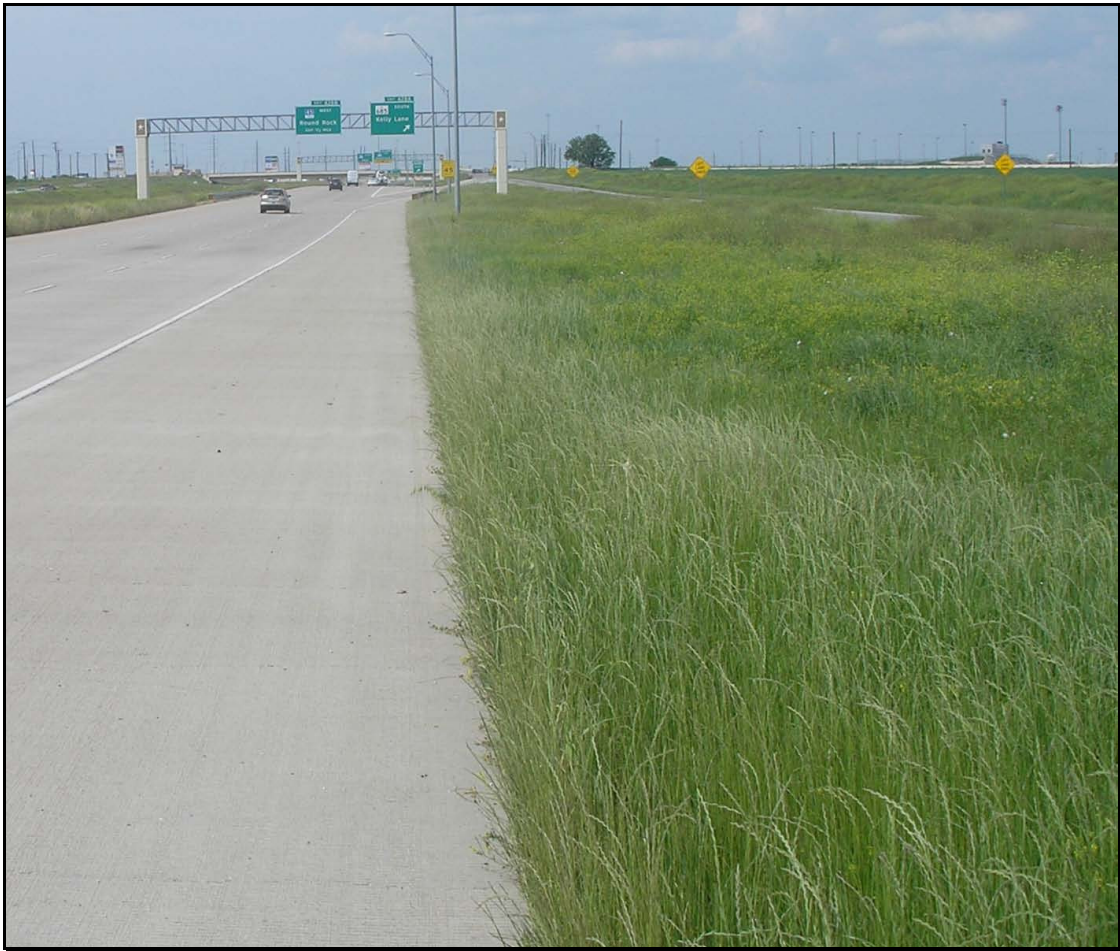
**Figure 6 –SH 130 Roadside Conditions**

The determination of the Roadside score for roadside features is generally based upon the consideration of vegetation management, litter removal, drainage structures, and other elements located outside of the paved travel way (Figure 2). The roadside category is in excellent condition and has achieved an overall score of 98. There were no characteristics that rated lower than 94. The lowest element, vegetation management, was found on SH 130.

It should be noted that the condition of vegetation management can vary greatly depending upon the time of year that the inspection is made and also weather conditions..

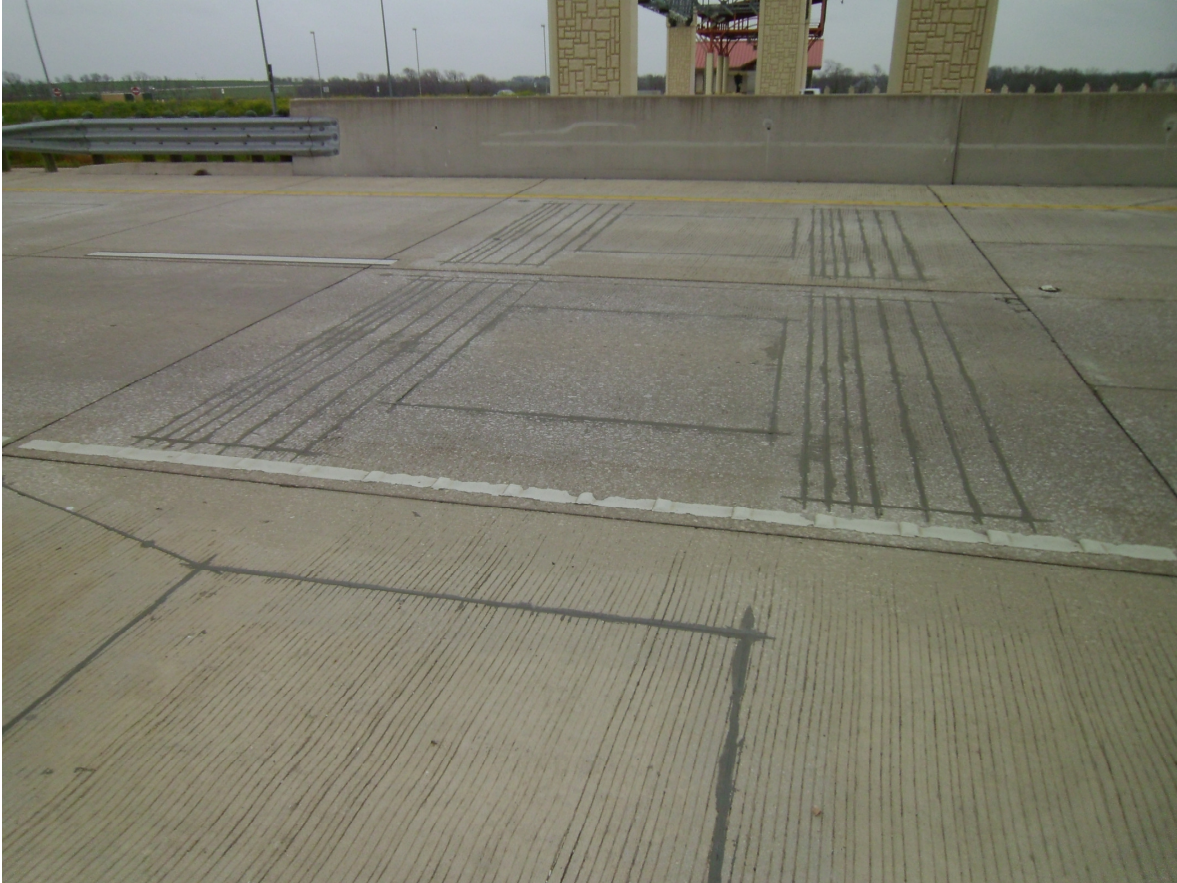
**Figure 8 - Toll System Pavement**

There have been concerns regarding concrete pavement cracks where the toll collection system is installed (shown on next page). Currently, the pavement score does not show a deficiency, but throughout the CTTS there are small cracks that have the potential to affect the toll system's collection capabilities. These locations require continual monitoring in order to determine the appropriate time for pavement rehabilitation or replacement. This is not expected to occur during FY 2013, but is anticipated sometime in the next several years.

A list of all facility assets that were rated has been sent to Austin District Maintenance with the deficiencies highlighted and recommendations for repair included.

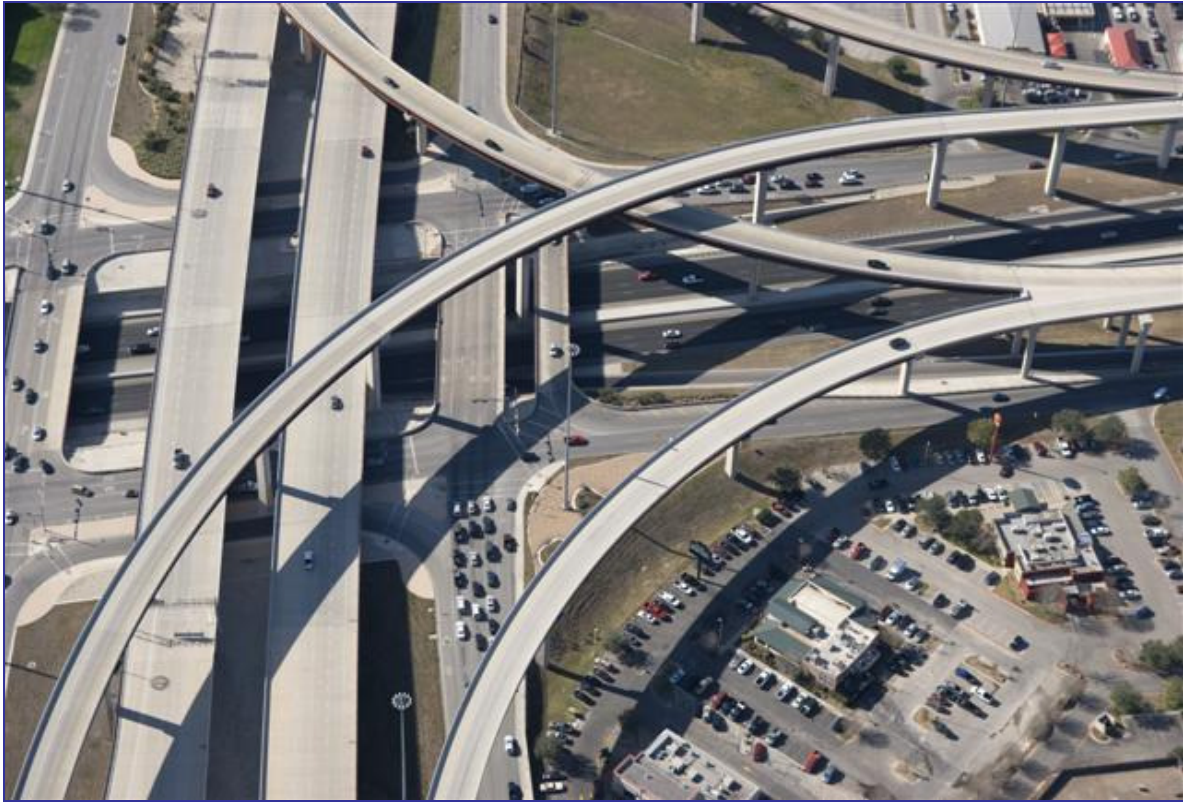
**Figure 13 - Bridges**

A total of 635 components were inspected on the 204 structures within the CTTS. Only 8 components (1.3%) had a rating as low as 6 (Satisfactory), with the remainder of the ratings all in the 7 to 9 range (Good to Excellent). The components that rated a 6 involved channel erosion or sediment buildup at 4 locations, minor cracking exhibited at 3 culverts, and shrinkage cracks on the bridge deck at one location. No components rated below Satisfactory.

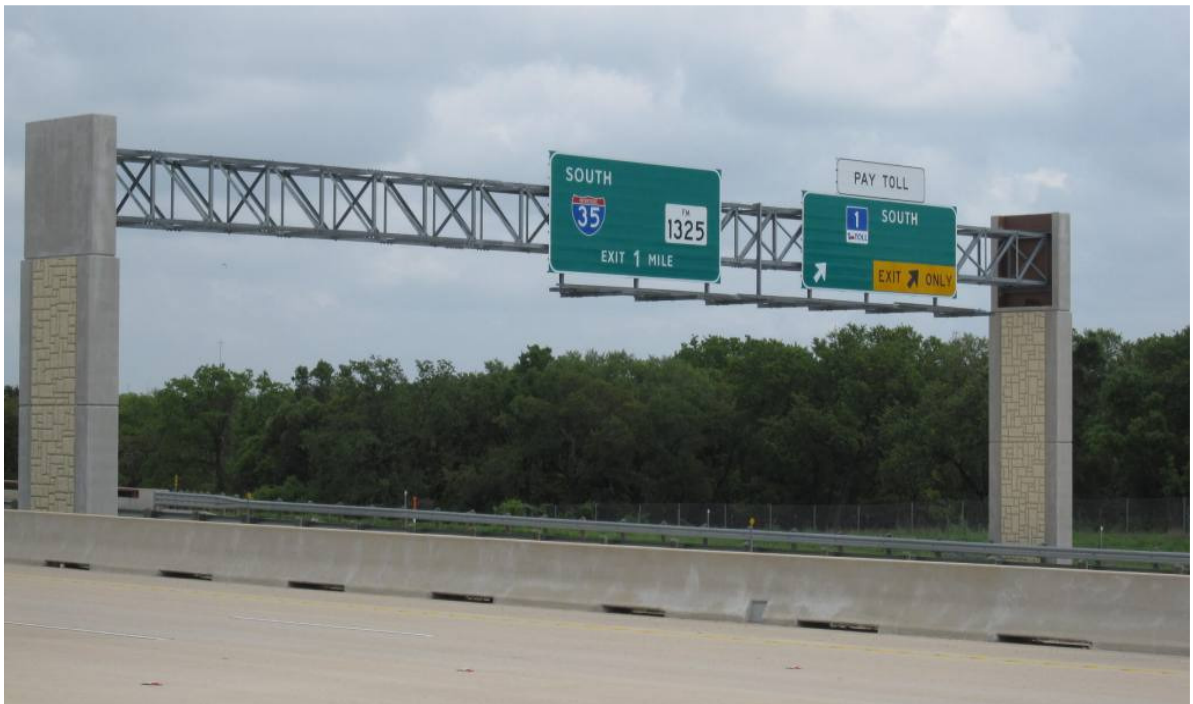
Figure 14 - Overhead Sign Structure

Overhead and cantilever signs, such as the one pictured in Figure 12, are suspended above the travel way by large support structures and are included in the roadside category. These signs provide critical directional information, guiding the patron throughout the Central Texas Turnpike System. TxDOT performed an inspection of the overhead/cantilever structures at the completion of their construction. At that time, none of the overhead/cantilever sign components and subcomponents inspected were noted as being in less than fair condition.

Beginning in FY 2011, the overhead and cantilever signs have been inspected biennially. In FY 2011, the overhead and cantilever signs for SH 45 were inspected. This year, the overhead and cantilever signs for Loop 1 and SH 130 were inspected. The results of this year's inspection indicate that Loop 1 and SH 130's 112 overhead and cantilever signs are in very good condition. A total of 2 items were found to be in need of repair. These items have been reported to Austin District Maintenance. A summary of the results and the items in need of repair can be found in Appendix D.

Maintenance. Also, we recommend that the two overhead and cantilever sign elements and the seven HMLT elements for Loop 1 and SH 130, that were found to be deficient, be repaired.

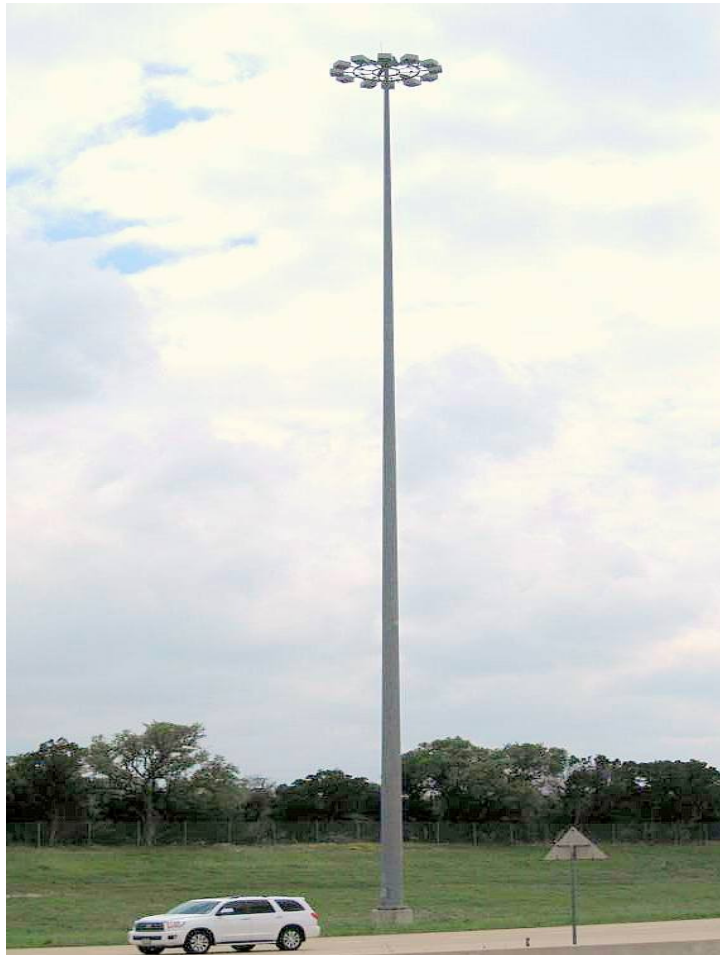
Figure 15 – High Mast Light Tower

Similar to overhead/cantilever signs, HMLTs were inspected by TxDOT at the completion of their construction. No deficiencies were noted during the post construction inspection. These structures, like the one pictured in Figure 13, provide illumination for improved nighttime visibility at various locations along the CTTS, such as interchanges and toll facilities.

Beginning in FY 2011, the HMLTs are inspected biennially. In FY 2011, the HMLTs for SH 45 were inspected. This year, the HMLTs for Loop 1 and SH 130 have been inspected. The results of this year's inspection indicate that Loop 1 and SH 130's 29 HMLTs are in very good condition. A total of 7 minor deficiencies were found to be in need of repair. These items have been reported to Austin District Maintenance. A summary of the results and the items in need of repair can be found in Appendix D.
