Historic Bridge Adoption Information Packet

Comanche County

County Road (CR) 310

Indian Creek

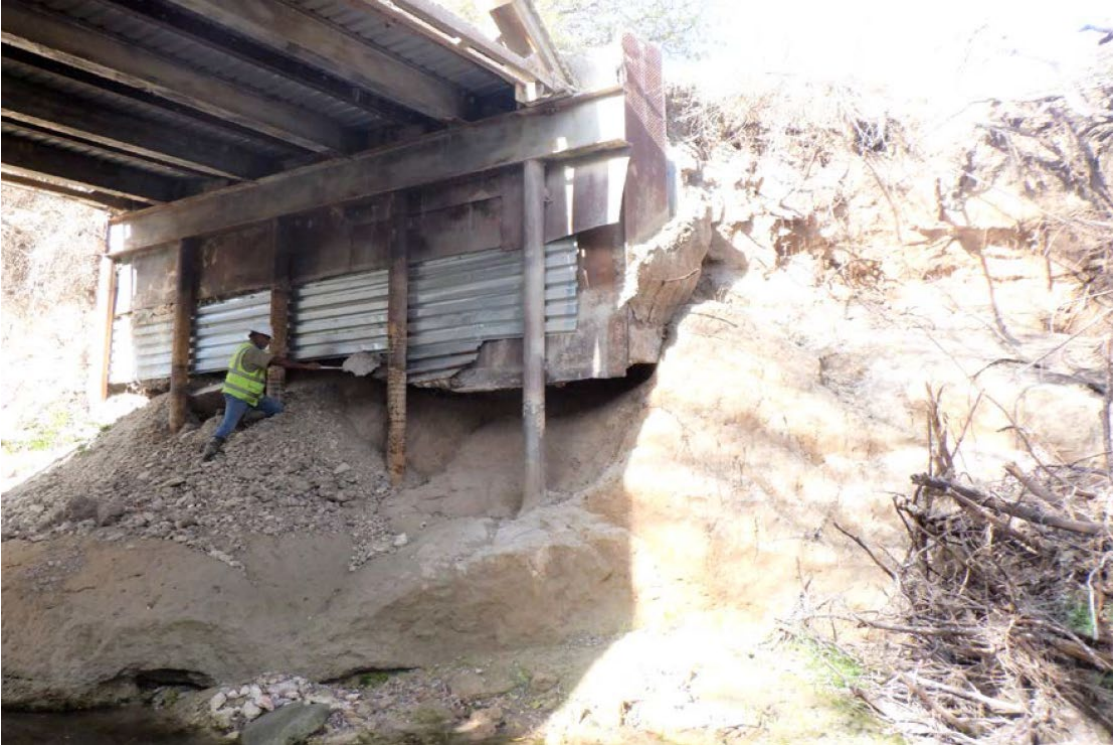
The truss remains in generally good condition; however, the bridge is currently closed due to instability caused by stream migration and associated erosion. Significant erosion is present near the bridge, particularly at the northwest abutment, where undermining of the abutment wall and exposure

Figure 1. Erosion on abutment wall and pile exposure.

- Existing substructure repair

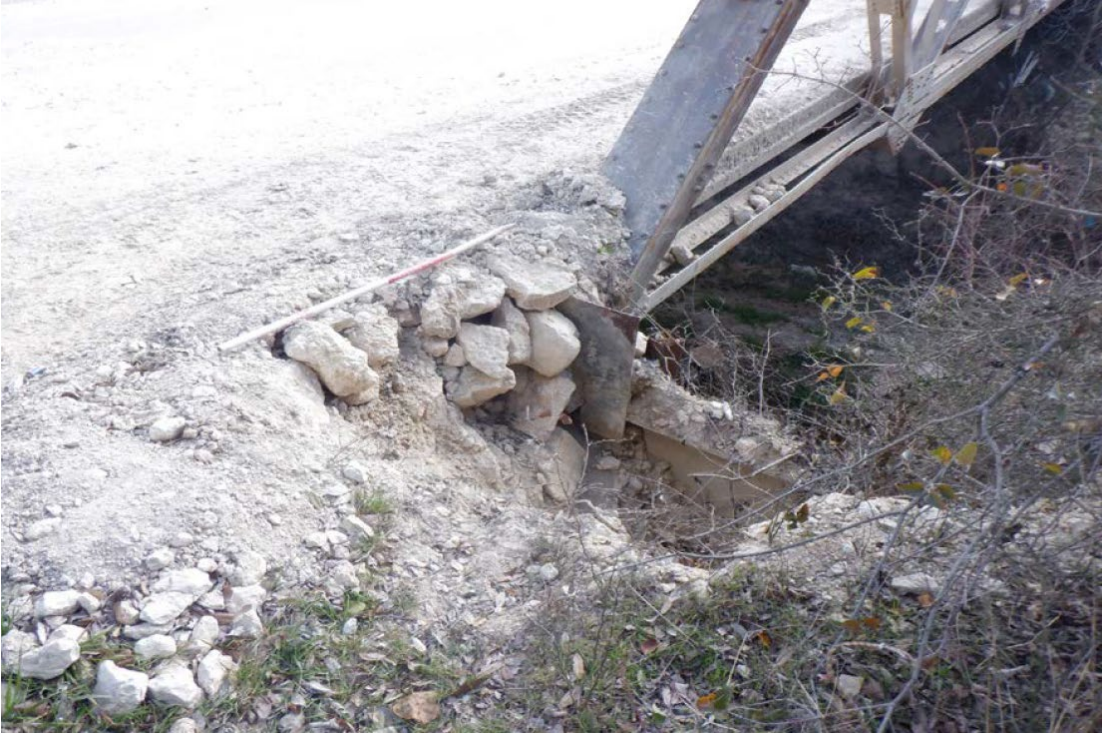
Figure 2. Erosion on northwest abutment.

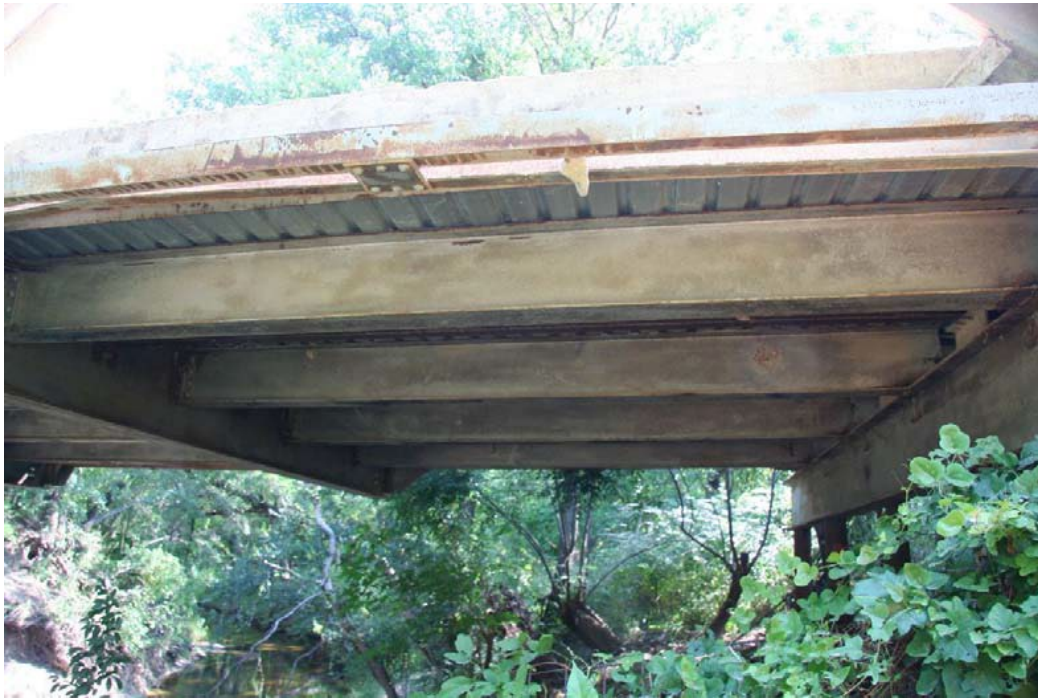
Figure 5. Underside of bridge, showing alterations to stringers and new bent

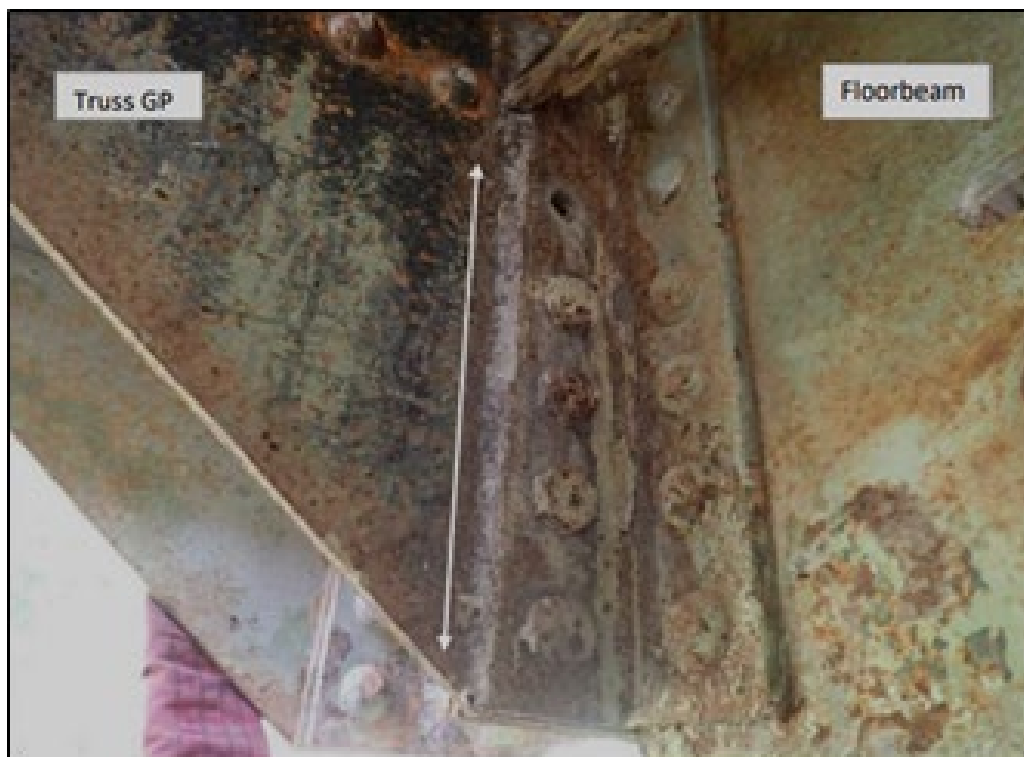
Figure 6. Photo showing missing bolts

- Install new deck
- Install new pedestrian rail
- Replace missing bolts

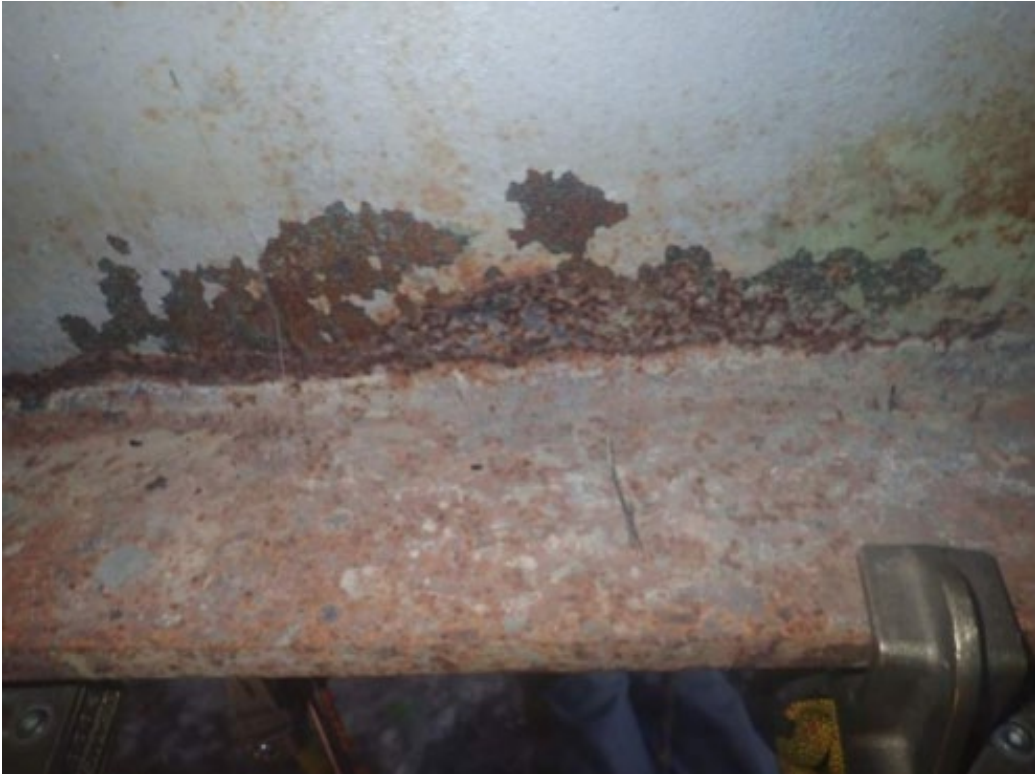
Figure 7. Photo showing paint loss and corrosion

- Cleaning bridge
- Painting bridge
