Historic Bridge Adoption Information Packet

Crockett County
State Highway (SH) 290
Pecos River
January 2026

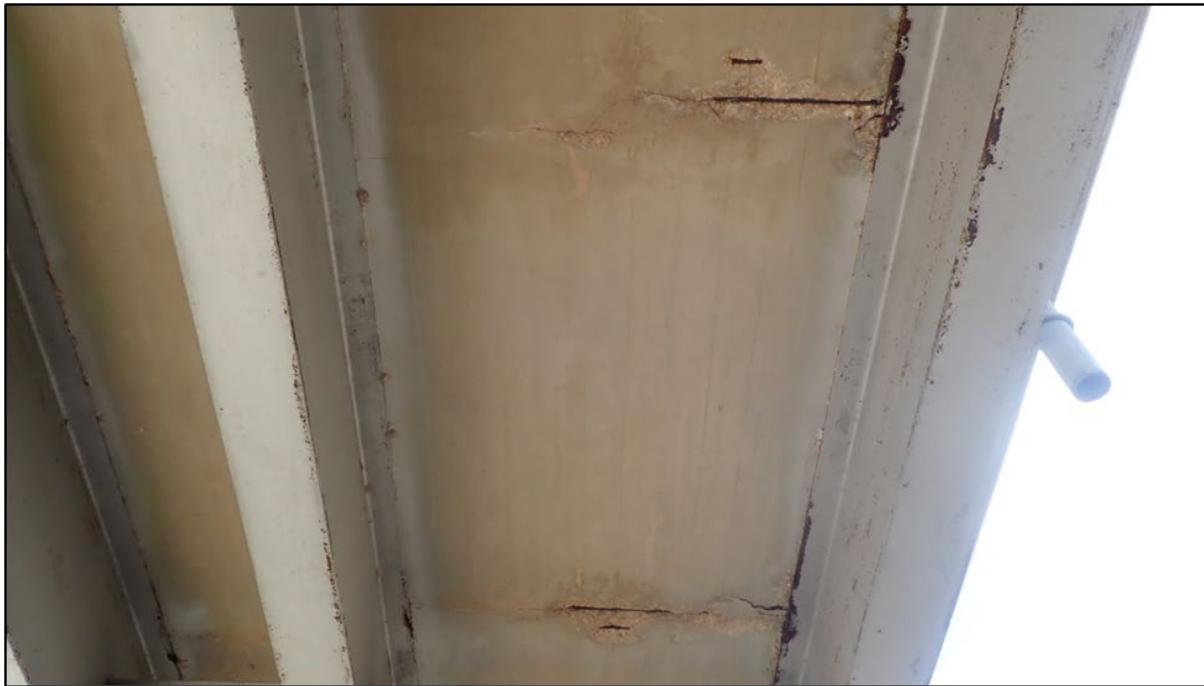
Figure 1 Spalls in deck soffit span

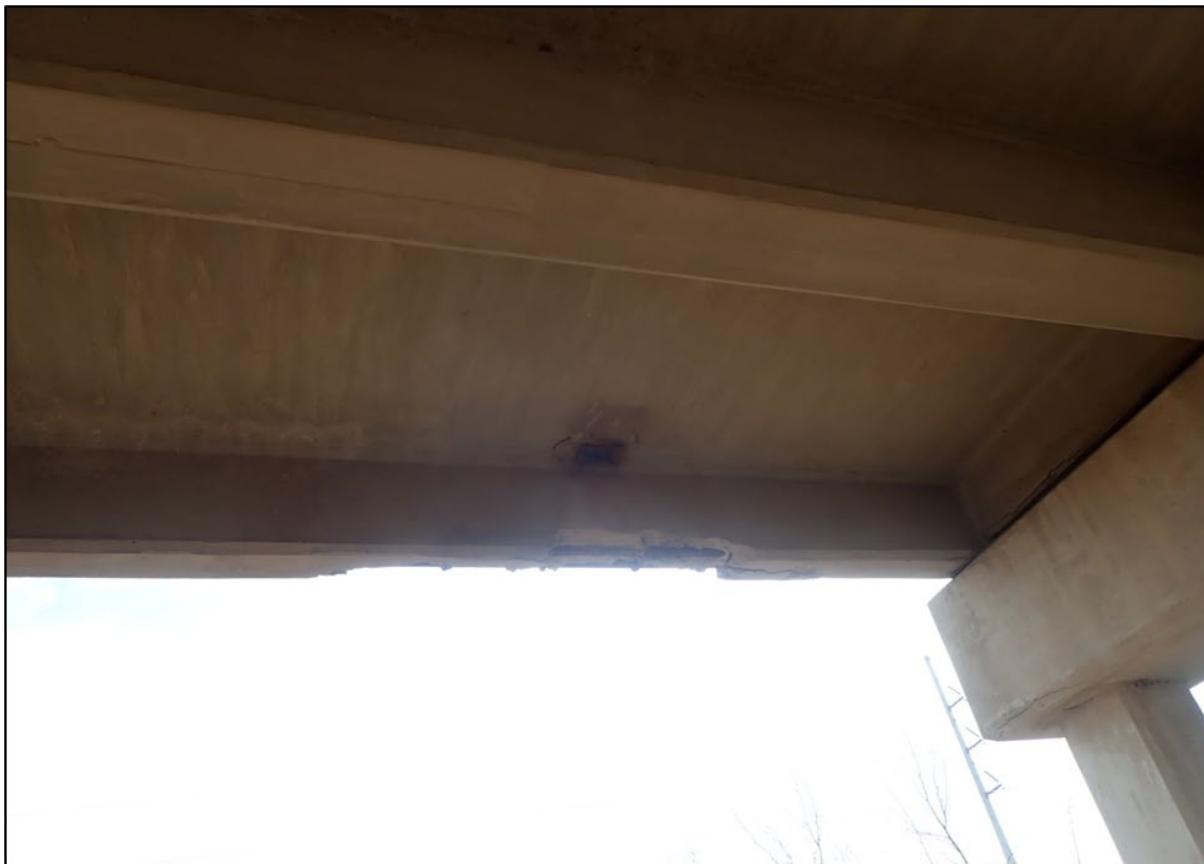
Figure 2 Spall in south beam span

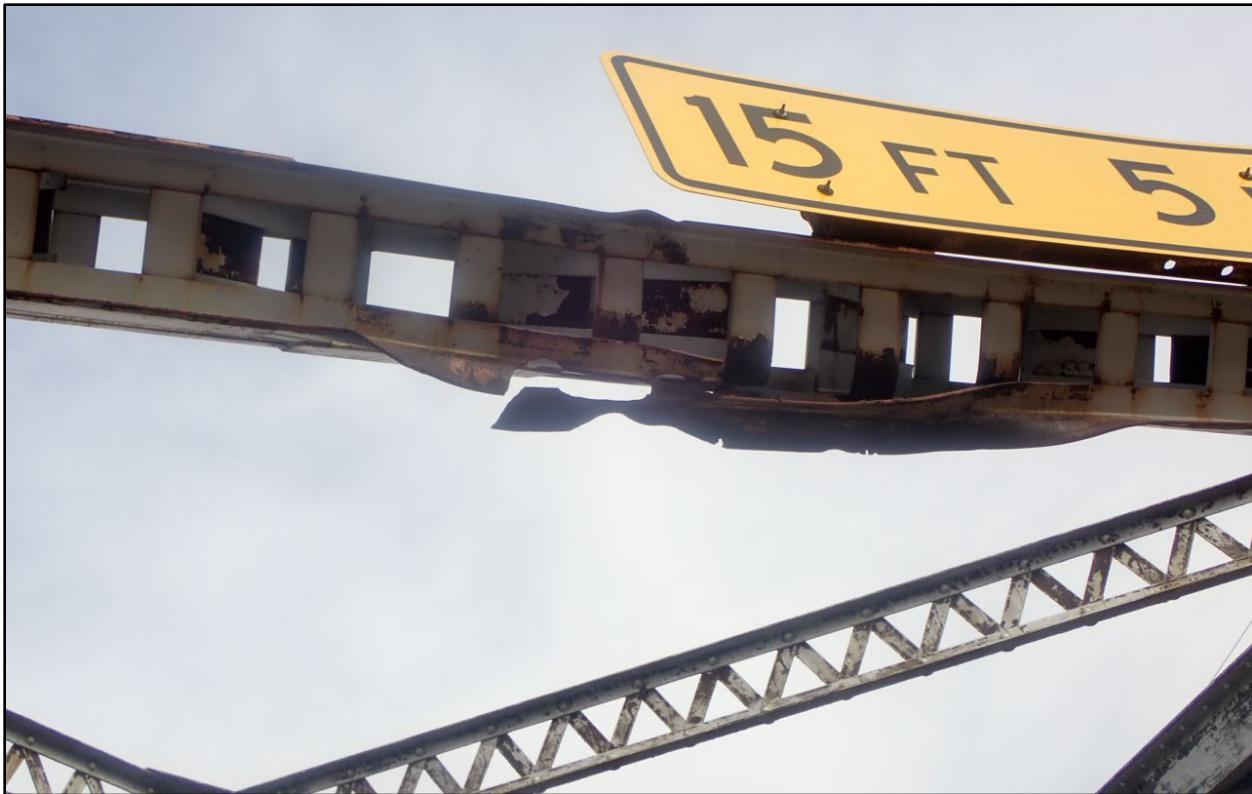
Figure 3 Impact damage on west horizontal

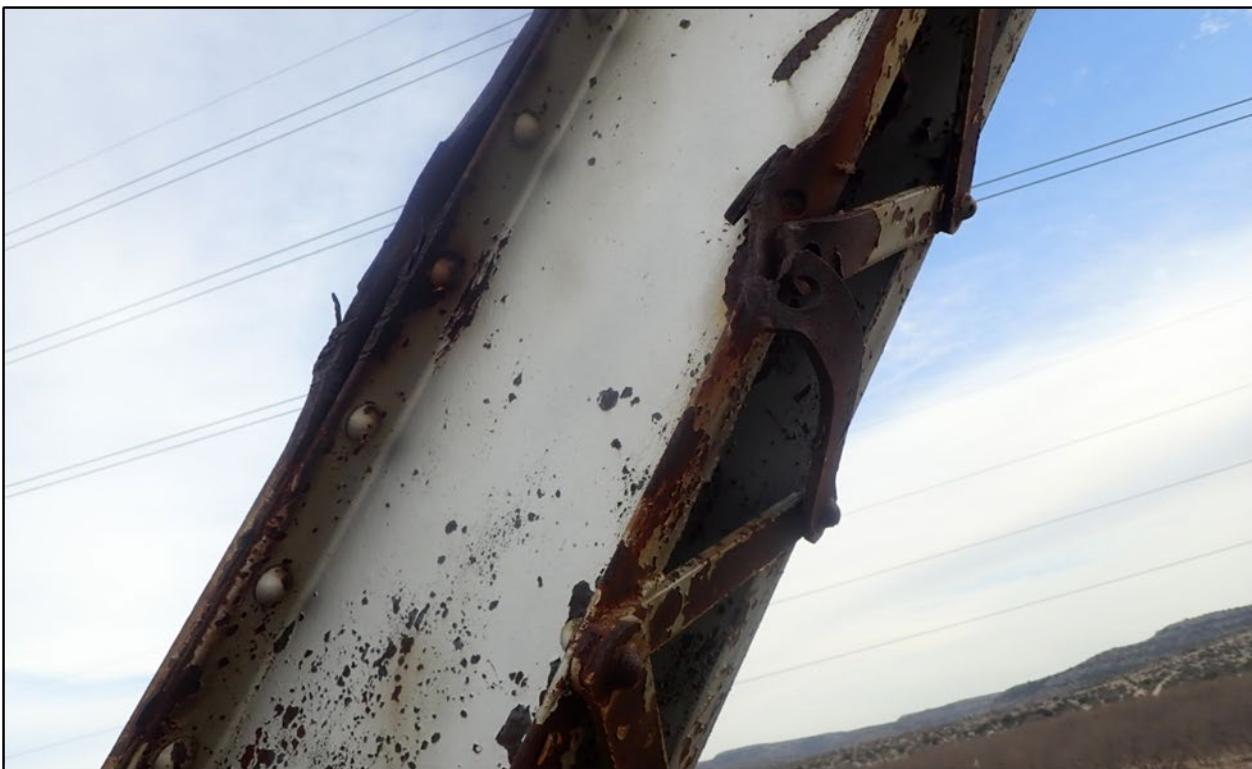
Figure 4 Impact damage south truss

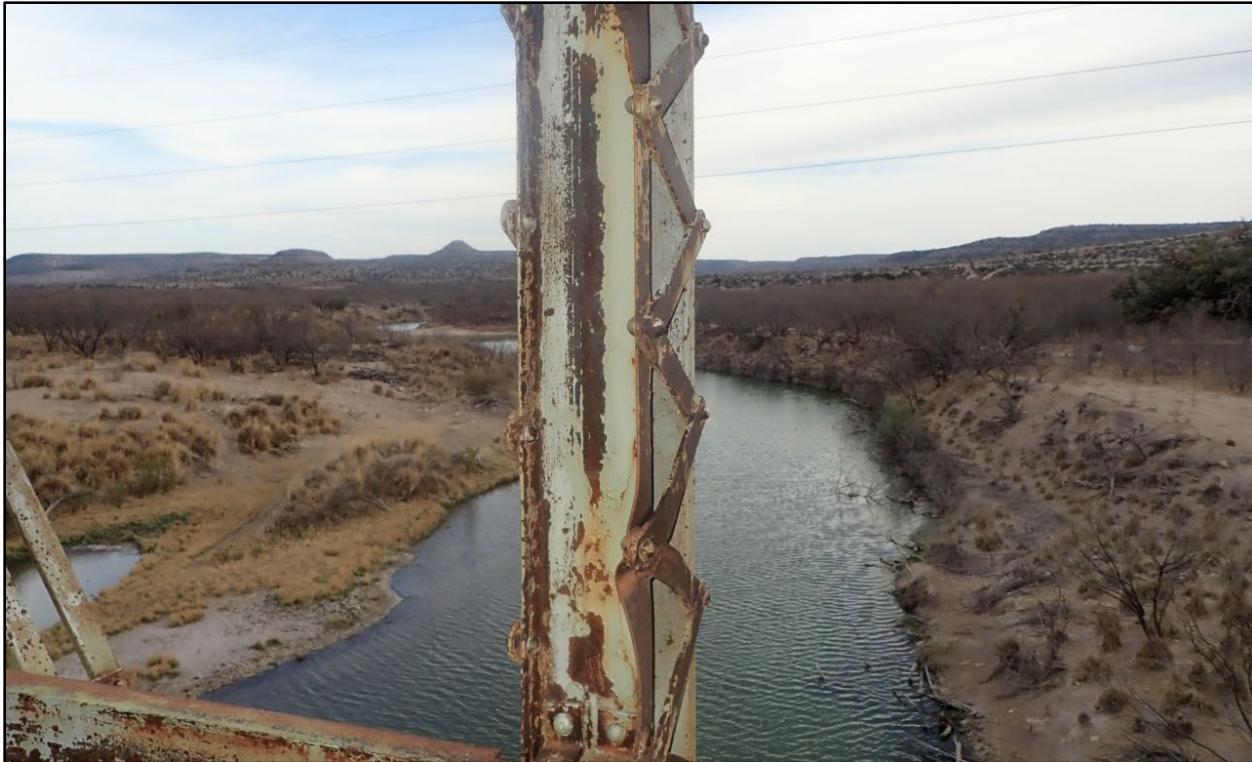
Figure 5 Impact damage south truss

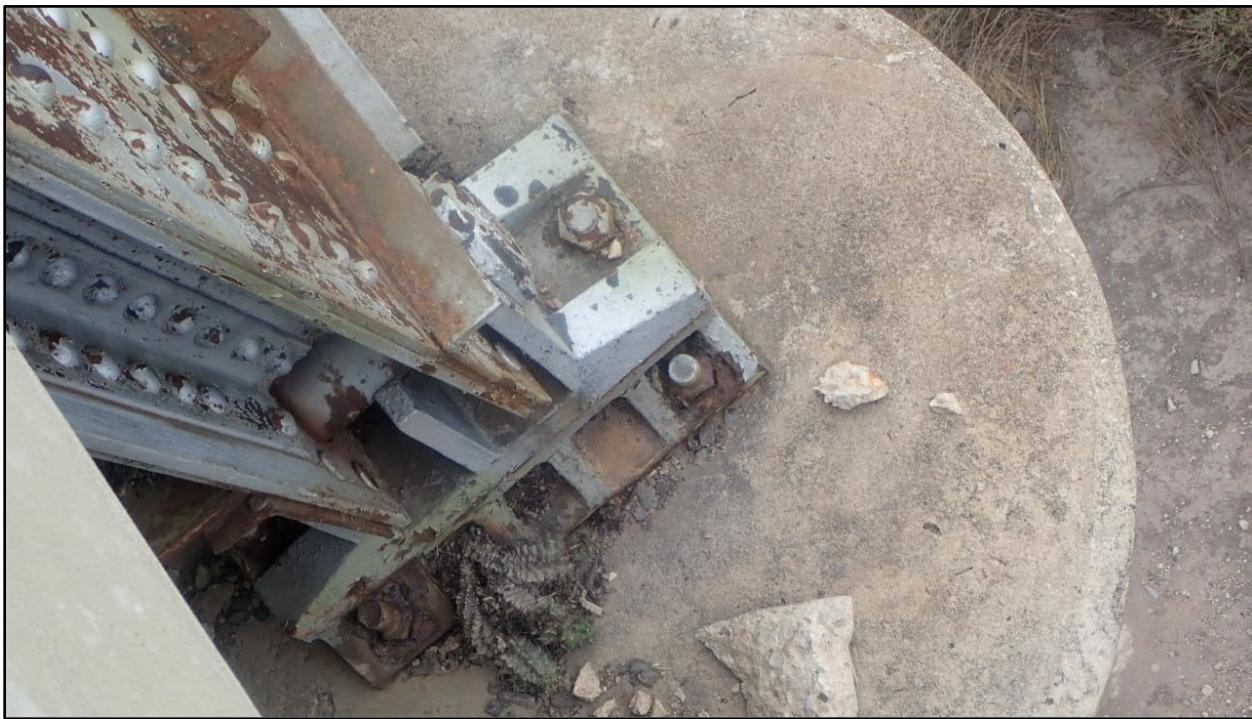
Figure 6 Rusted east bearing plate for truss bent

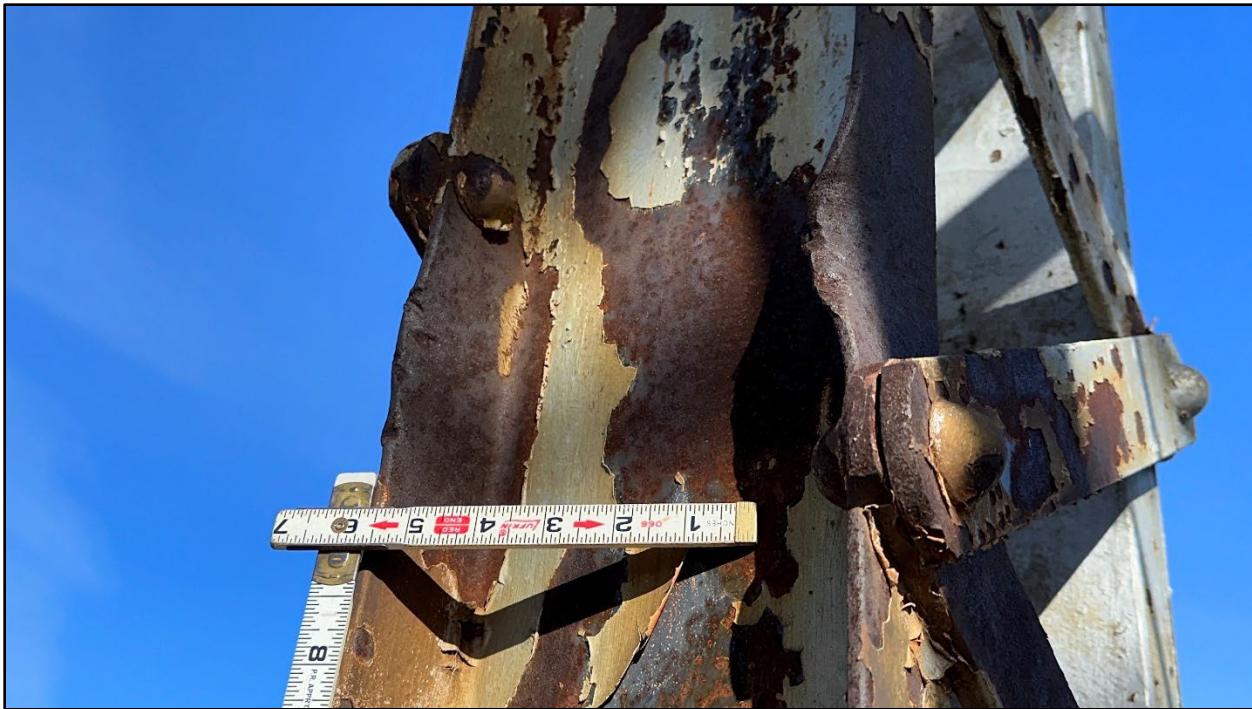
Figure 13 North truss unseated rivet

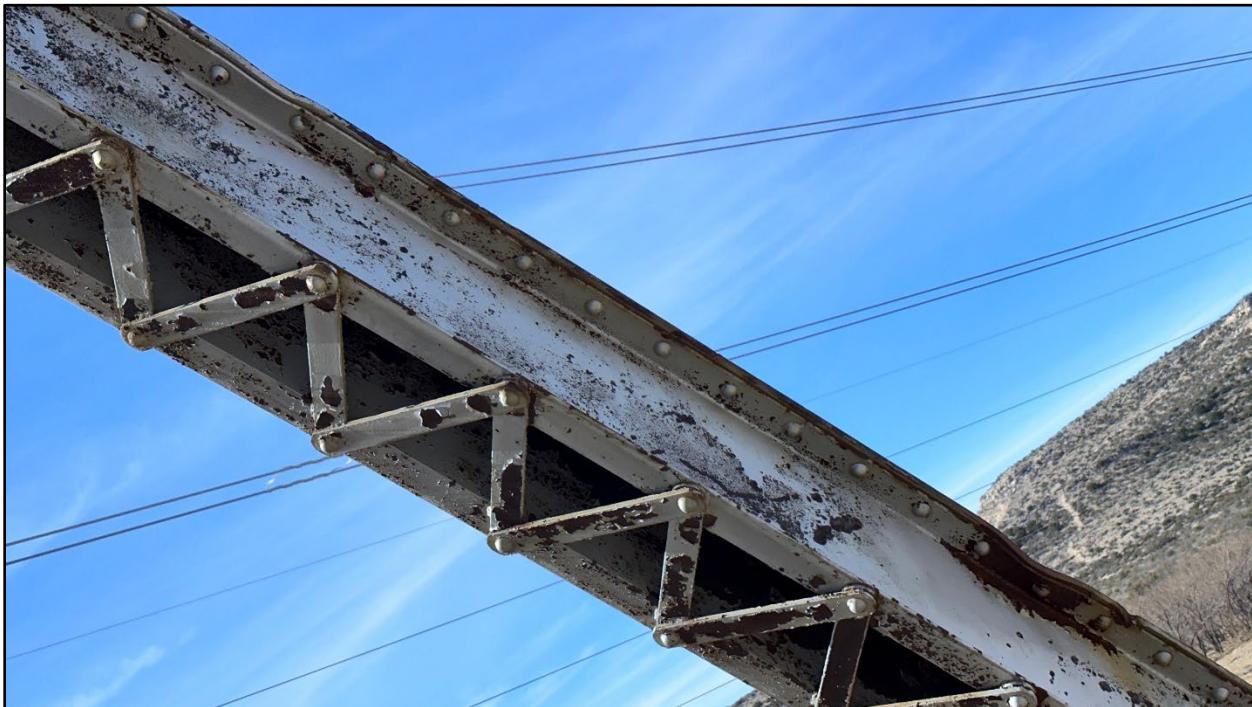
Figure 14 South truss impact damage

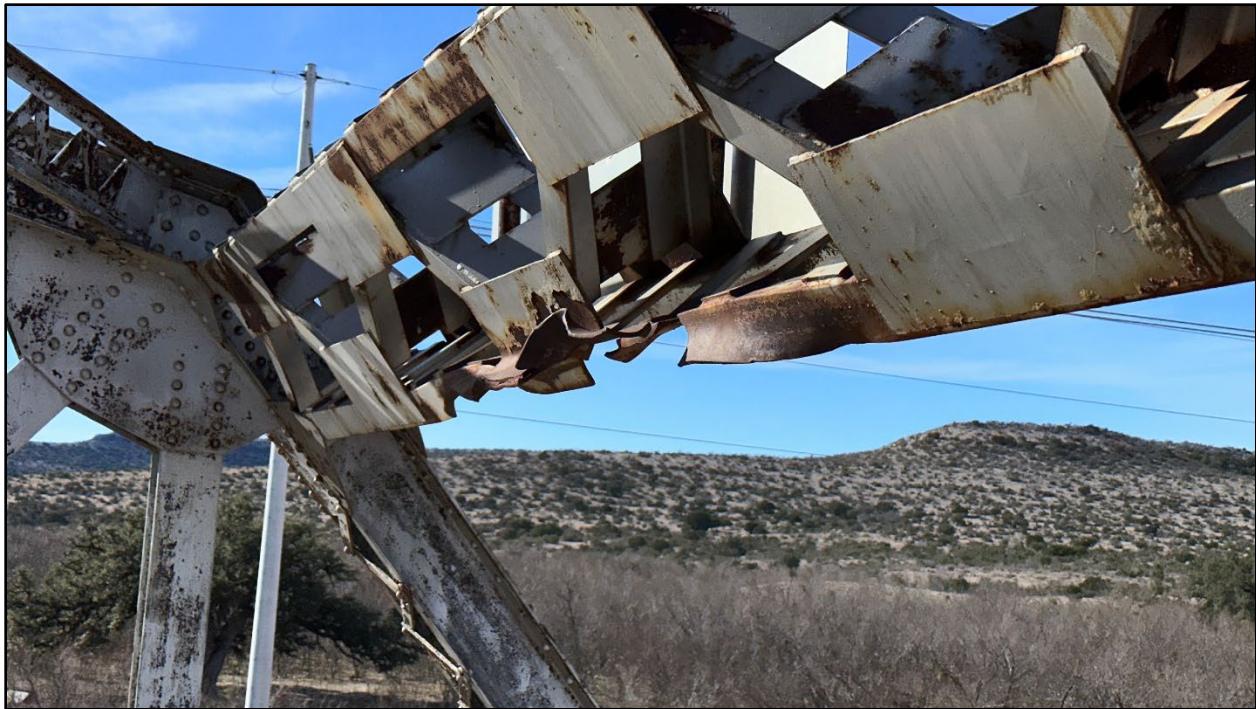
Figure 15 Portal bracing impact damage

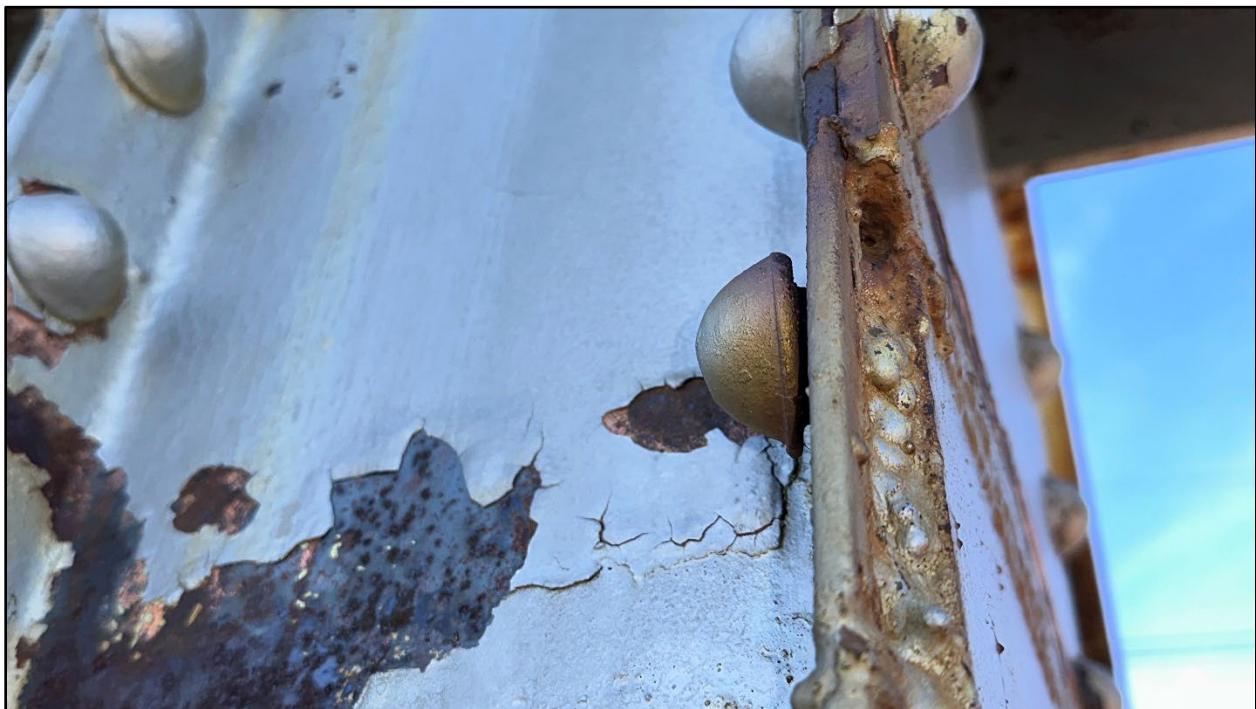
Figure 16 North truss unseated rivet

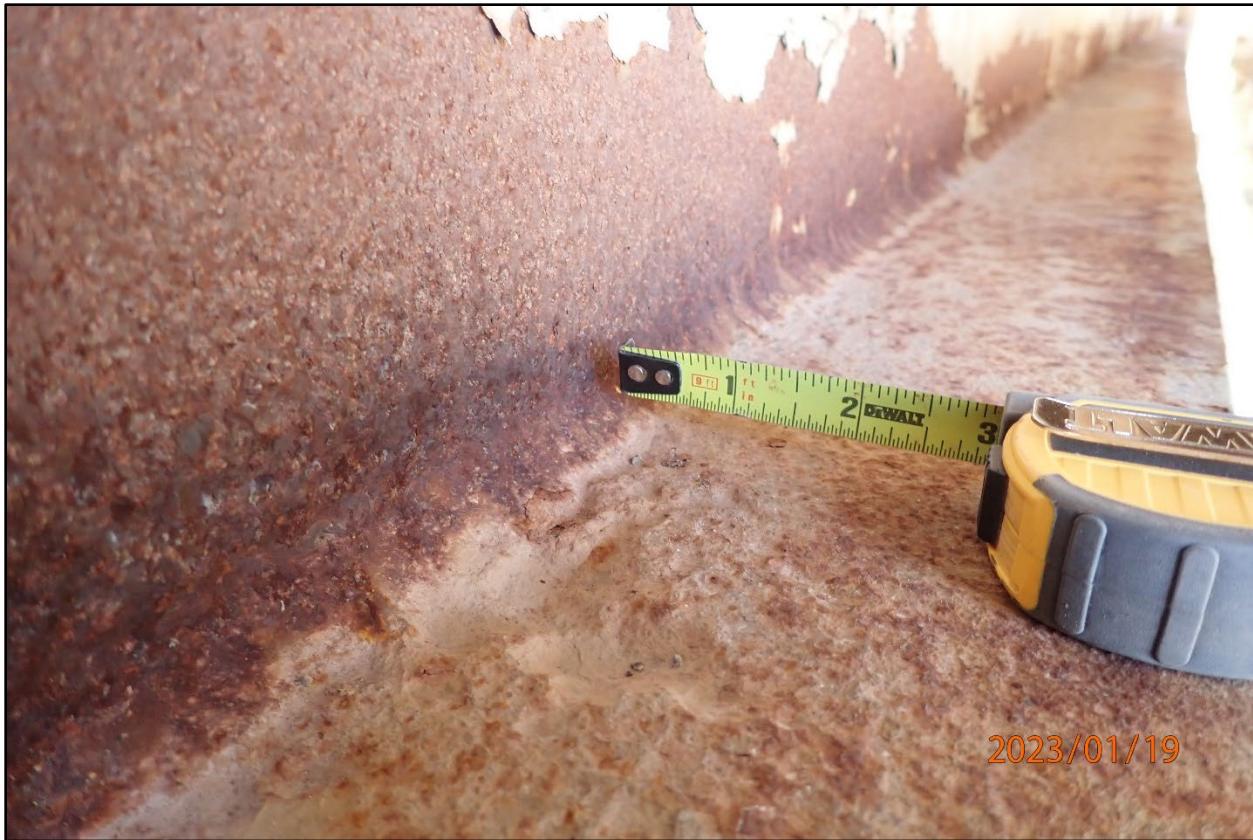
Figure 17 Floorbeam pitting

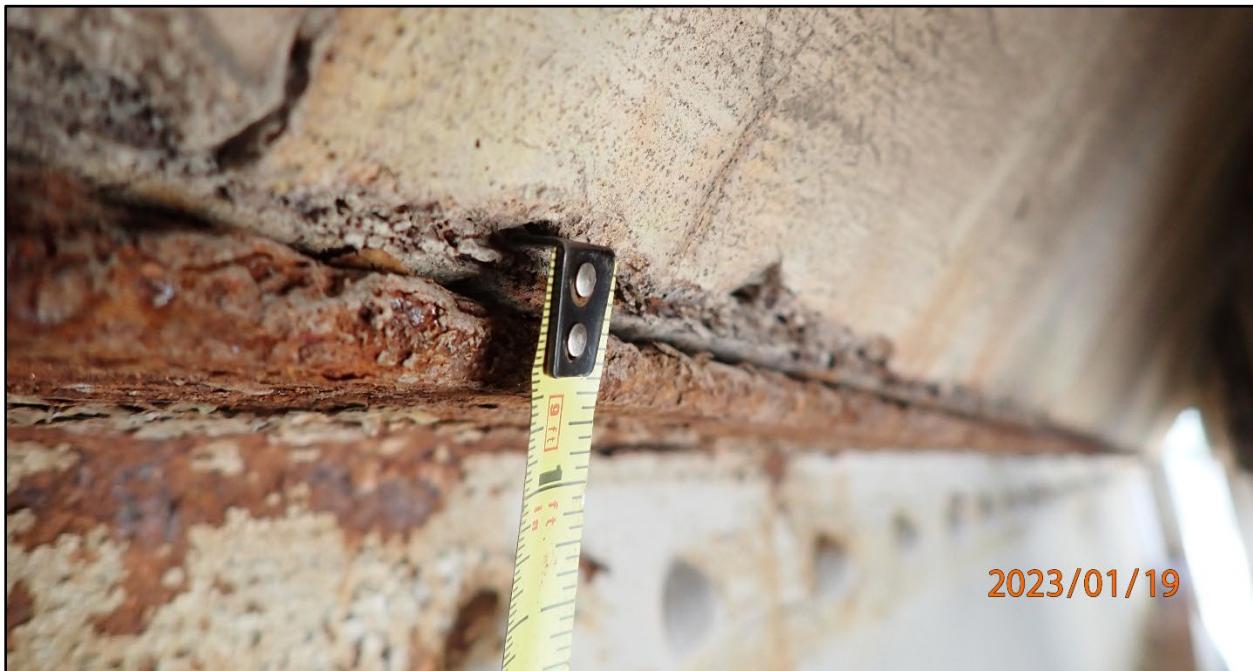
Figure 18 Floorbeam pack rust

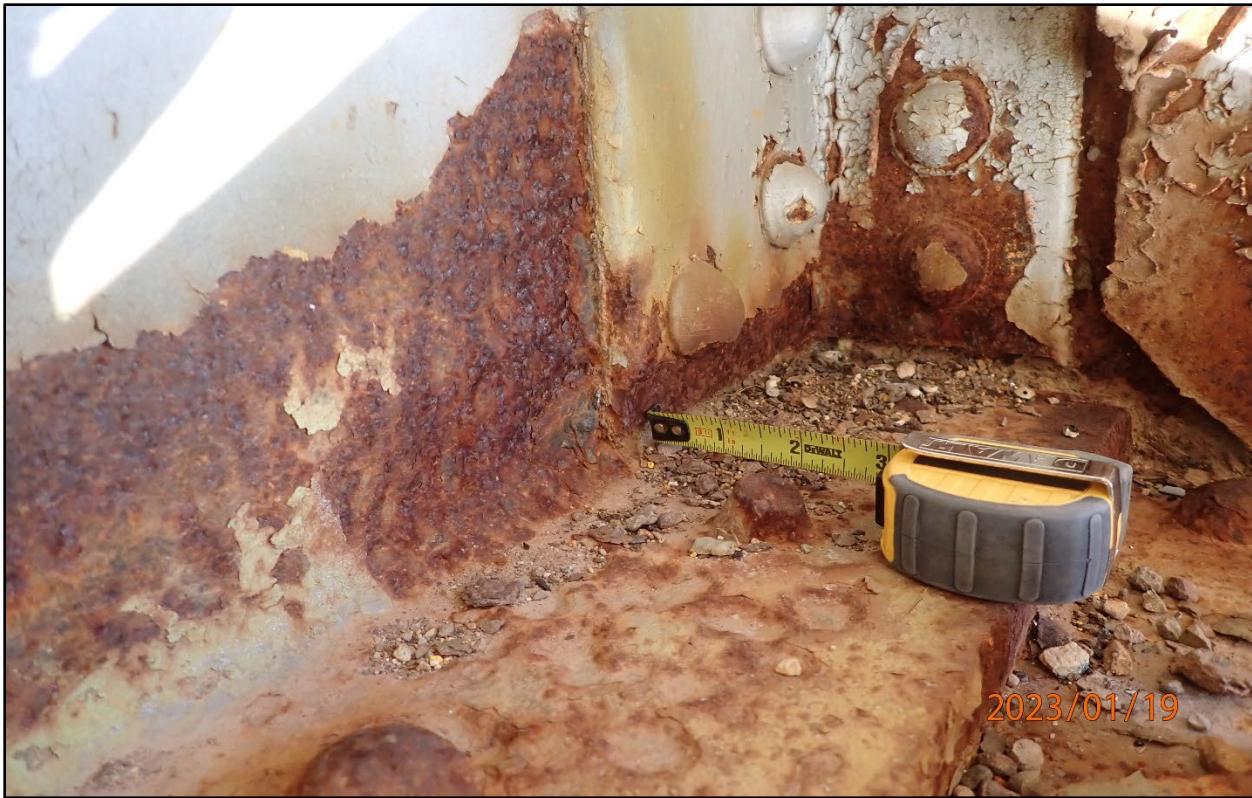
Figure 19 Floorbeam section loss

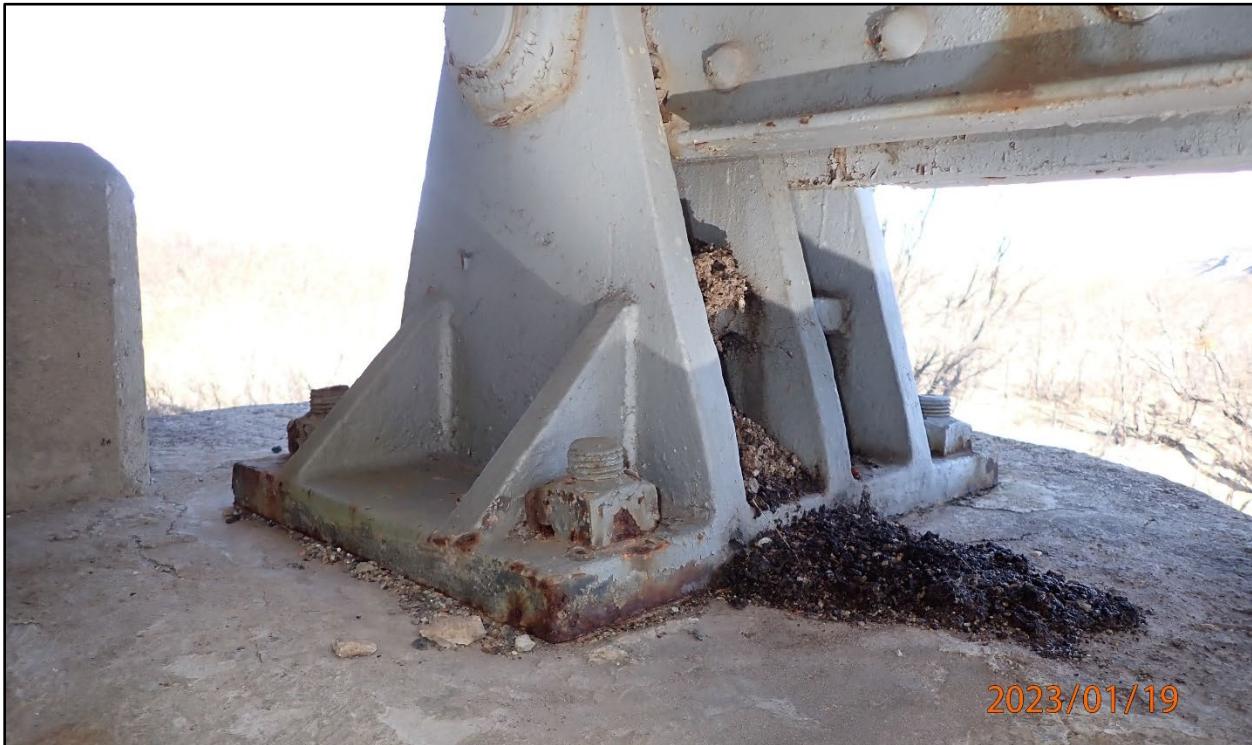
Figure 20 Truss bearing surface corrosion

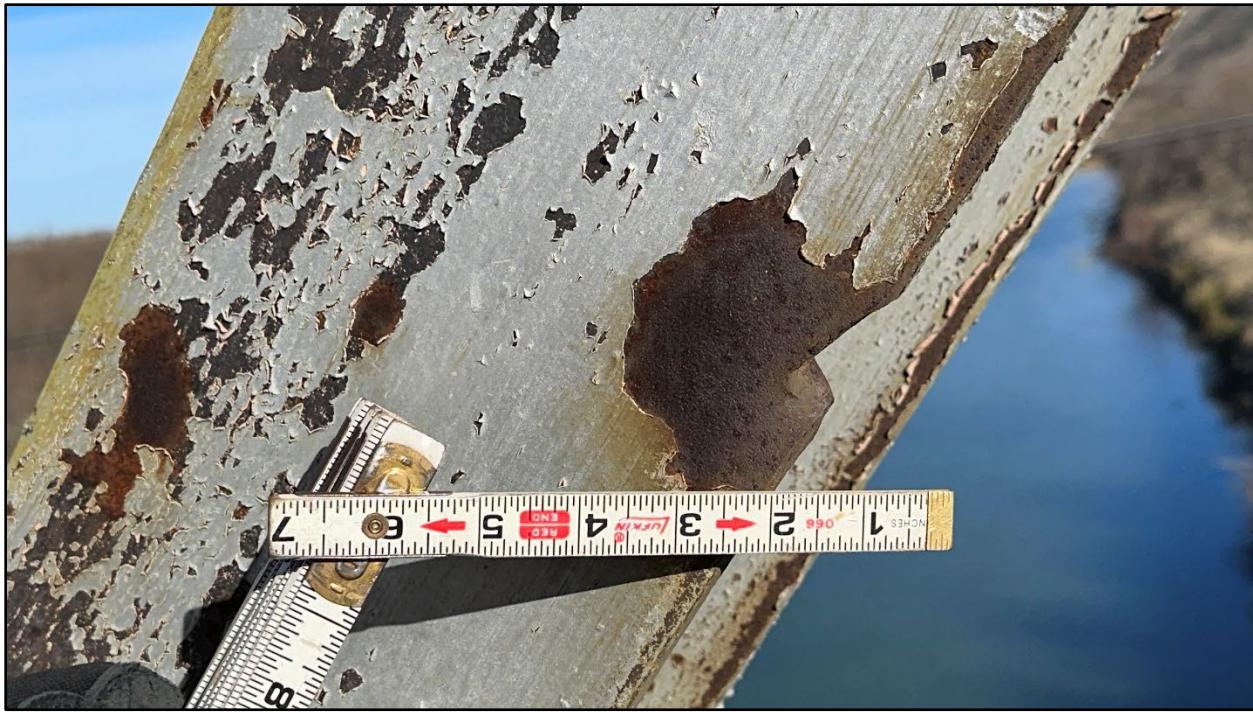
Figure 21 Typical base metal fatigue
