# Historic Bridge Adoption Information Packet

Parker County

Interstate 20 (I-20) Northbound Frontage Road

Brazos River

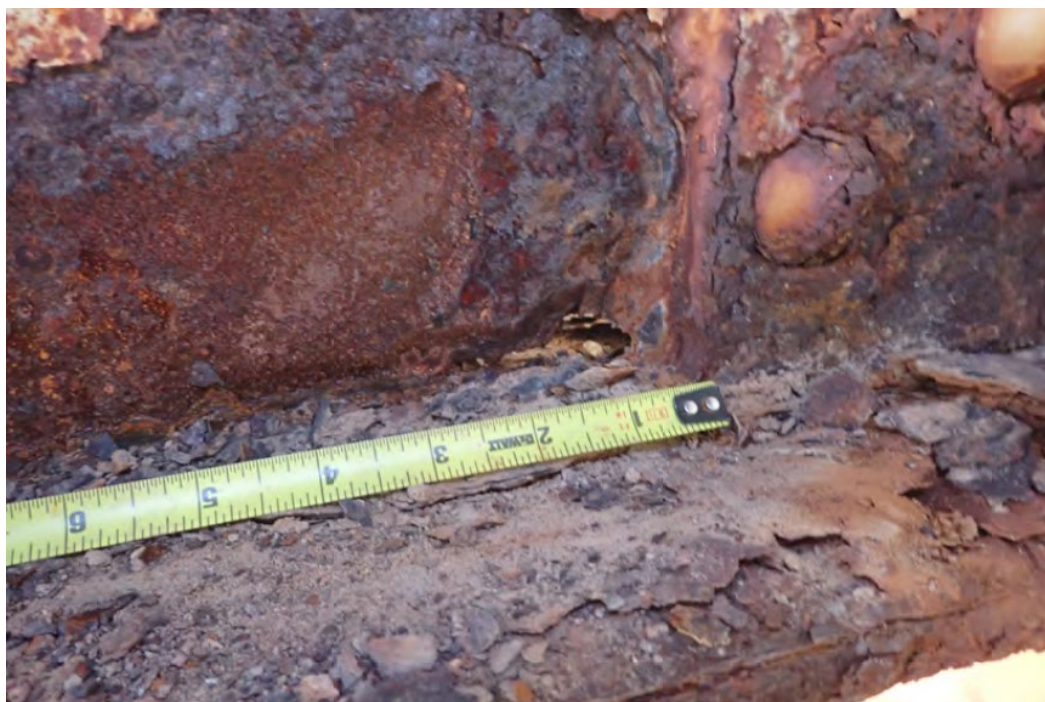
Corrosion at stringers

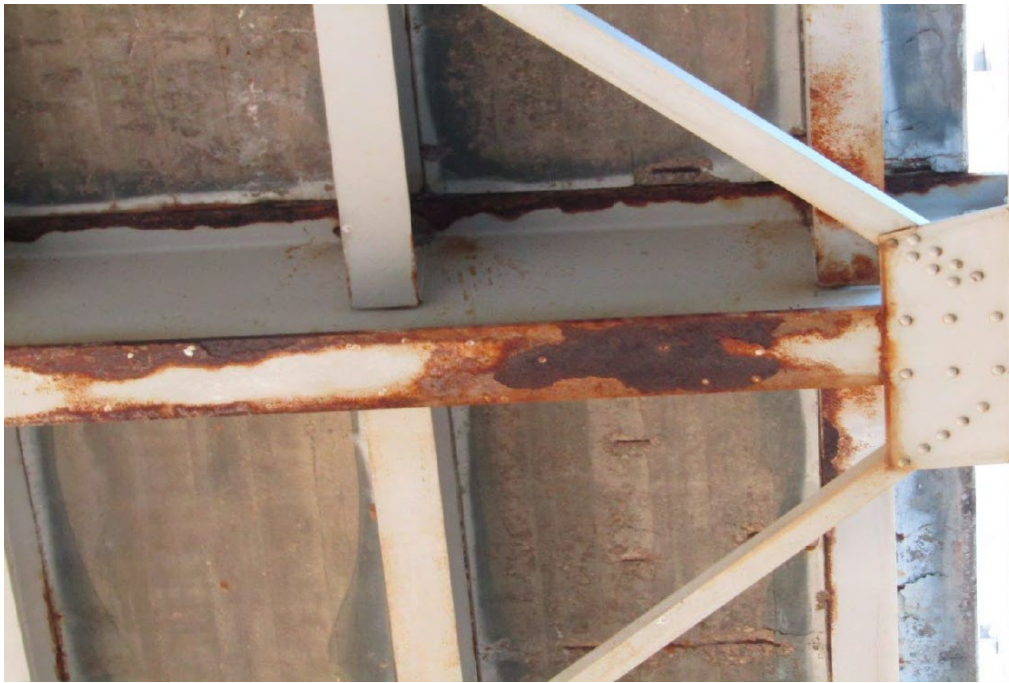
Typical floor system corrosion

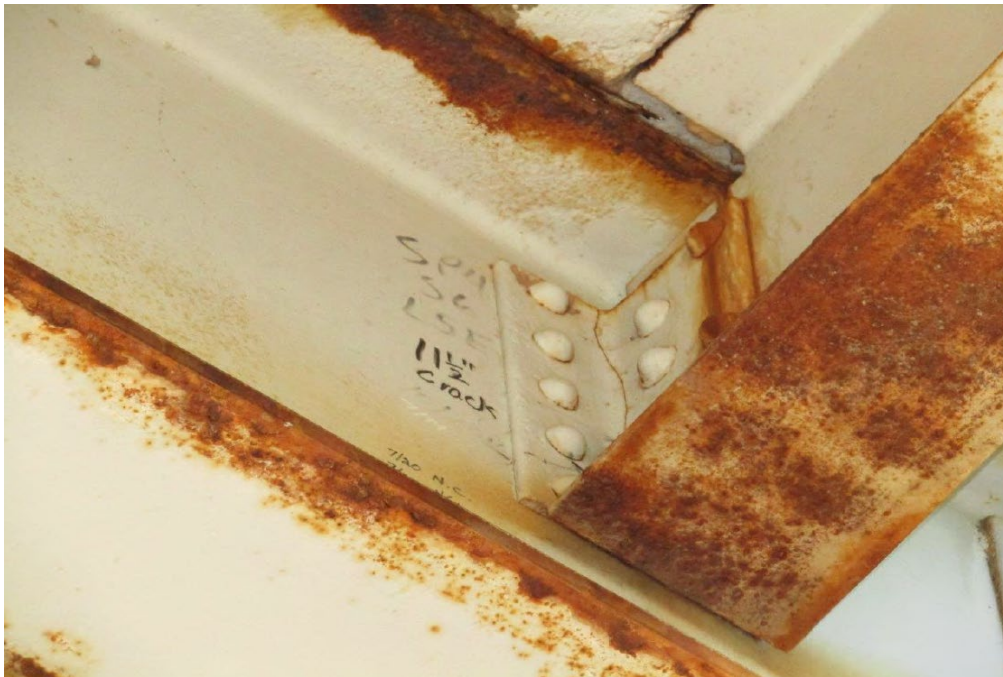
Cracking at floor system connections. Found at multiple locations.

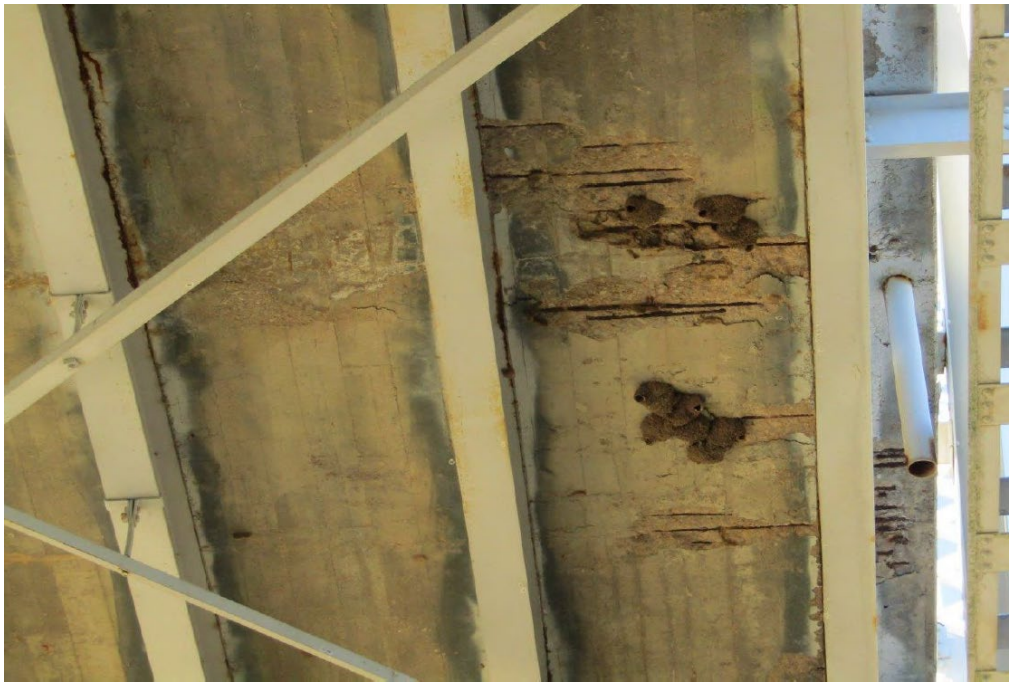
Typical deck damage

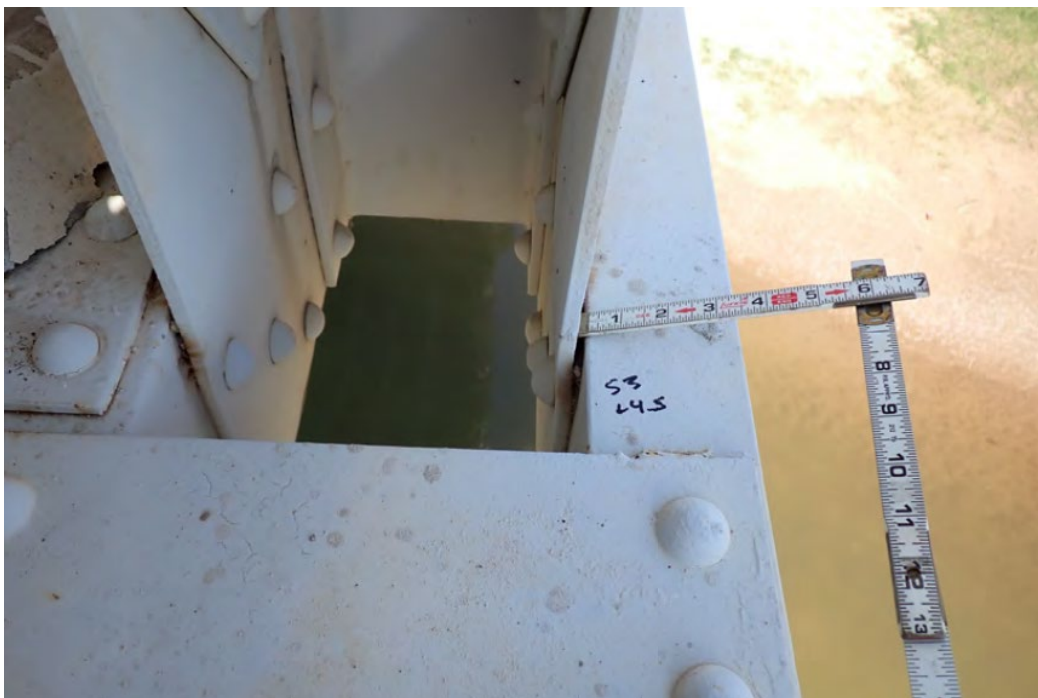
Pack rust with deformation at lower chord-gusset plate connection.

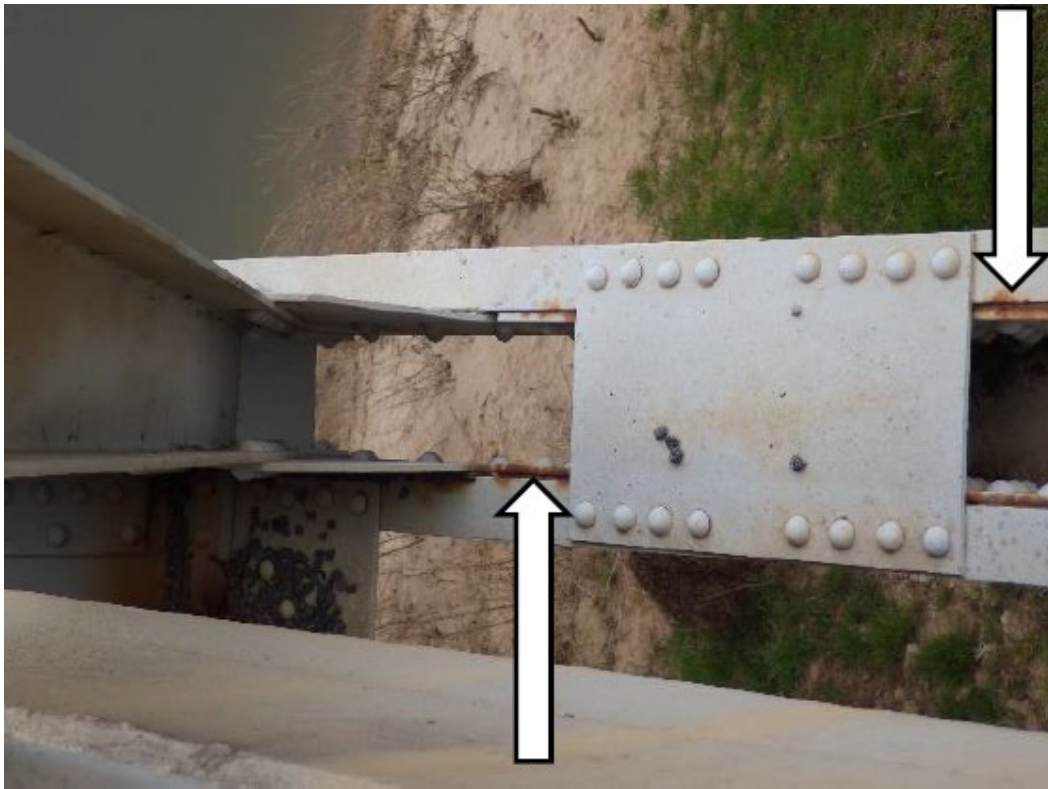
Pack rust at splice plates

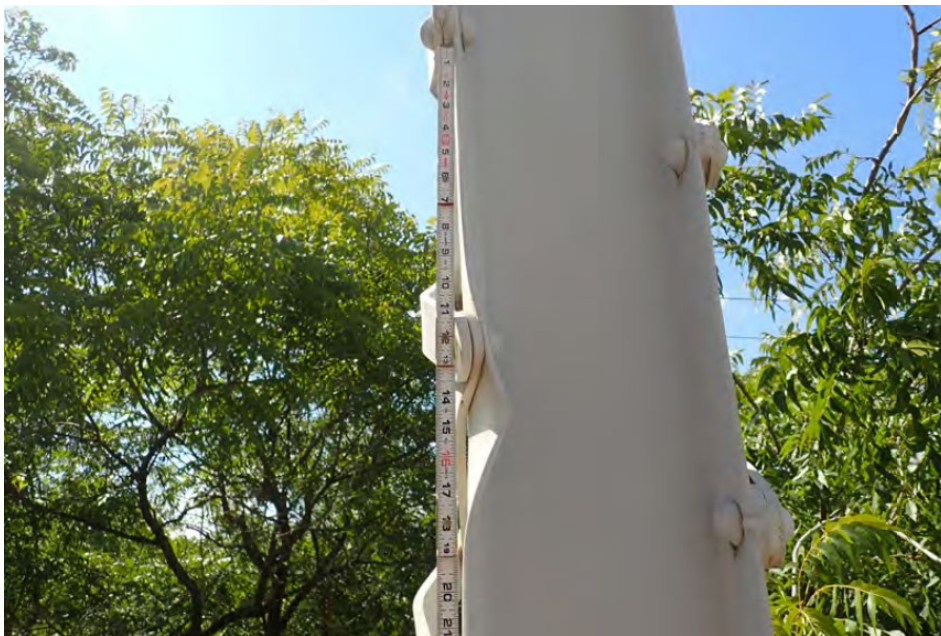
Impact damage

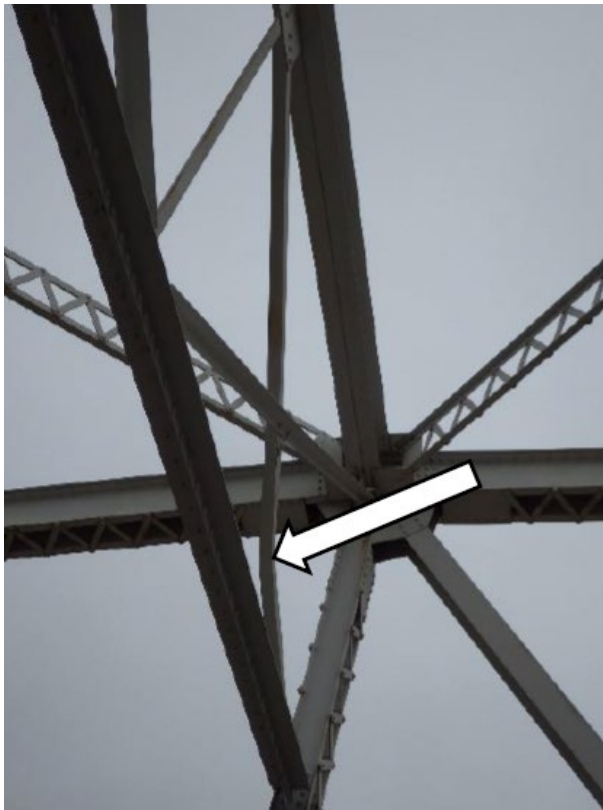
Distorted portal bracing member at location of previously repaired impact damage.

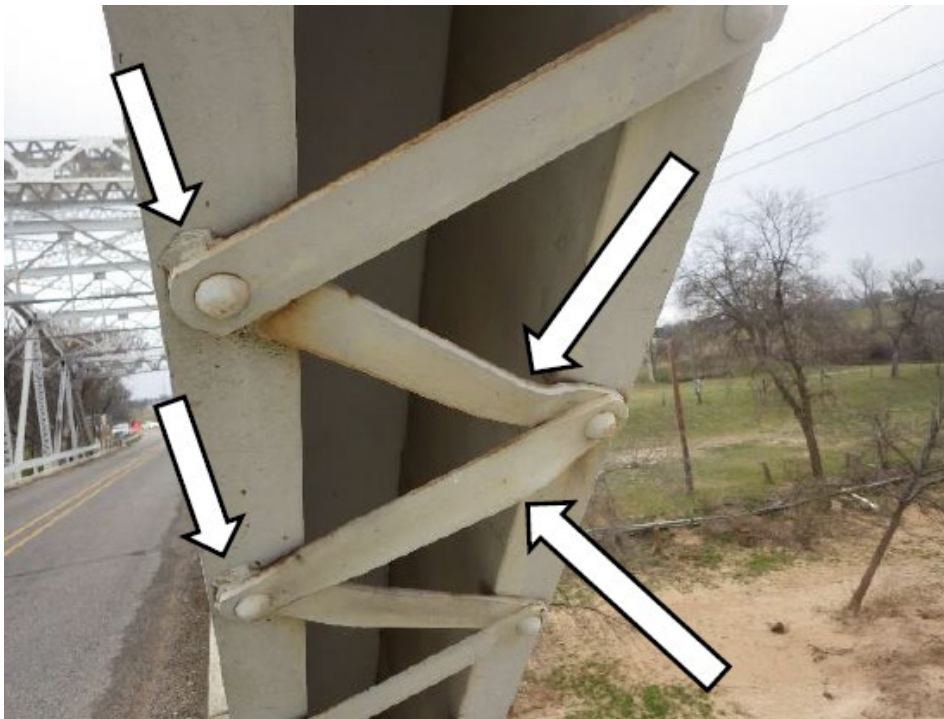
Distorted lacing and welded repair at location of previously repaired impact damage.

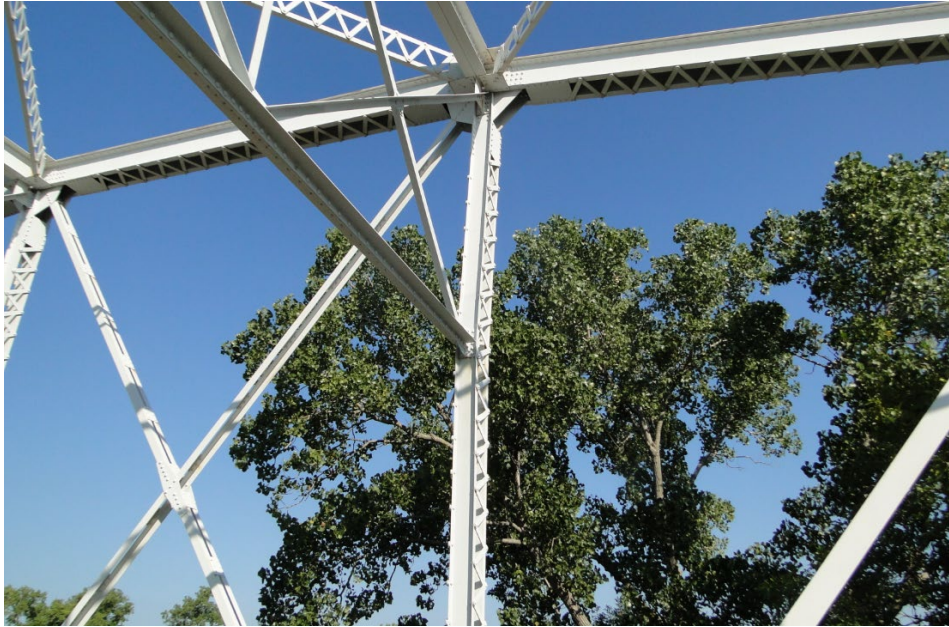
Bent vertical member at location of previously repaired impact damage (U3-L3).

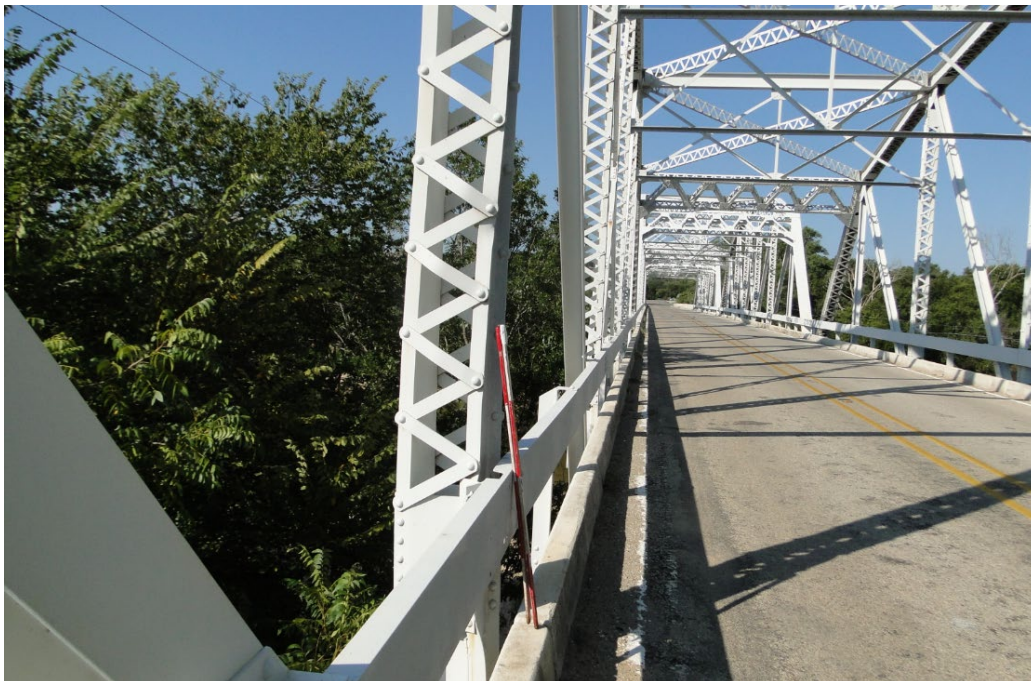
Bent vertical member at location of previously repaired impact damage (U2-L2).

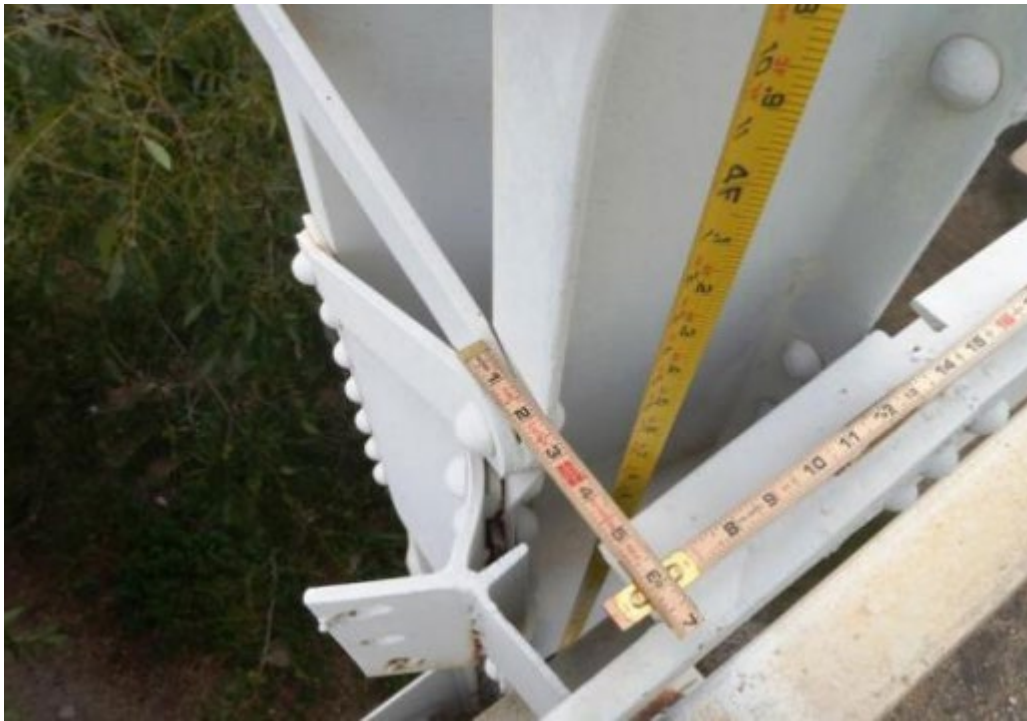
Impact damage

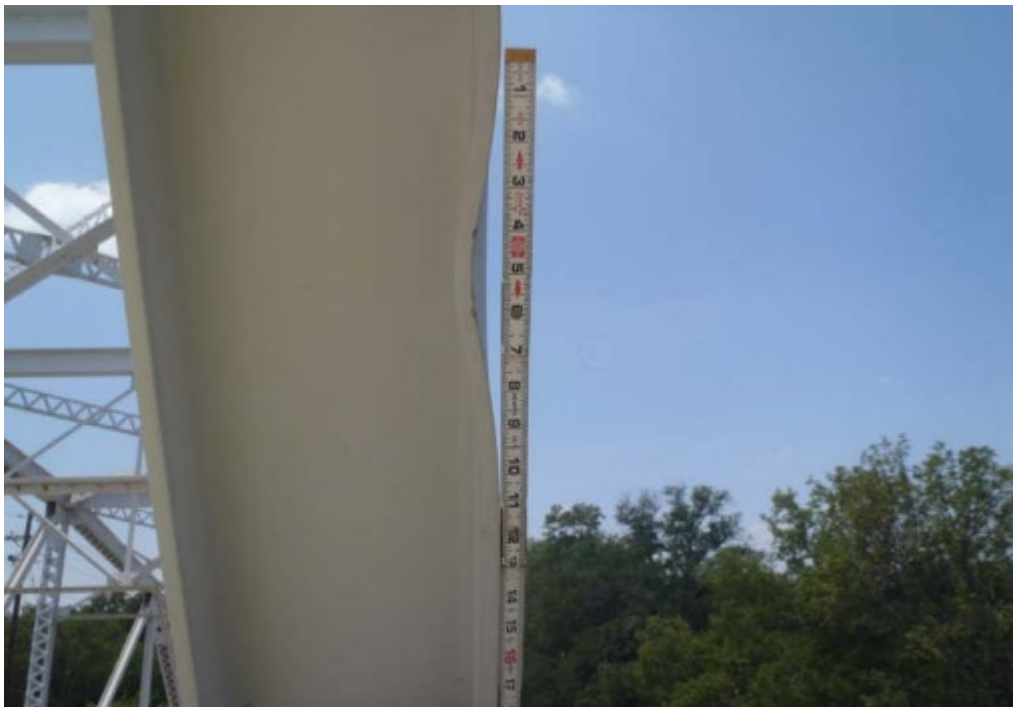
Impact damage to end post

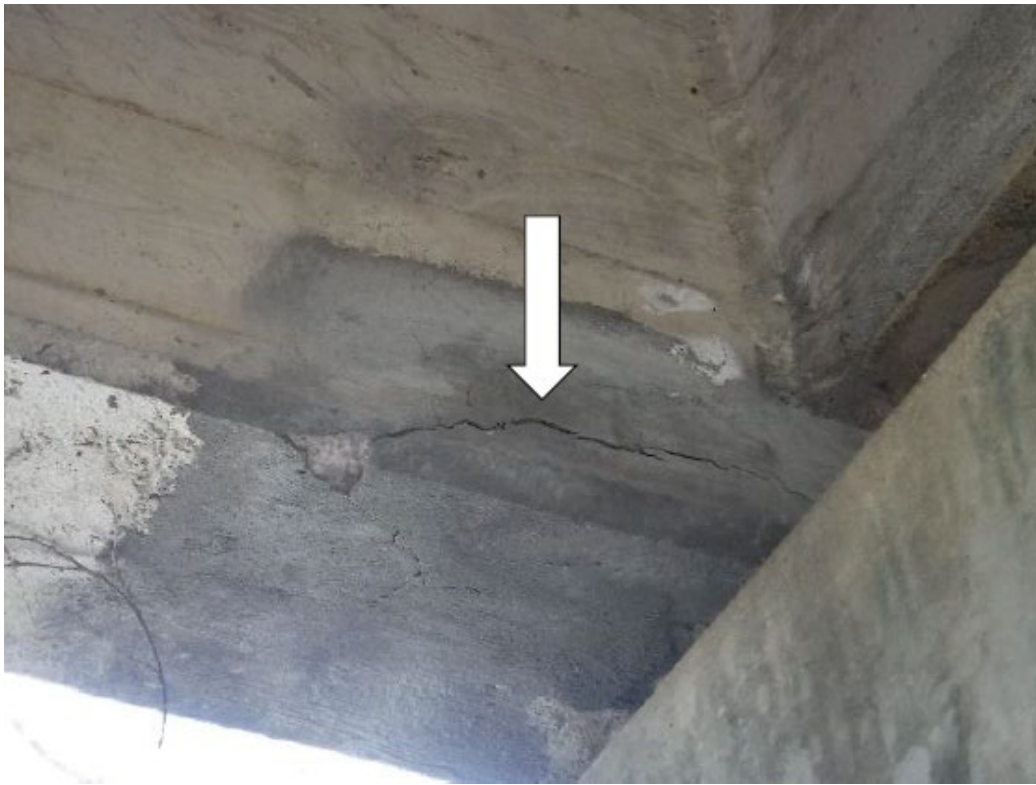
Delamination at girder stem

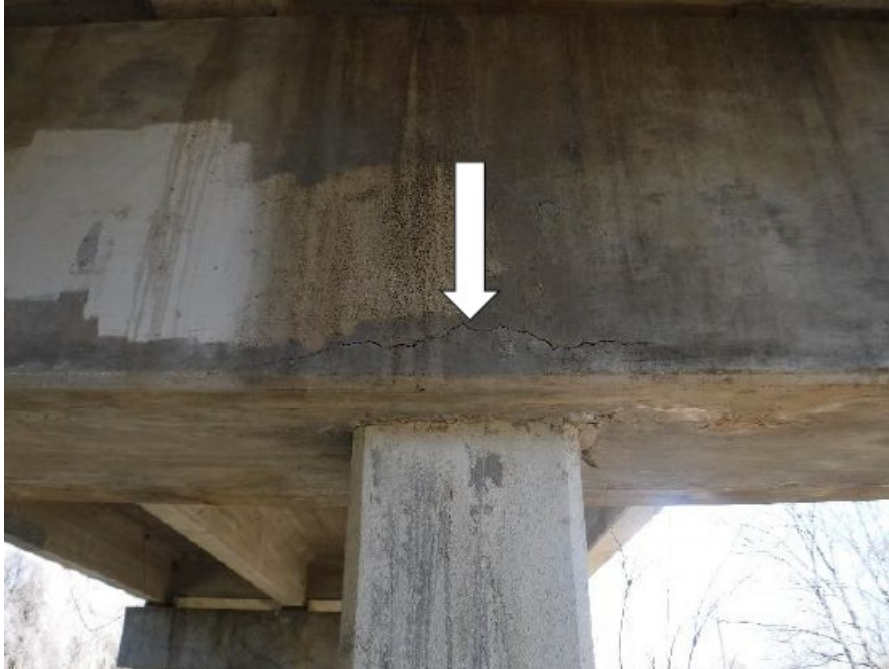
Delamination at substructure

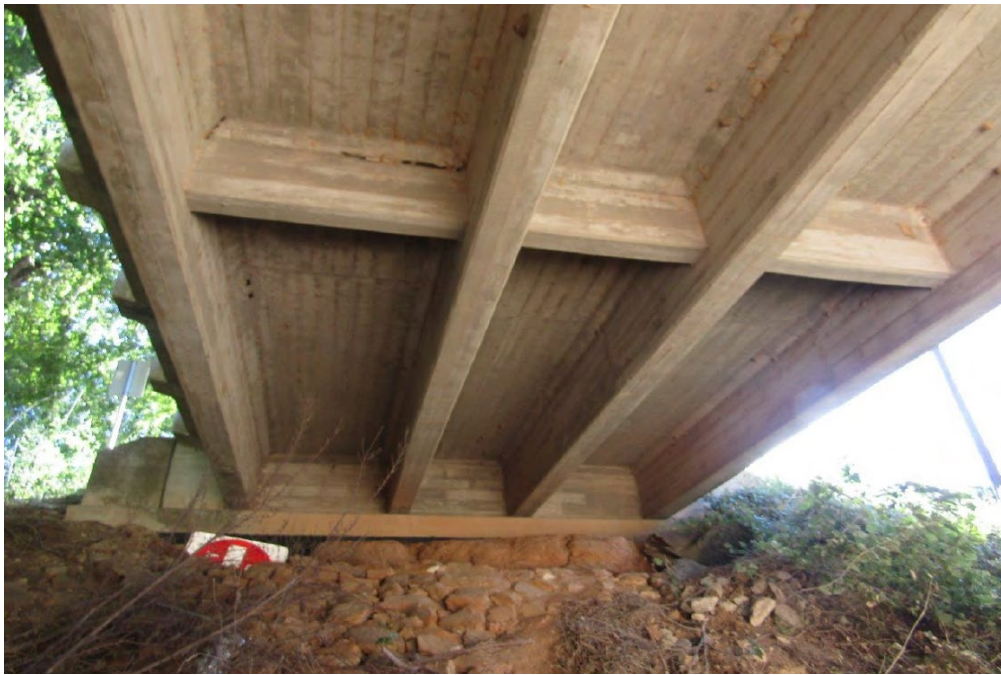
Scour and undermining
