Historic Bridge Adoption Information Packet

Eastland County

County Road (CR) 336

Colony Creek

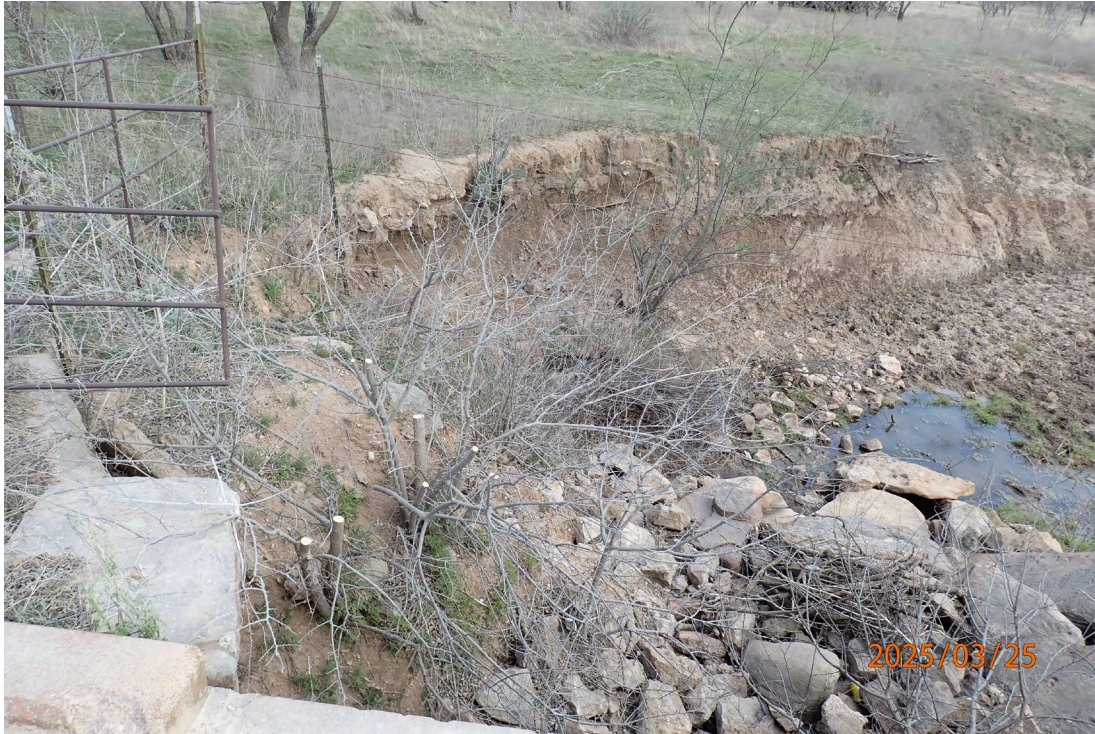
The bridge is in poor condition. The original design strength of the culvert is inadequate for the traffic needs of the site. The culvert will require replacement to provide adequate load carrying capacity for emergency vehicles and farming equipment. Brush and debris currently block the culverts and there are full vertical cracks in the masonry substructure. The concrete slab has exposed rebar that is beginning to rust. Erosion at the northeast channel bank due to stream migration is also evident.

Figure 4. Northeast channel bank, showing erosion and stream migration.

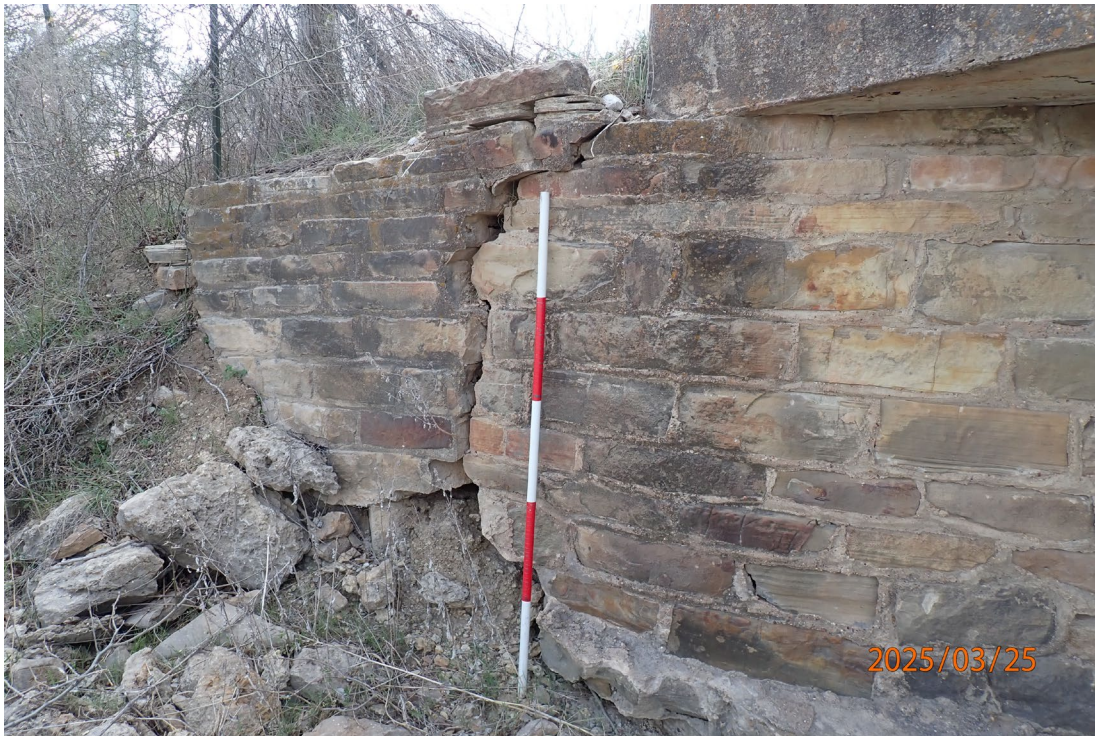
Figure 5. Southeast wingwall with vertical crack.

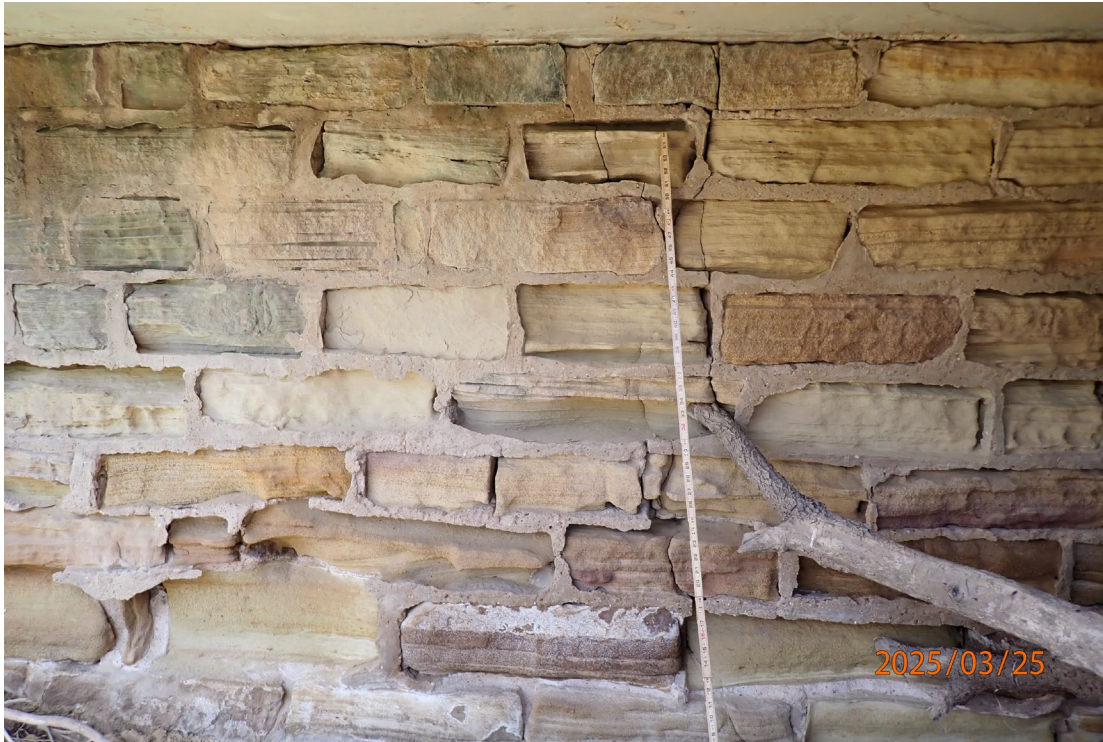
Figure 6. Abutment wall showing missing stones and vertical cracks.

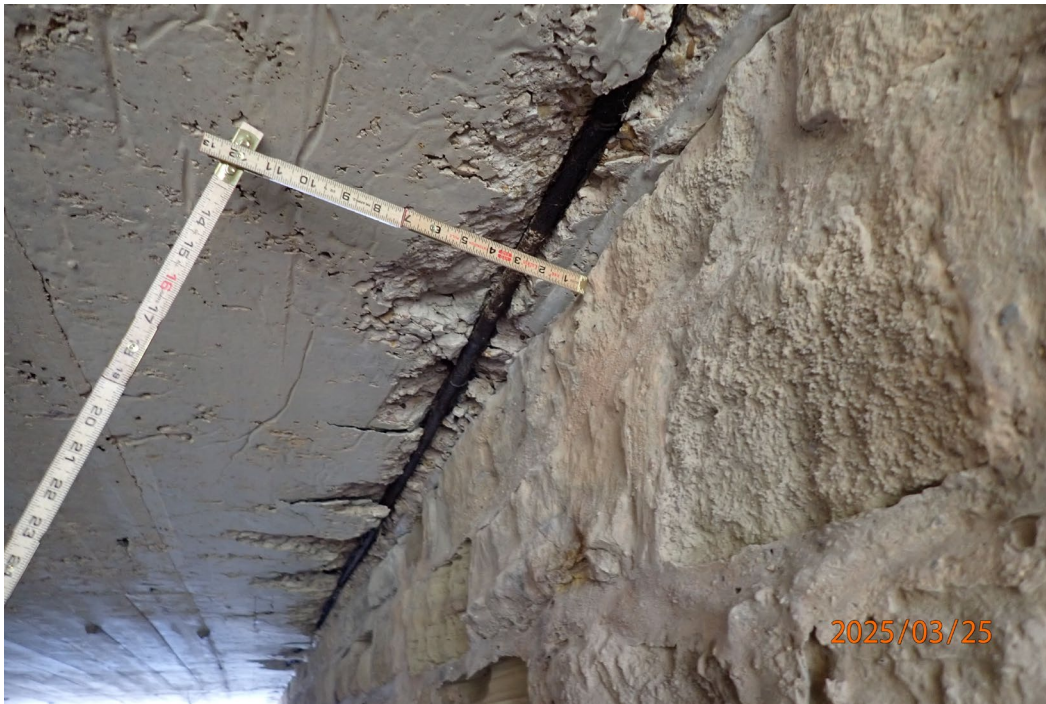
Figure 7. Photo of the underside of the slab with exposed rebar.

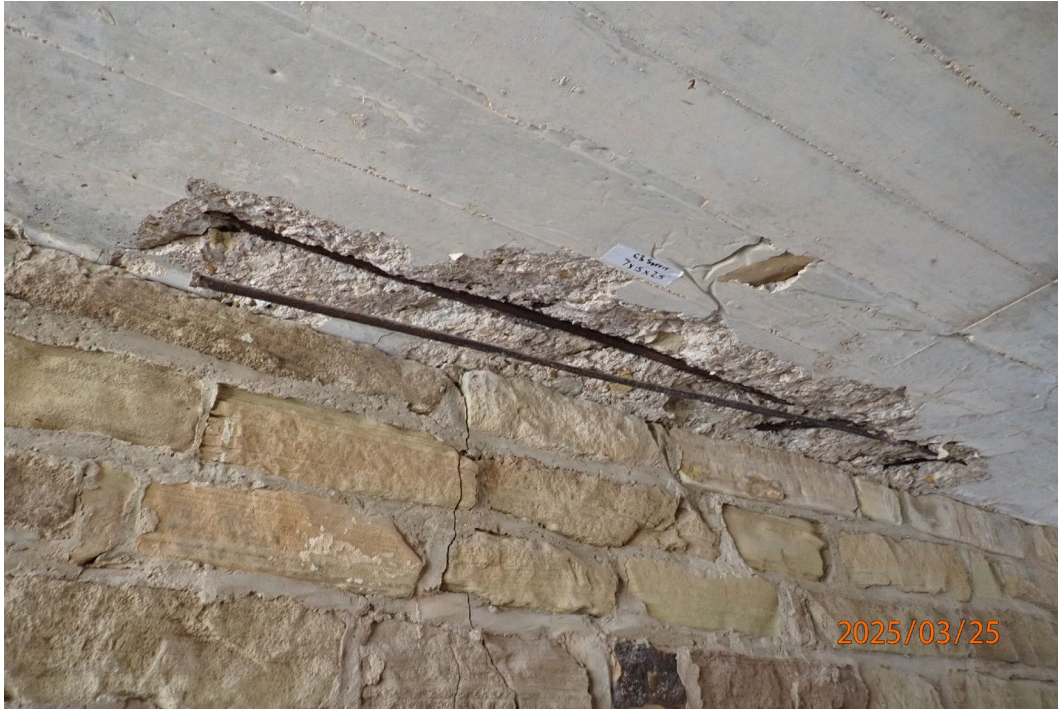
Figure 8. Photo of the underside of the slab with exposed rebar.
