Historic Bridge Adoption Information Packet

Grayson County Craft Road Choctaw Creek Tributary October 2024

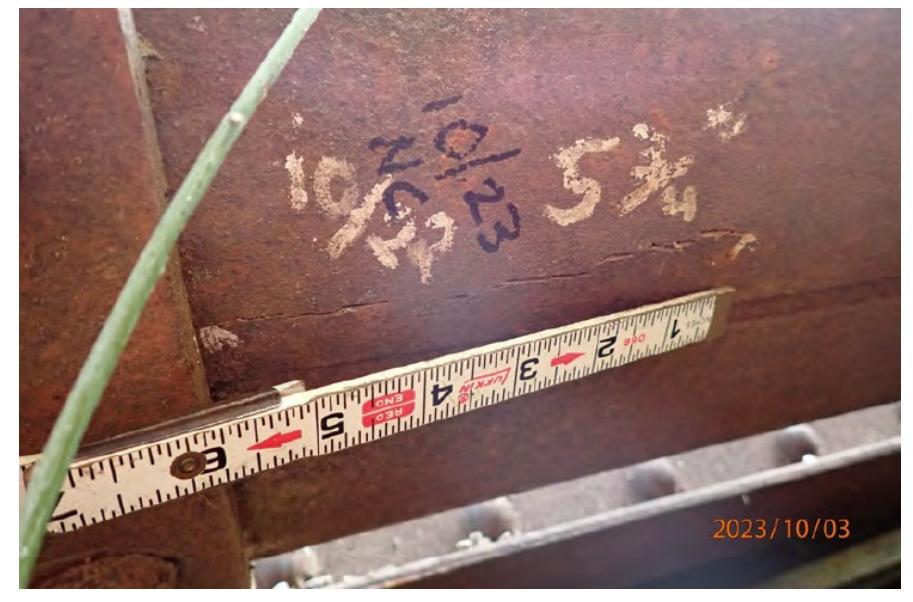
Photo 1: West Truss Bottom Chord (L1-L2)

Bottom flange angle at midspan with 5-3/4 inch long crack.

The damage created from cracking in photos 1-6 must be analyzed by an engineer to determine proper repair. The crack analysis and repairs can be completed after moving the truss but prior to converting the truss to pedestrian use.
