Central Texas Turnpike Project Annual Inspection Report 2009

Subject: FY 09 Inspection of the Central Texas Turnpike Project

Annual Inspection Report
for the fiscal Year ending August 31, 2009

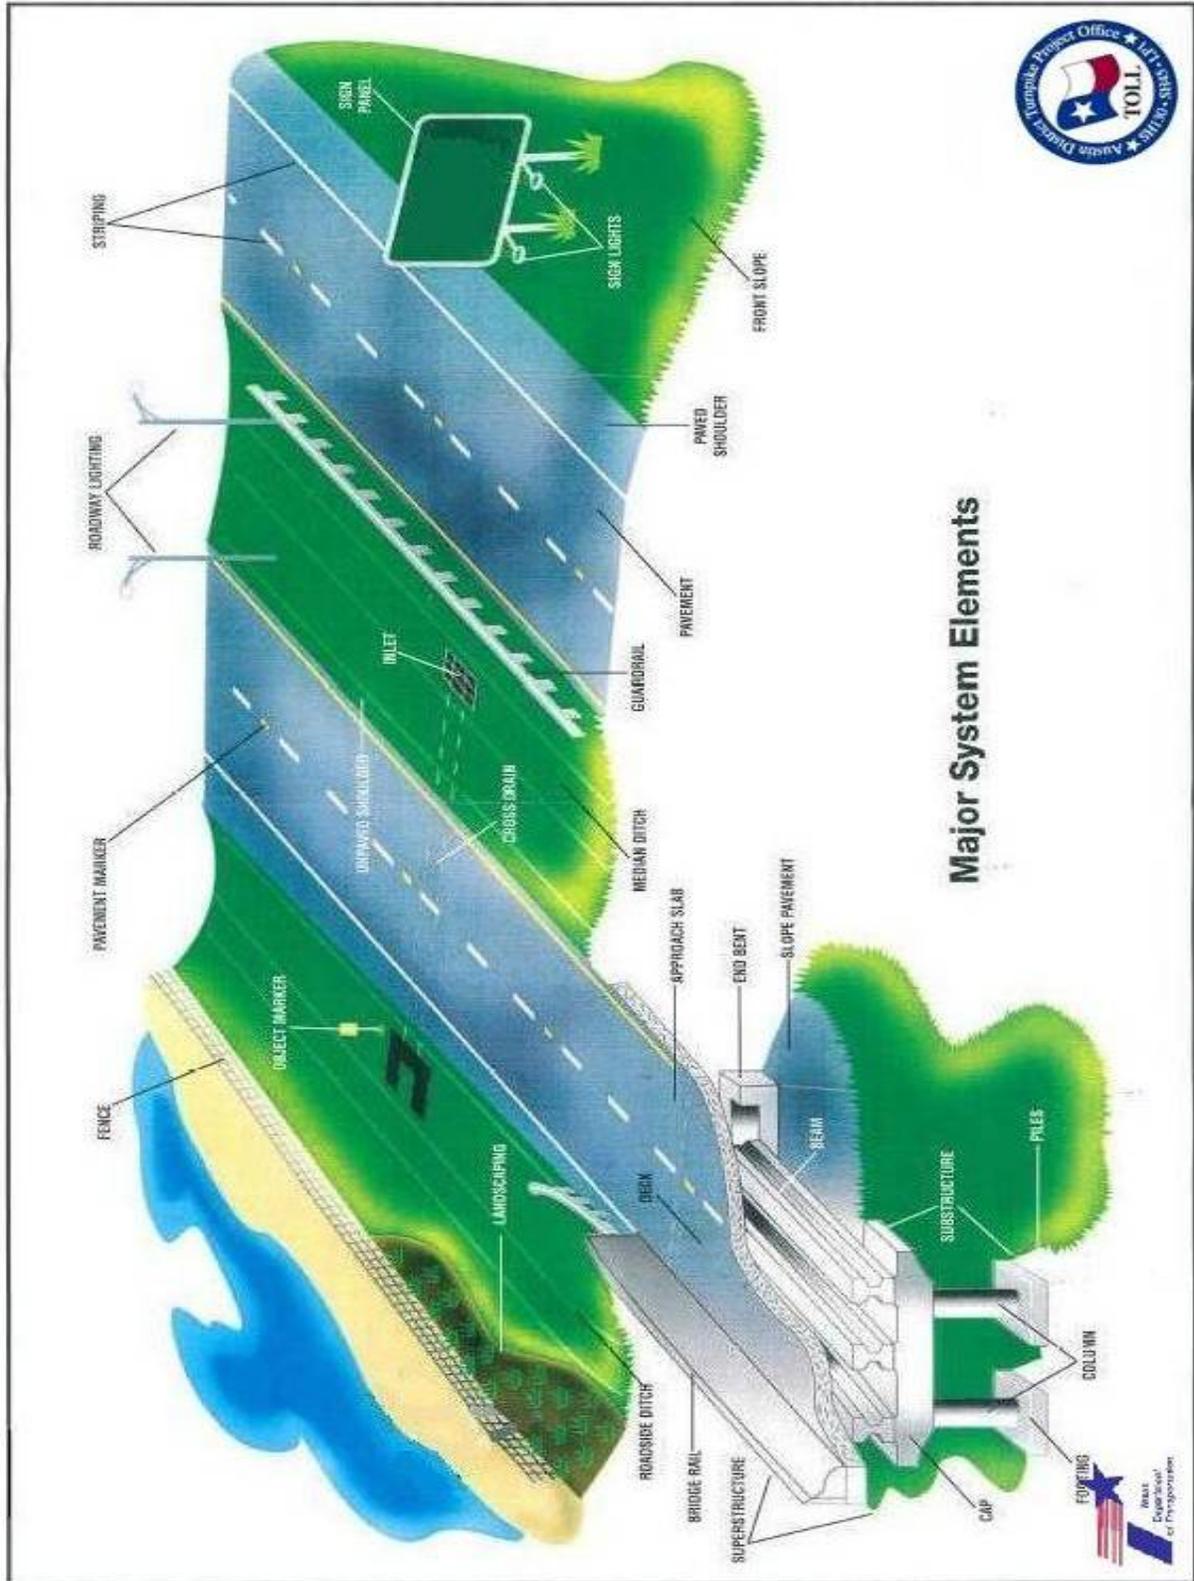
Fig 2 – Major System Elements

The roadway inspection is divided into three general categories of roadway elements: pavement, traffic operations and roadside features. A sketch identifying the major elements of a typical roadway is included as Figure 2.

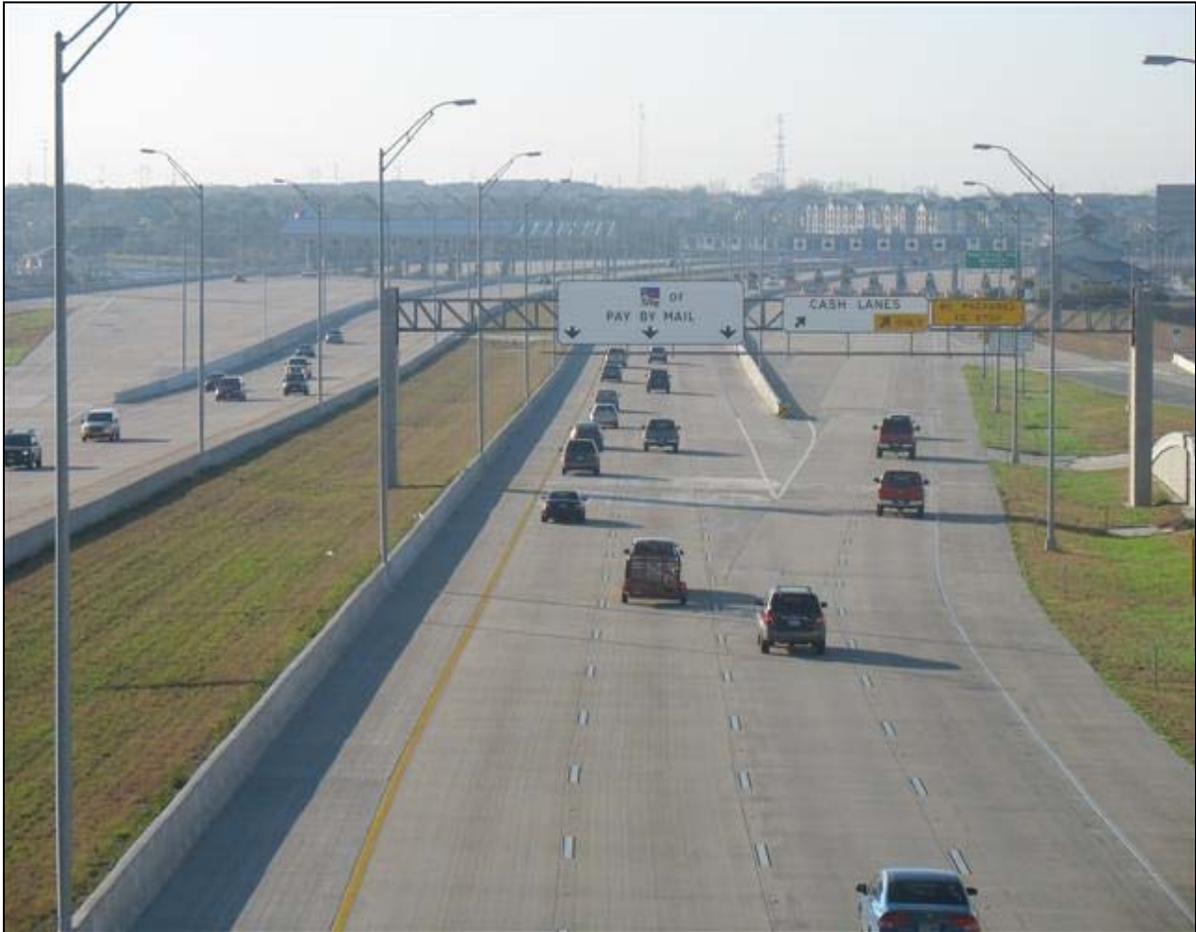
Figure 3 - Typical Roadway Section

The pavement category includes; rutting, cracking, pavement failures, ride rating edges and shoulders. Pavement throughout the CTTTP was generally found in new condition and achieved an overall score rating of 96. None of the pavement elements rated a score below 80 percent. The lowest pavement element score, cracking, received a score of 80 percent and was noted on Loop 1. There were no major deficiencies on any of the three roadway systems reported by the annual inspection.

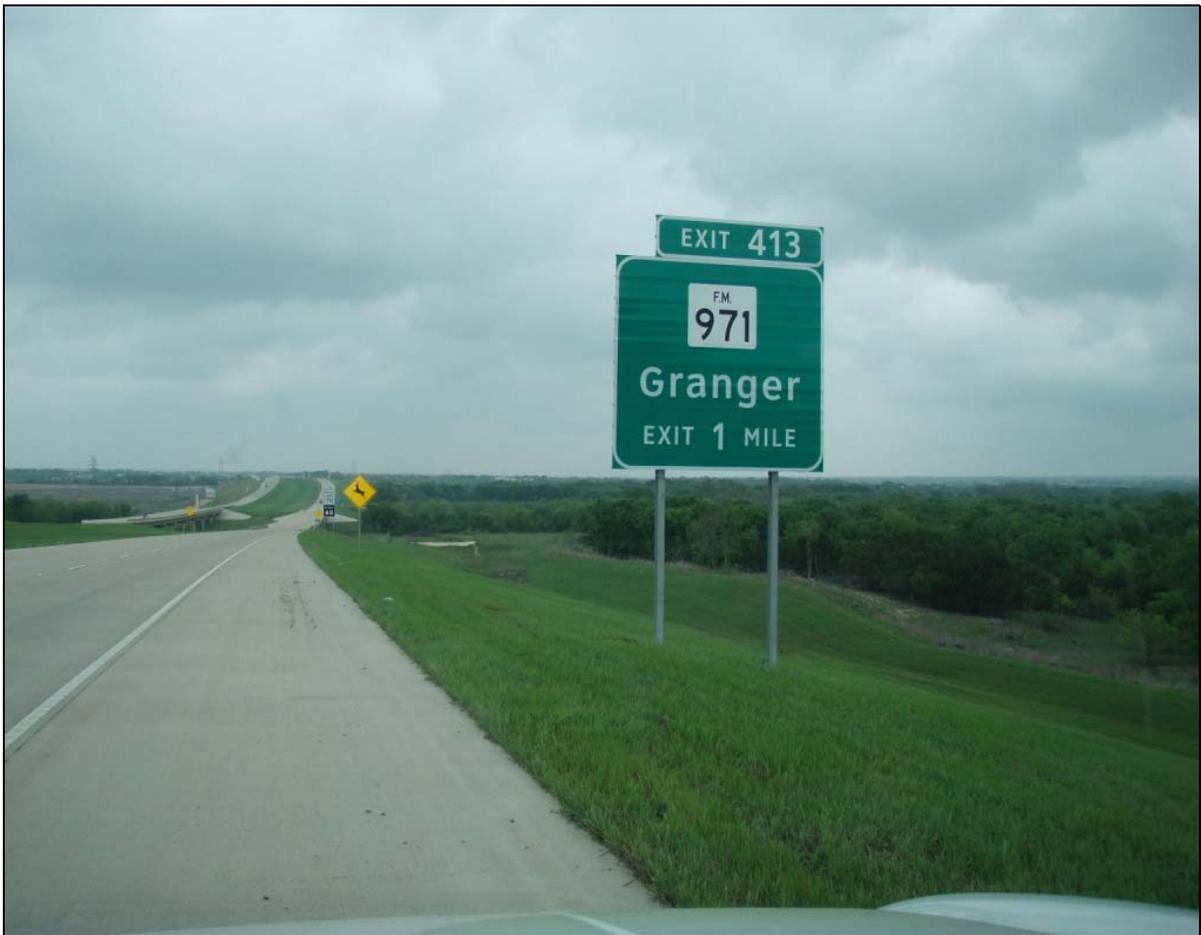
Figure 4 – Typical Roadside Section

The determination of the Roadside score for roadside features is generally based upon the consideration of vegetation management, litter removal, drainage structures, and other elements located outside of the paved travel way (Figure 2). The roadside category is in excellent condition and has achieved an overall score of 98. There were no characteristics that rated lower than 91. The lowest element, vegetation management, was found on SH 130. A combination of sparse and or missing turf in combination with minor erosion contributed to the reduced score.

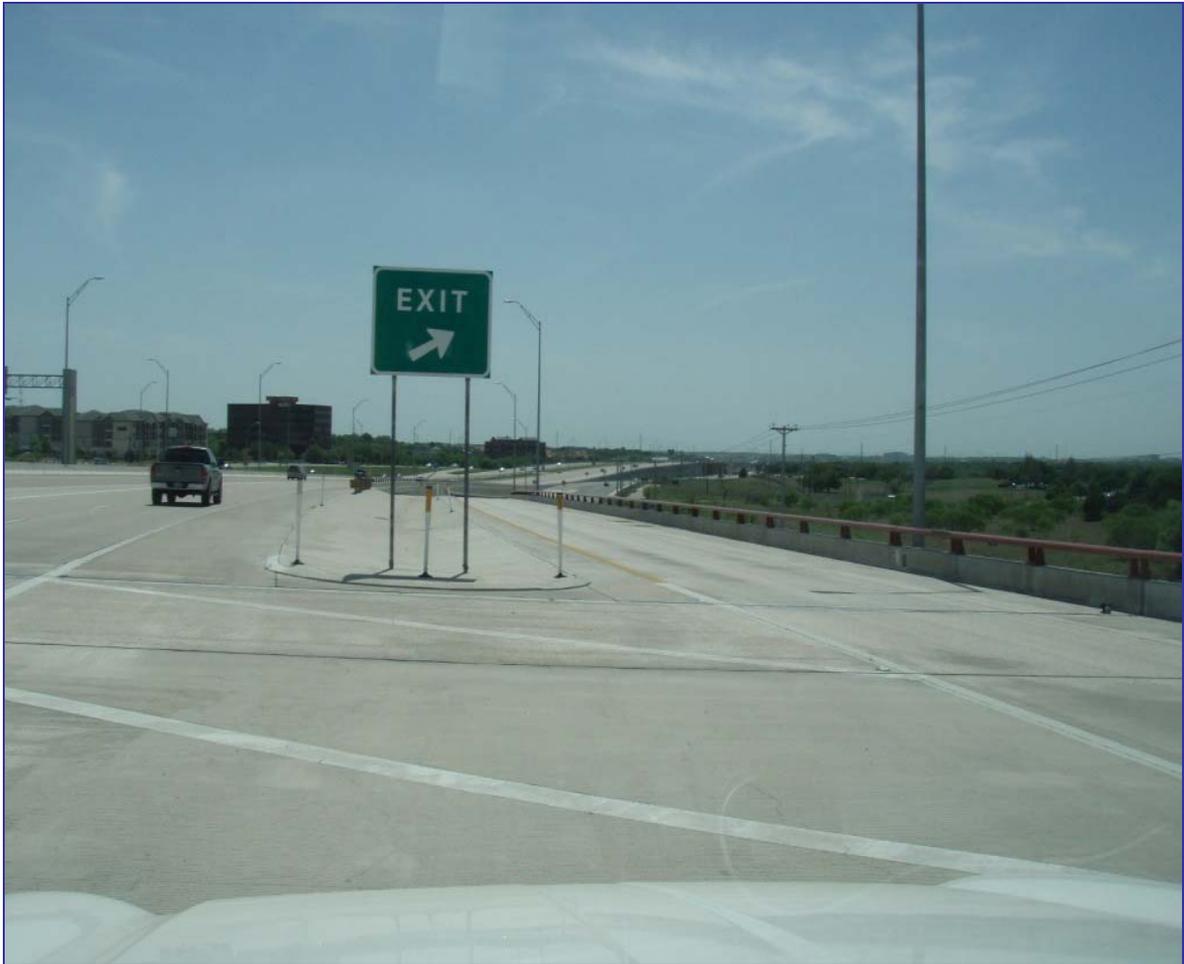
Figure 5 – Roadside Sign and Pavement Symbols

The Traffic Operations category ratings are based on the condition of all features that guide, protect, and assist the patron while traveling the Turnpike System's roadways and interchanges. A Traffic Operations score rating of 94 was achieved in this category. While the overall score generally reflects the good condition of this category, delineators / mile markers were noted to be less than adequate. During the inspection, many delineators and mile markers were noted as missing on SH 130. The delineators were rated at 70% on SH 130, the lowest score of all three CTPP highways. Mile markers are only present on SH 130 and were not scored on SH 45 and Loop 1.

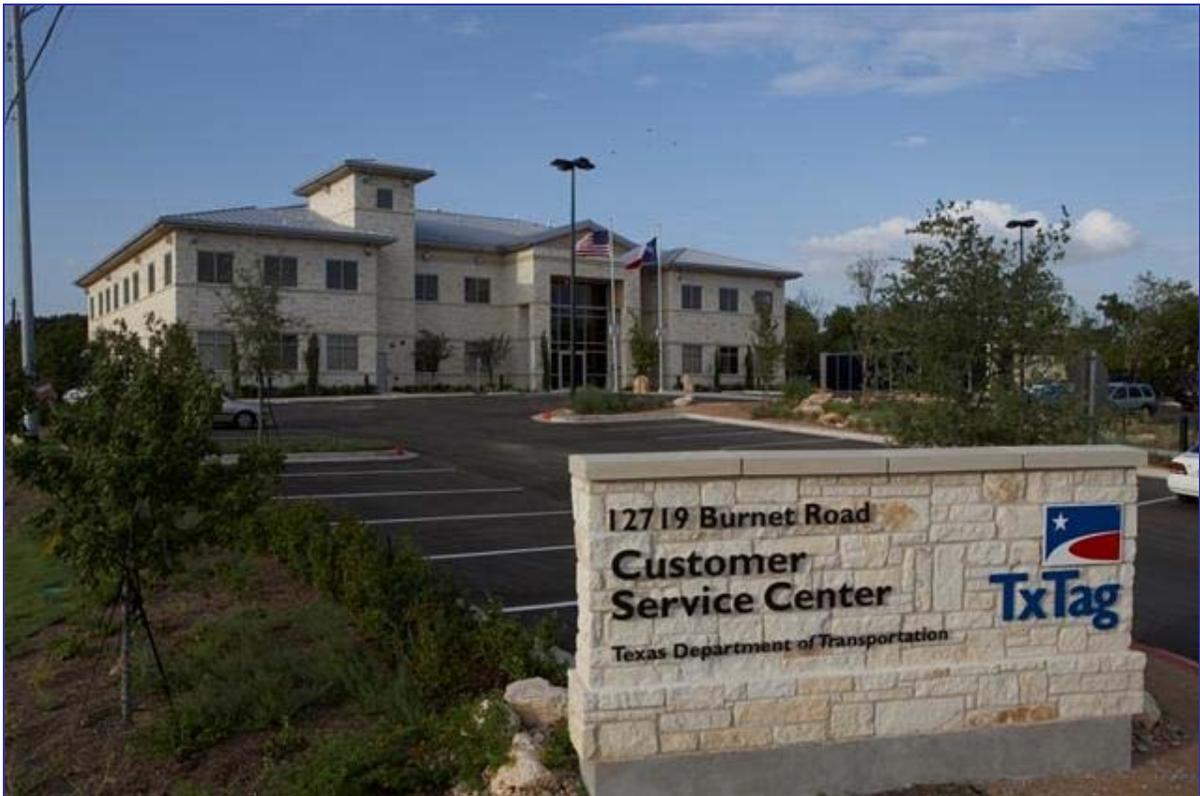
Figure 6 - Customer Service Center

The Texas Tag (TxTag) Customer Service Center (CSC) as shown in Fig. 6 below provides support for TxDOT's and other toll projects throughout the state. "TxTag" is the toll transponder that patrons use to pay tolls electronically by establishing a pre-paid account. The TxTag CSC supports patrons using TxTags as well as toll road patrons choosing to use the Pay by Mail process for their tolls monthly. In both cases, a customer account is established to accept payment or pre-payment for tolls. For transponder-based accounts, the CSC also supports inventory, fulfillment and distribution of the TxTag kits.

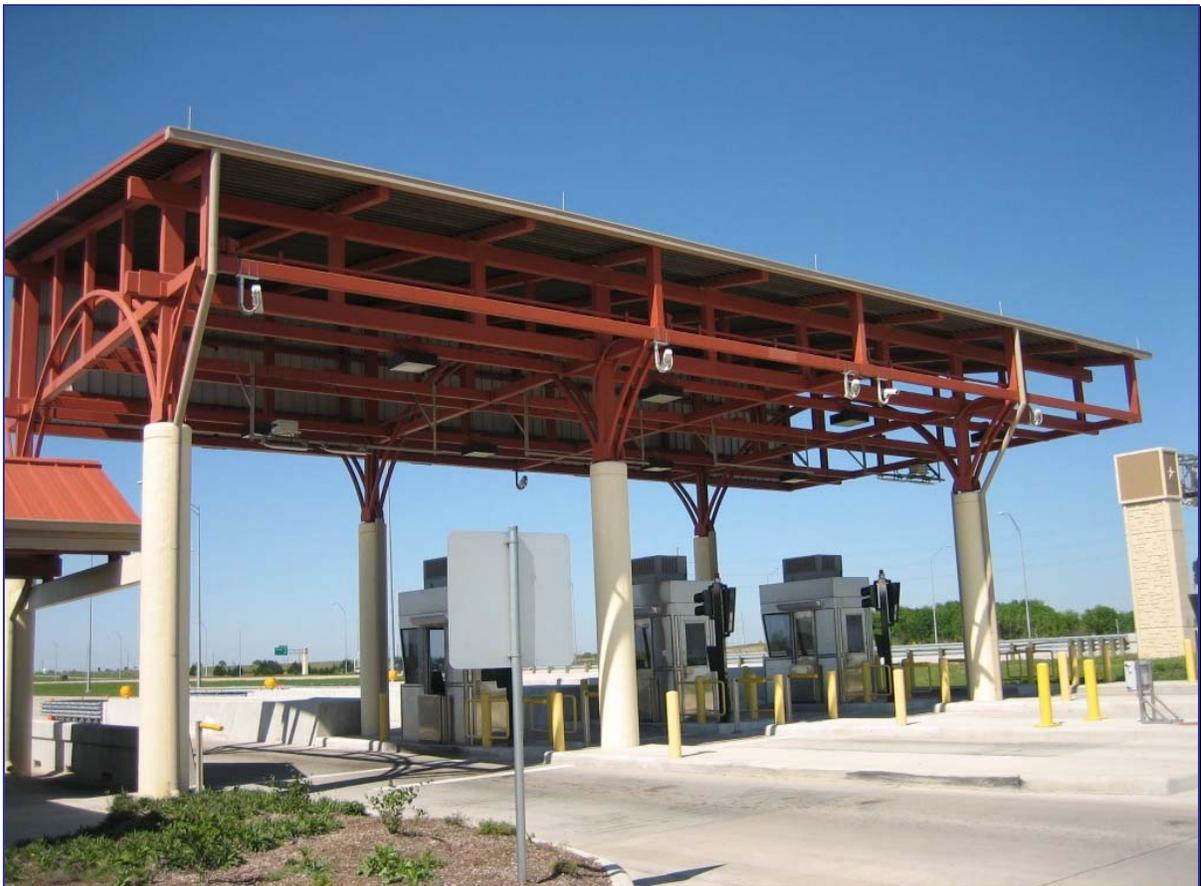
Figure 7 - Mainline Canopy

The toll plaza administration buildings and canopies are located either as part of a mainline toll plaza or ramp toll plaza facility. The canopies typically extend from the administration buildings outward, over the tollbooths or toll collection equipment located between the travel lanes. The administration buildings may also be connected to the toll collection booths/equipment by means of an underground tunnel, which facilitates the transport of personnel, toll collection data, and supplies.

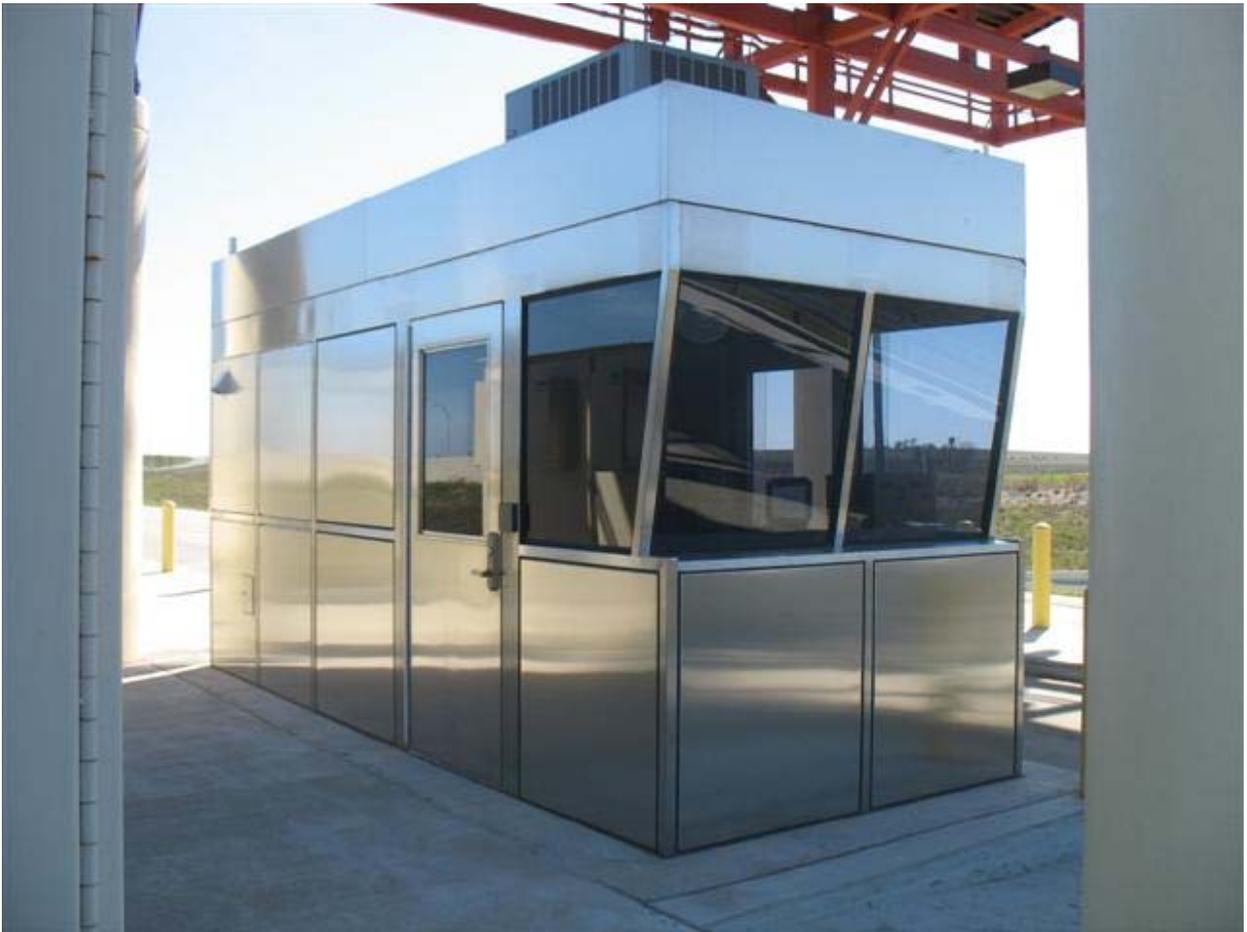
Figure 8 - Toll Booth

All tollbooths, including those that have been decommissioned, were inspected during the FY 09 inspection. Tollbooths and related subcomponents were noted in excellent condition throughout the CTTTP. Only one tollbooth element, Toll A/C at 10.00% was rated greater than 5% deficient within the system. A typical tollbooth configuration is pictured below in figure 8. The condition of the elements and the corresponding deficiencies for each of these categories is summarized in Tables 9 through 11, with a system-wide summary shown in Table 12.

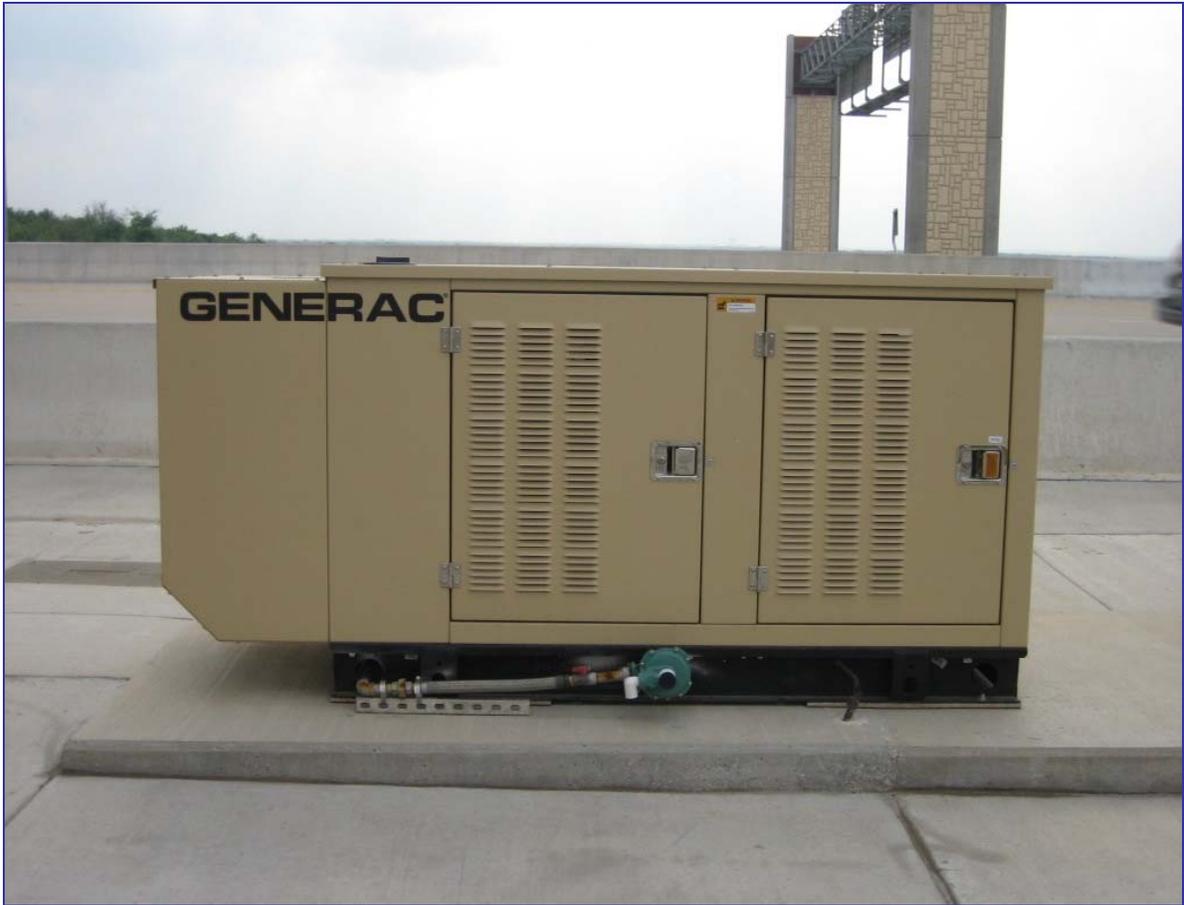
Figure 9 – Facility Generator

Of the 1279 total electrical elements in the electrical category, only twelve deficient elements were noted as deficient for an overall deficiency rate of 0.94%. Ten of the elements are non-functioning GFI receptacles located at several facilities throughout the system. Two generators are noted as not installed at the Heatherwilde Blvd facilities.

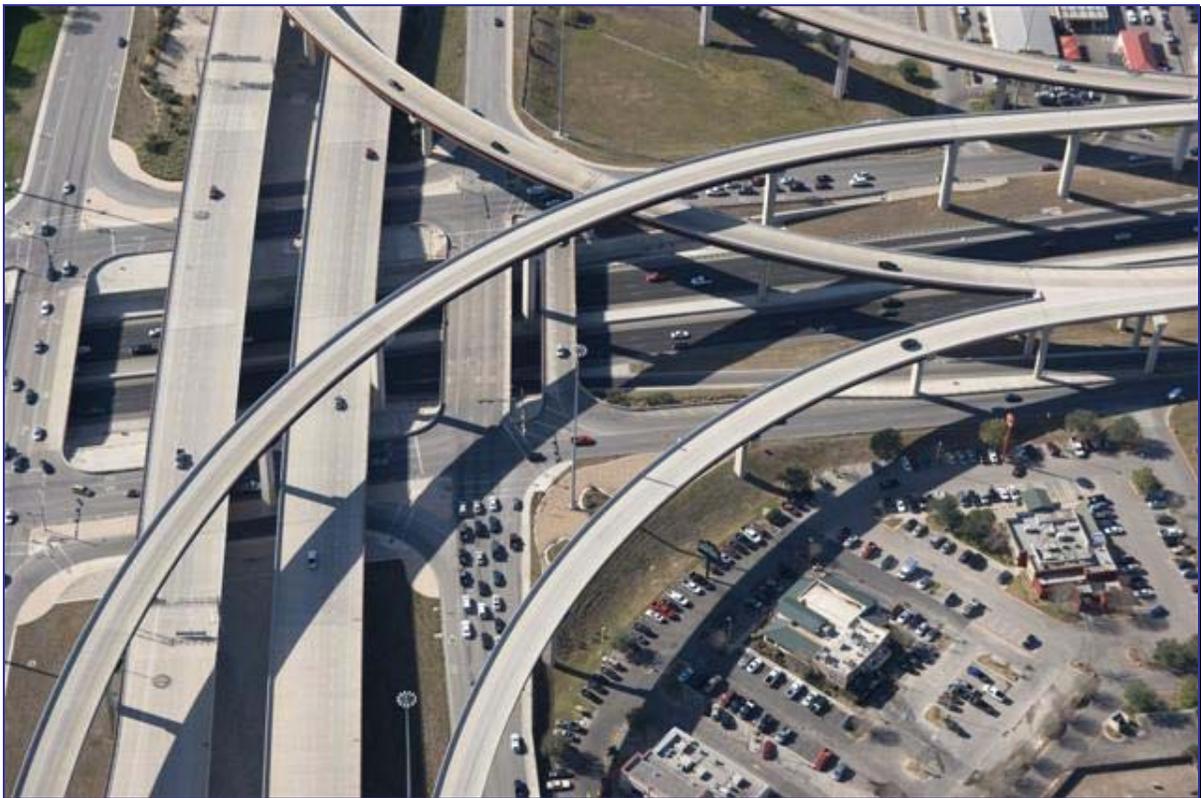
Figure 10 - Bridges

The Federal Bridge Inspection Summary Report (Appendix C) was compiled, reviewed, and are included on the CD located in the CD jacket inside the back cover of this report. The bridge components and major elements are listed in Table 14. The biennial inspection is based on three main components, comprised of a total of 93 elements, and 117 sub elements, for fixed bridges only. A numerical score is generated for each component based on the rating scale shown in Table 15. A review of the Federal Bridge Inspection Summary Report found no major deficiencies on any bridge within the CTTTP.

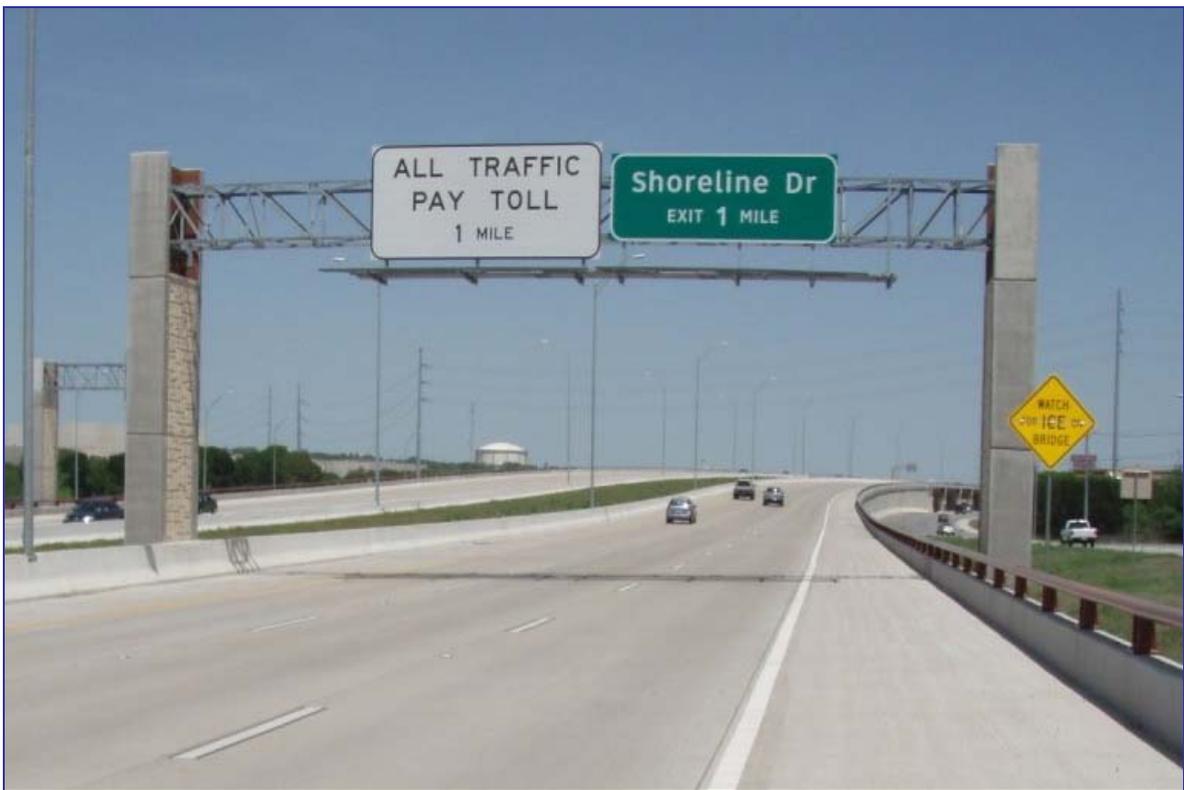
Figure 11 - Overhead Sign Structure

Overhead and cantilever signs, such as the one pictured in Figure 11 are suspended above the travel way by large support structures and are included in the roadside category. These signs provide critical directional information, guiding the patron throughout the Central Texas Turnpike Project. TxDOT performed an inspection of the overhead structures at the completion of their construction. At that time, none of the overhead / cantilever sign components and subcomponents inspected were noted as being in less than fair condition. Overhead sign components included in the assessment are listed in Table 16 below. The standard five point TxCAP rating scale was utilized to assess the condition of all overhead / cantilever sign structures.

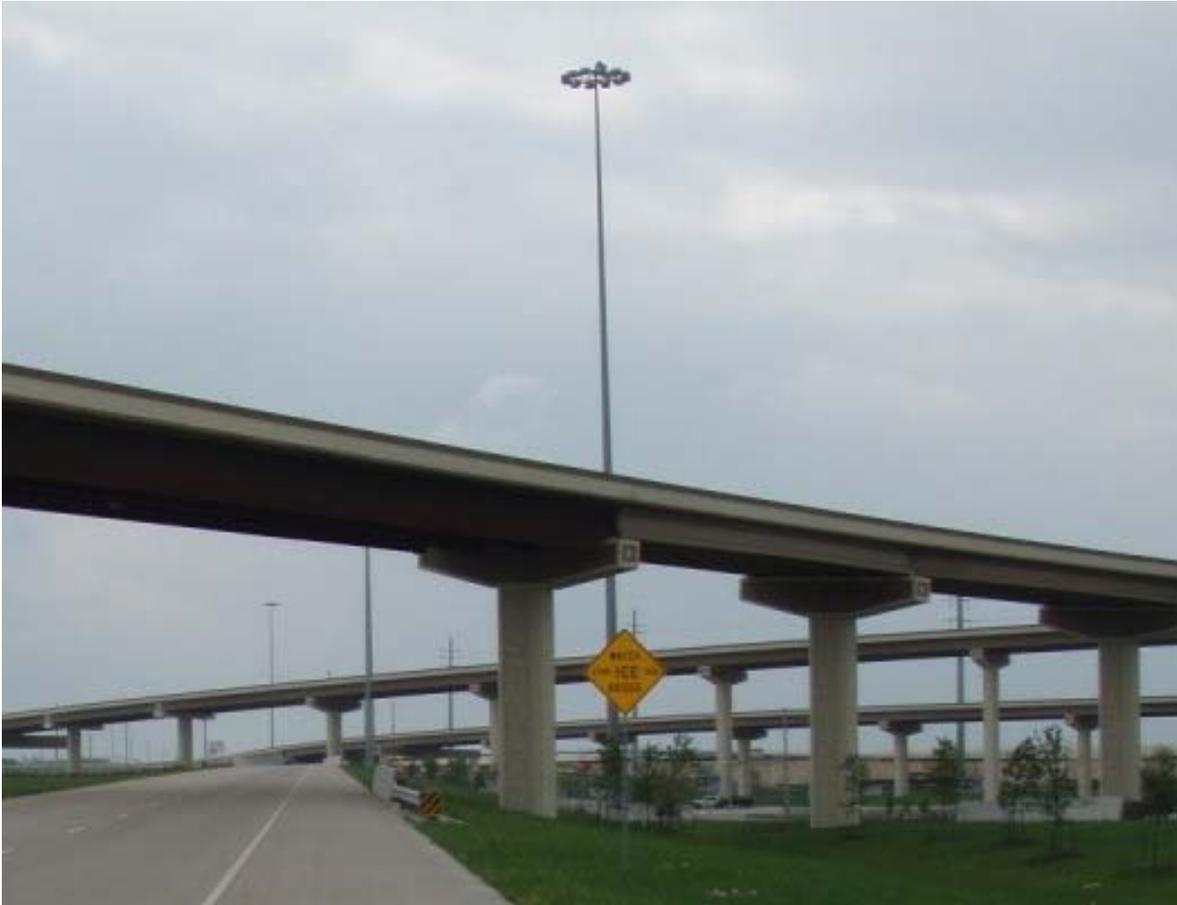
Figure 12 – High Mast Light Pole

Similar to overhead / cantilever signs, HMLTs were inspected by TxDOT at the completion of their construction. No deficiencies were noted during the post construction inspection. These structures, like the one pictured in Figure 12, provide illumination for improved nighttime visibility at various locations along the Turnpike Project, such as interchanges, and toll facilities. The condition of high mast light towers is determined by the two components listed in Table 17 below.
