Texas Department of Transportation
TECHNICAL PROVISIONS

STATE HIGHWAY 71 TOLL LANES

Attachment 17-1
Conceptual ITS Layout

TTI Pedestrian and Bicycle Study
State Highway 71 – Del Valle Area

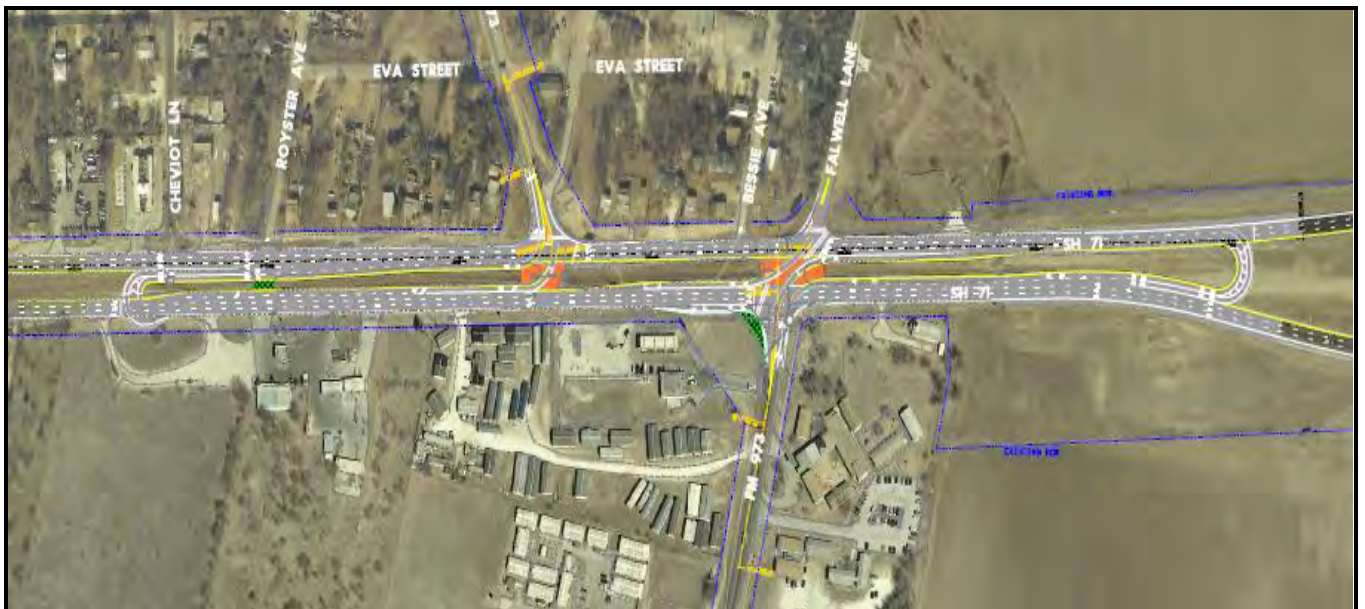
The Texas Department of Transportation (TxDOT) is in the process of designing a “superstreet” along SH 71 to reduce congestion. A superstreet is a new type of intersection design which is intended to reduce the delay for motorists. The project increases the number of vehicles through the signalized intersections by eliminating left turn movements. Those left turning motorists would be required to turn right and then make a U-turn to effectively complete the left turn maneuver. See Figure 1.

Figure 1. Proposed Layout of Superstreet

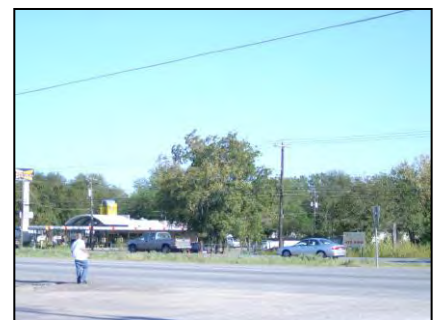
Figure 2. Pedestrian Crossing Midblock on SH 71

Walking and biking volume and origin/destination data was gathered on Thursday, November 18, 2010 from 6:00am to 6:00pm with two 1-hour breaks in the day from 10-11am and 3-4pm. Daylight hours limited the view prior to 6:30am. Almost 300 pedestrian crossings and six bicyclists were counted crossing and/or traveling along the roadway over the course of the 10-hour period. These were mostly adults and a few teenagers. Data were collected in three parts as shown circled in Figure 2: SH 71 West, SH 71 East and FM 973 (south leg). The highest hourly volume crossing SH 71 was 23 pedestrians, 19 of whom crossed midblock at uncontrolled locations in the western section of SH 71. In the eastern section, many more pedestrians were seen crossing at the signalized intersections of FM 973. There were seven (7) pedestrians who crossed midblock between 5-6pm and six (6) pedestrians who crossed midblock between 2-3pm. Over 100 pedestrians were counted

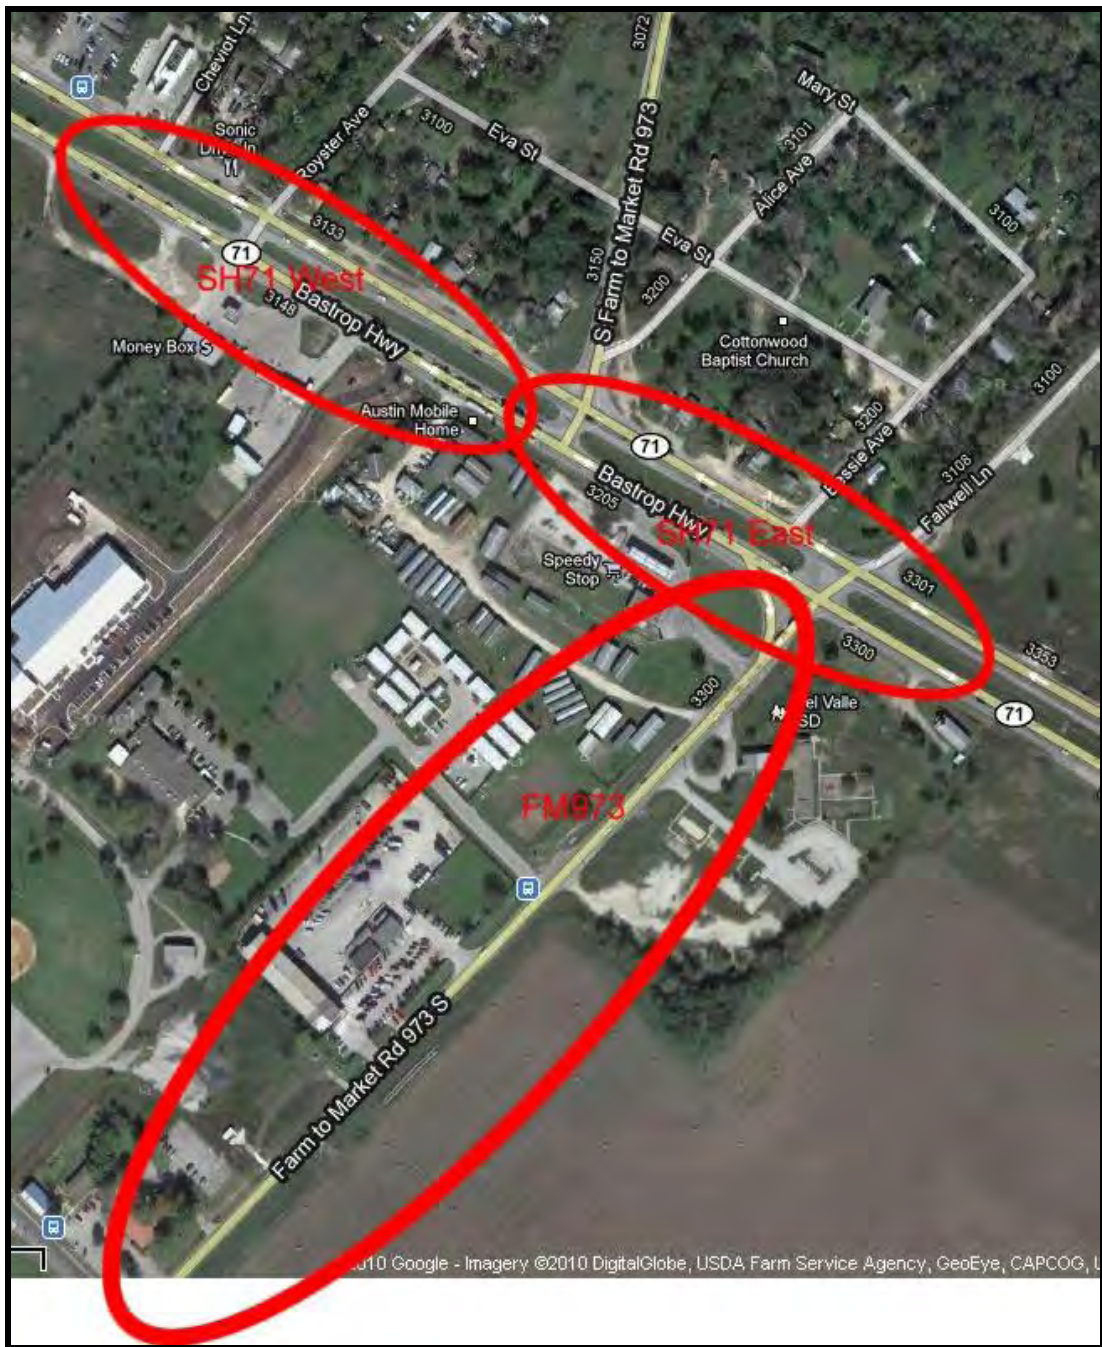
Figure 3. SH 71 West, SH 71 East, and South leg of FM 973

1. SH 71 was divided into two parts and covered by two observers (Figure 3). Some of the pedestrians may have been counted twice since their activities may extend to two observers' range. This issue doesn't exist in the figures since every activity has its own trajectory.

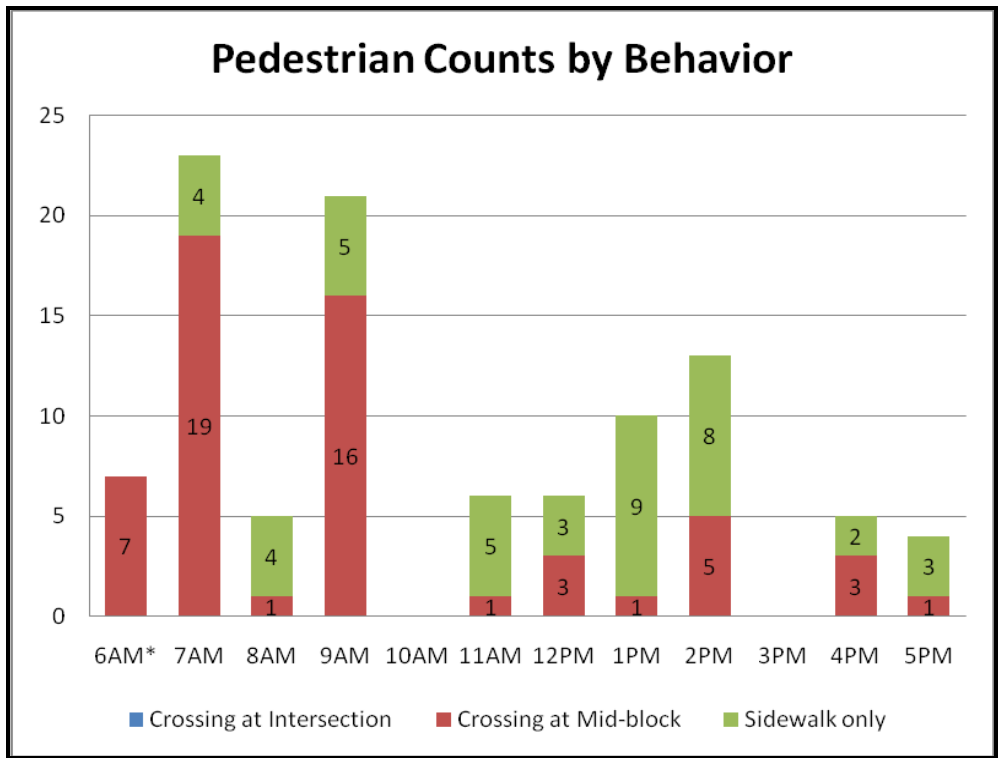
Note: No data was collected from 10-11am and 3-4pm

Figure 4. SH 71 West Pedestrian Counts by Behavior

6. Figures 4, 5, and 6 chart the pedestrian and bicycle count data by behavior.

Charts showing approximate age of the pedestrian by time of day are available in Appendix C. As seen in Figures 4-6 above, there were 10 or more pedestrians per hour in each of these sections. The maximum hour for SH 71 pedestrian activity occurred from 7:00 to 8:00 AM when 23 people were counted walking

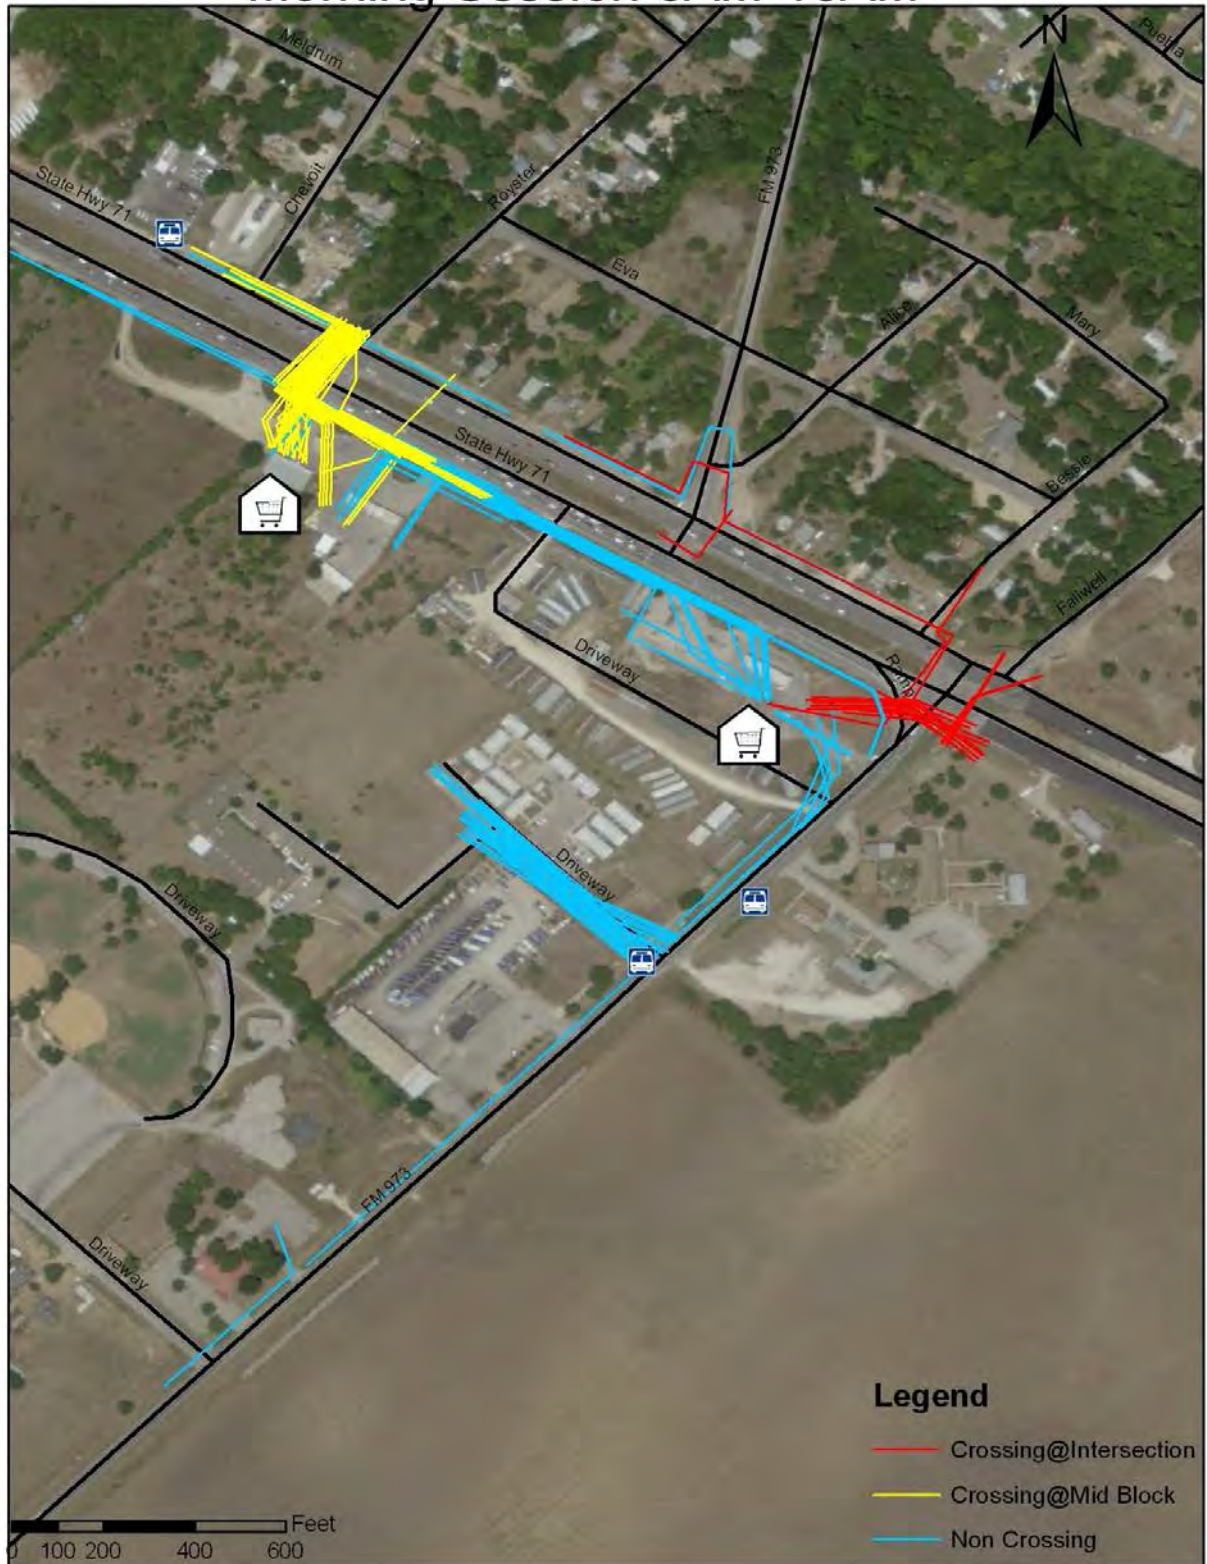
Austin Texas SH71/FM973 Pedestrian Activity Map Morning Session 6AM-10AM

Figure 8. Morning Pedestrian Travel

Lines were drawn on a satellite image of the study area and extended beyond the roadway to better indicate the pedestrian's origin and destination. These lines are shown in Figures 8-10 where each pedestrian is represented by a line. The pedestrians who crossed the roadway are not counted as walking along even though they might have walked adjacent to the roadway for some part of their walking trip. A closer view of each of the primary crossing points showing arrows for the direction of travel is included in Appendix D.

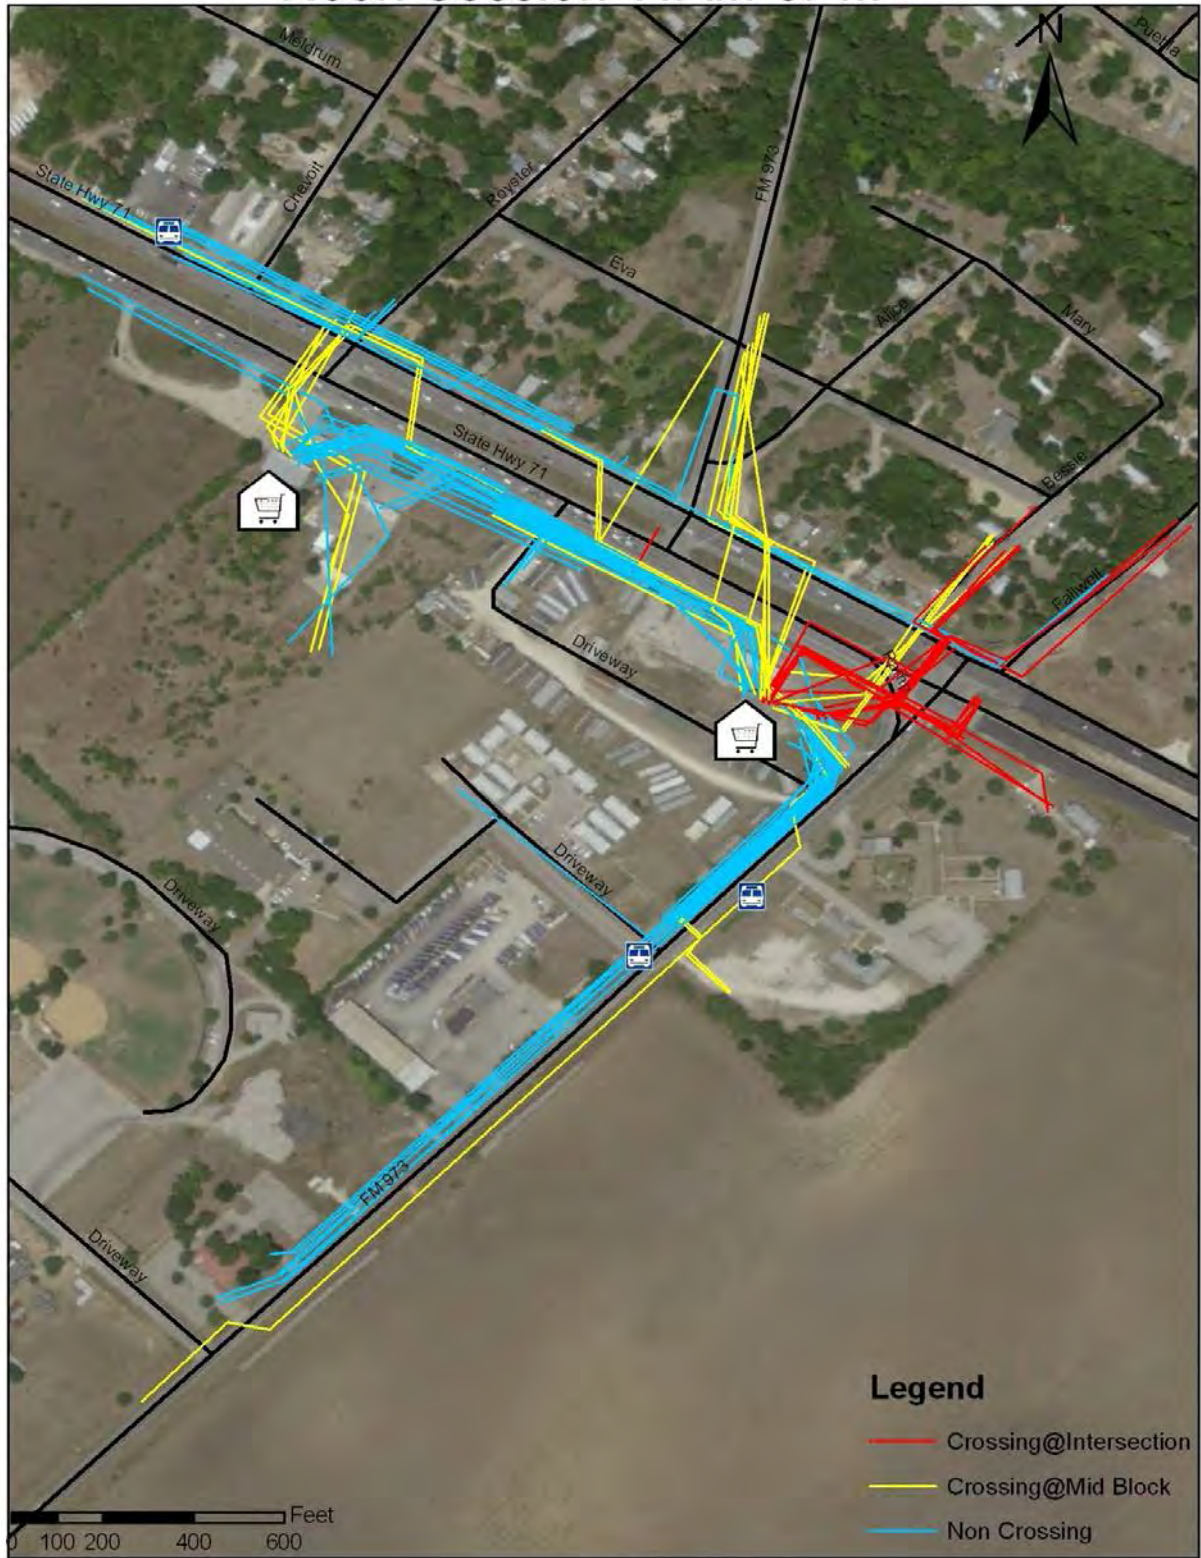
Austin Texas SH71/FM973 Pedestrian Activity Map Noon Session 11AM-3PM

Figure 9. Noon-time Pedestrian Travel

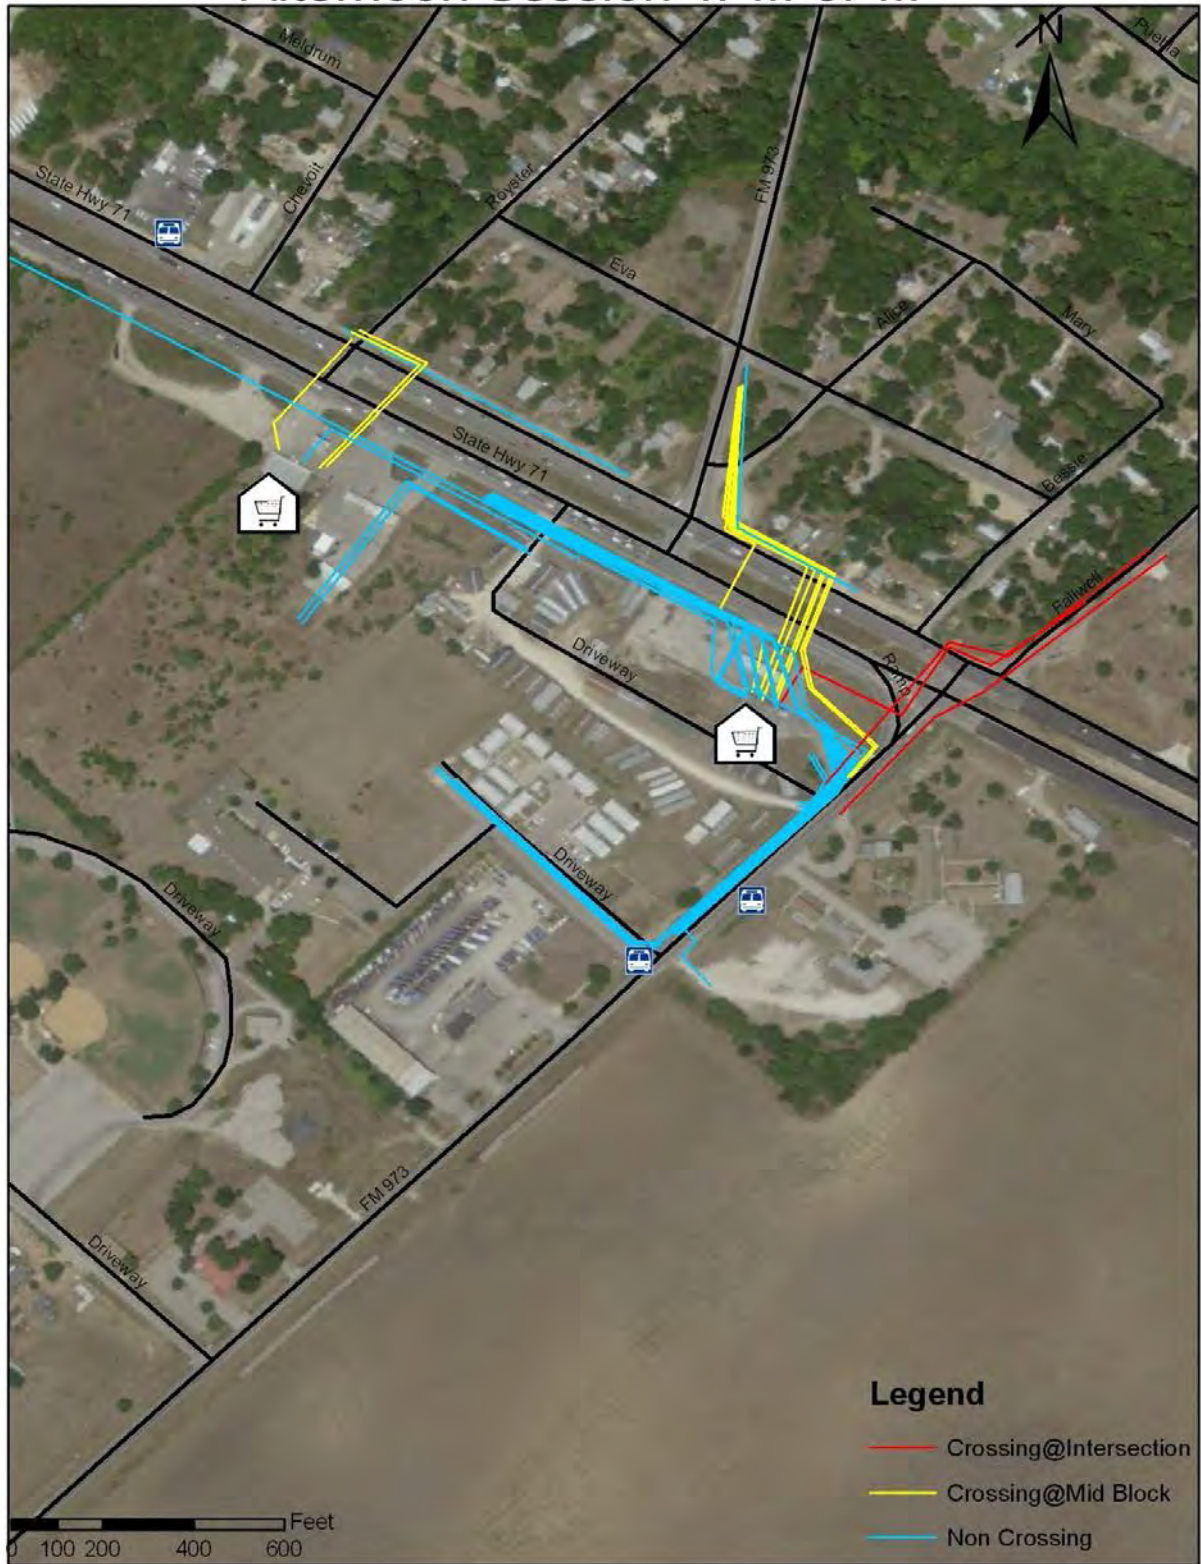
Austin Texas SH71/FM973 Pedestrian Activity Map Afternoon Session 4PM-6PM

Figure 10. Afternoon Pedestrian Travel

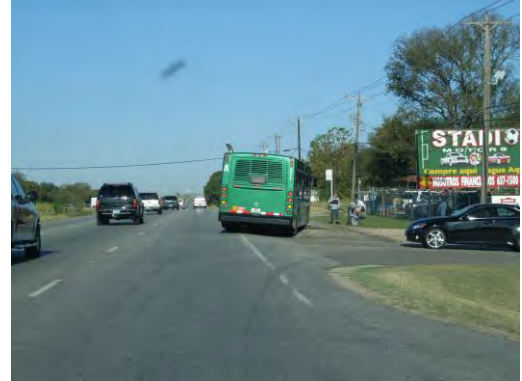
Figure 11. Westbound Bus Stop at Cheviot Lane

To compound matters, the administrators of the correctional facility recently decided to remove the bus stop due to damage caused to the pavement structure and problems during weekends when motor vehicle

parking around the fields constrains bus travel. Administrators have been in discussion with CapMetro about this bus stop removal.

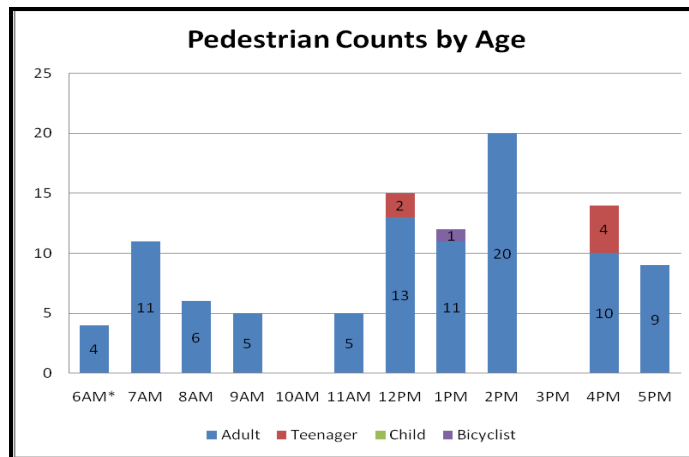
Figure 14. SH 71 East Pedestrian Volume by Age

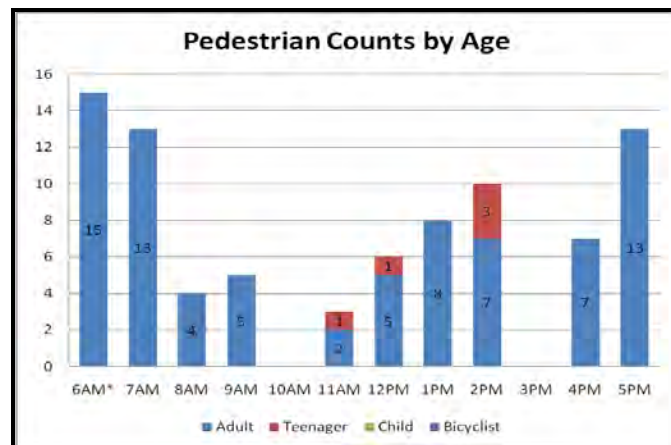
Figure 15. FM 973 (south leg) Pedestrian Volume by Age

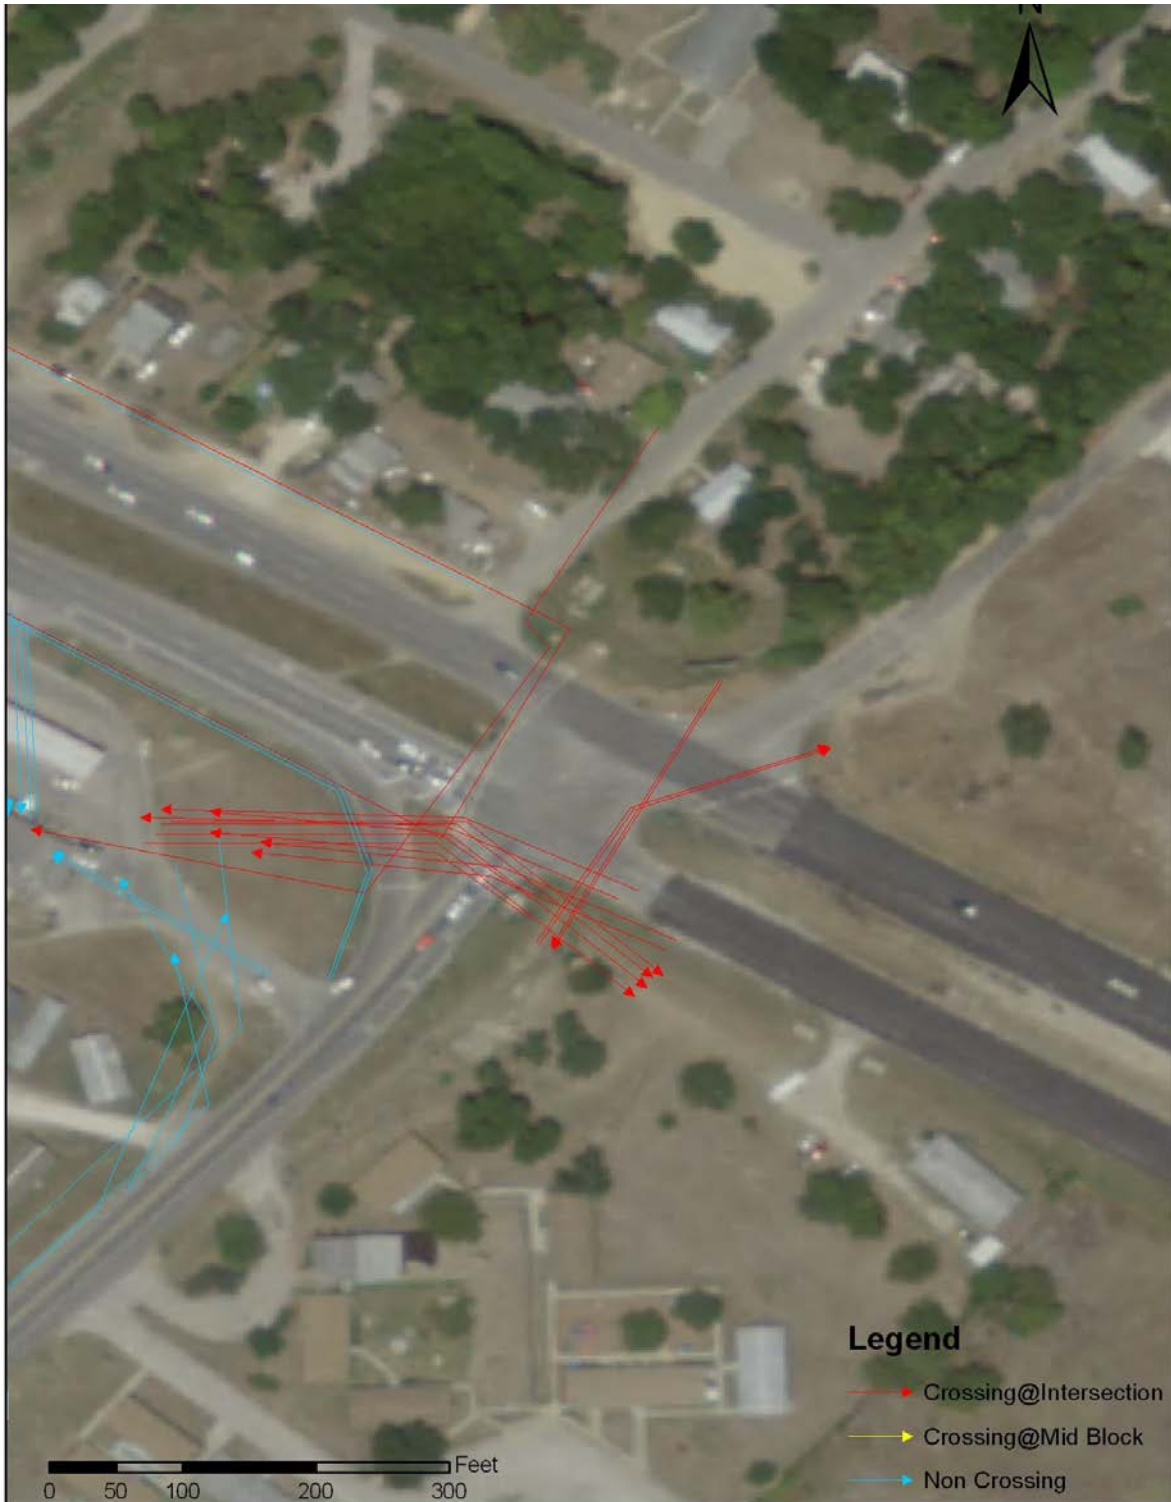
Figure 16. SH 71 at FM 973 South Leg

Morning Period - 6-10AM

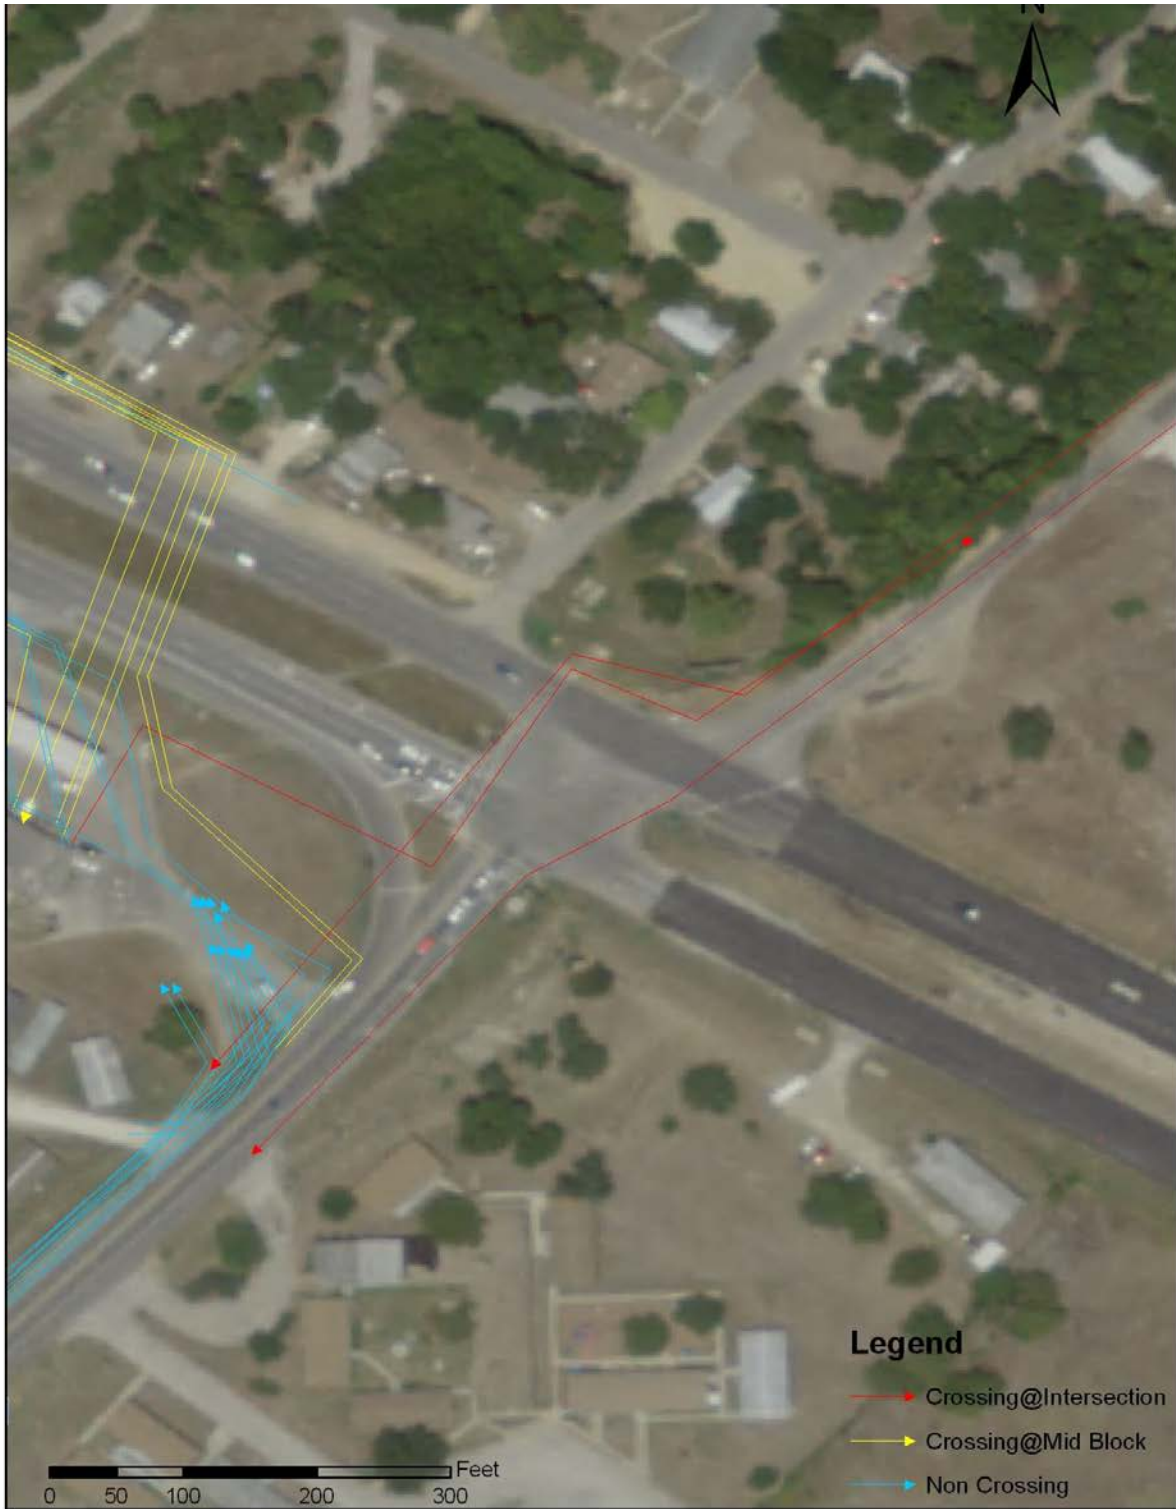
Figure 18. SH 71 at FM 973 South Leg

Afternoon Period – 4-6PM

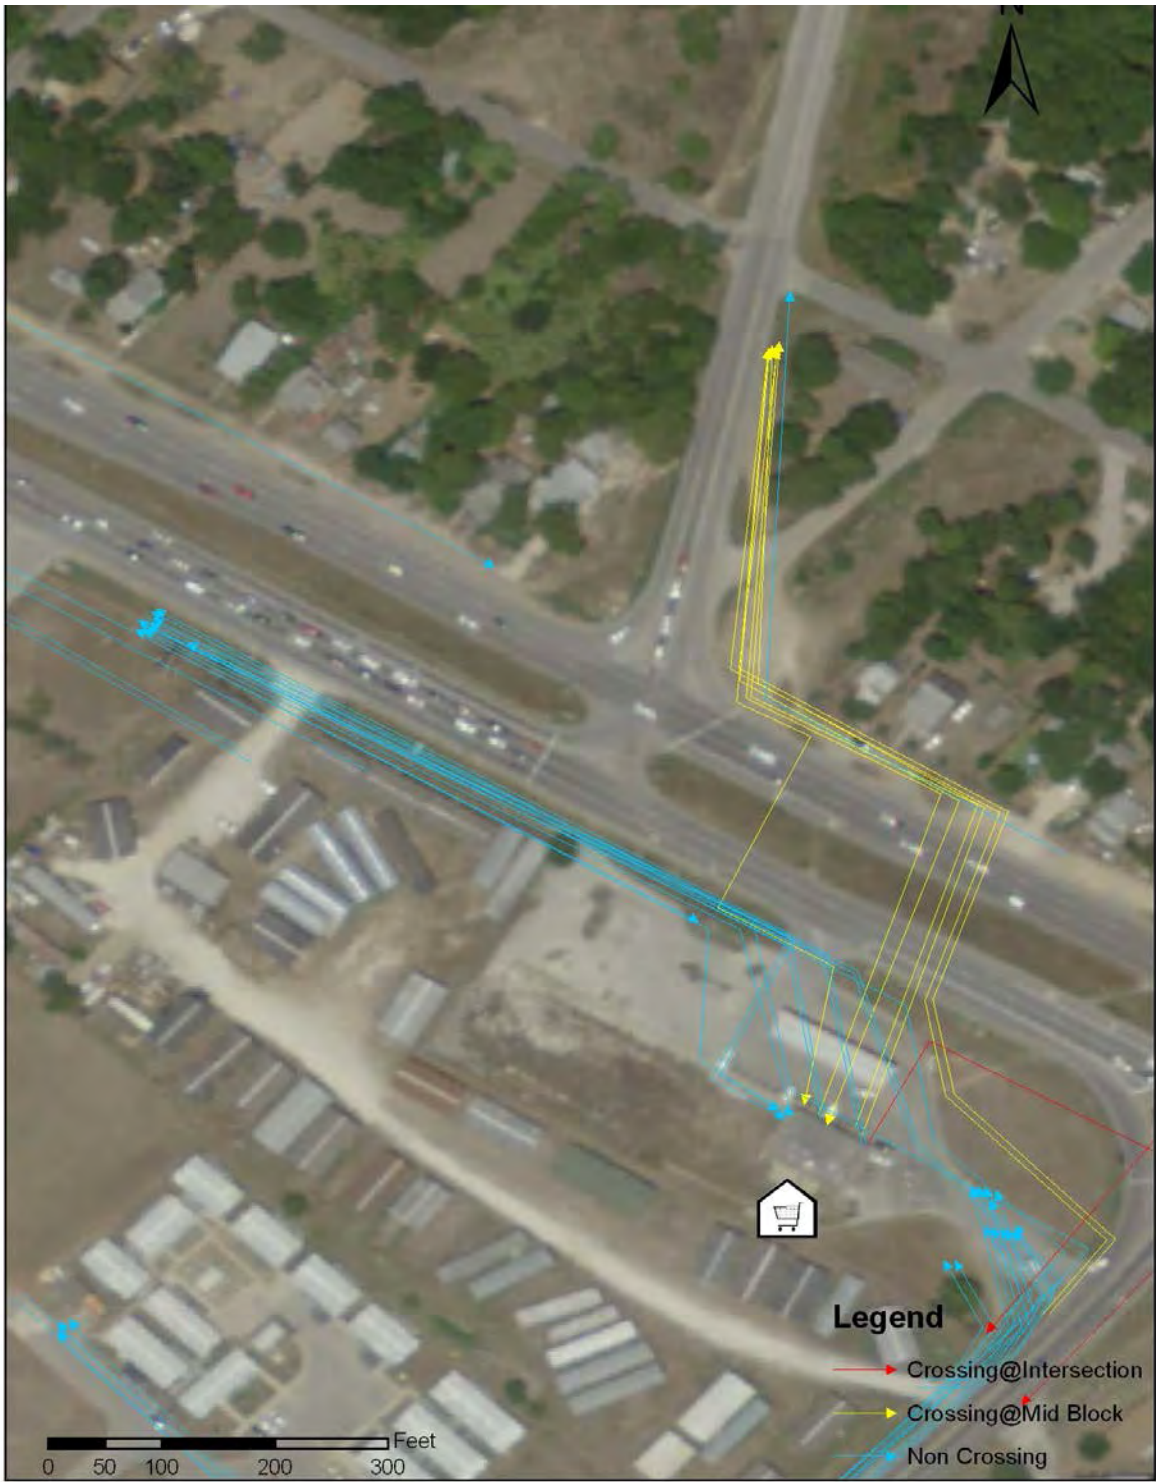
**Figure 21. SH 71 East Section at FM 973 North Leg
Afternoon Period – 4-6PM**

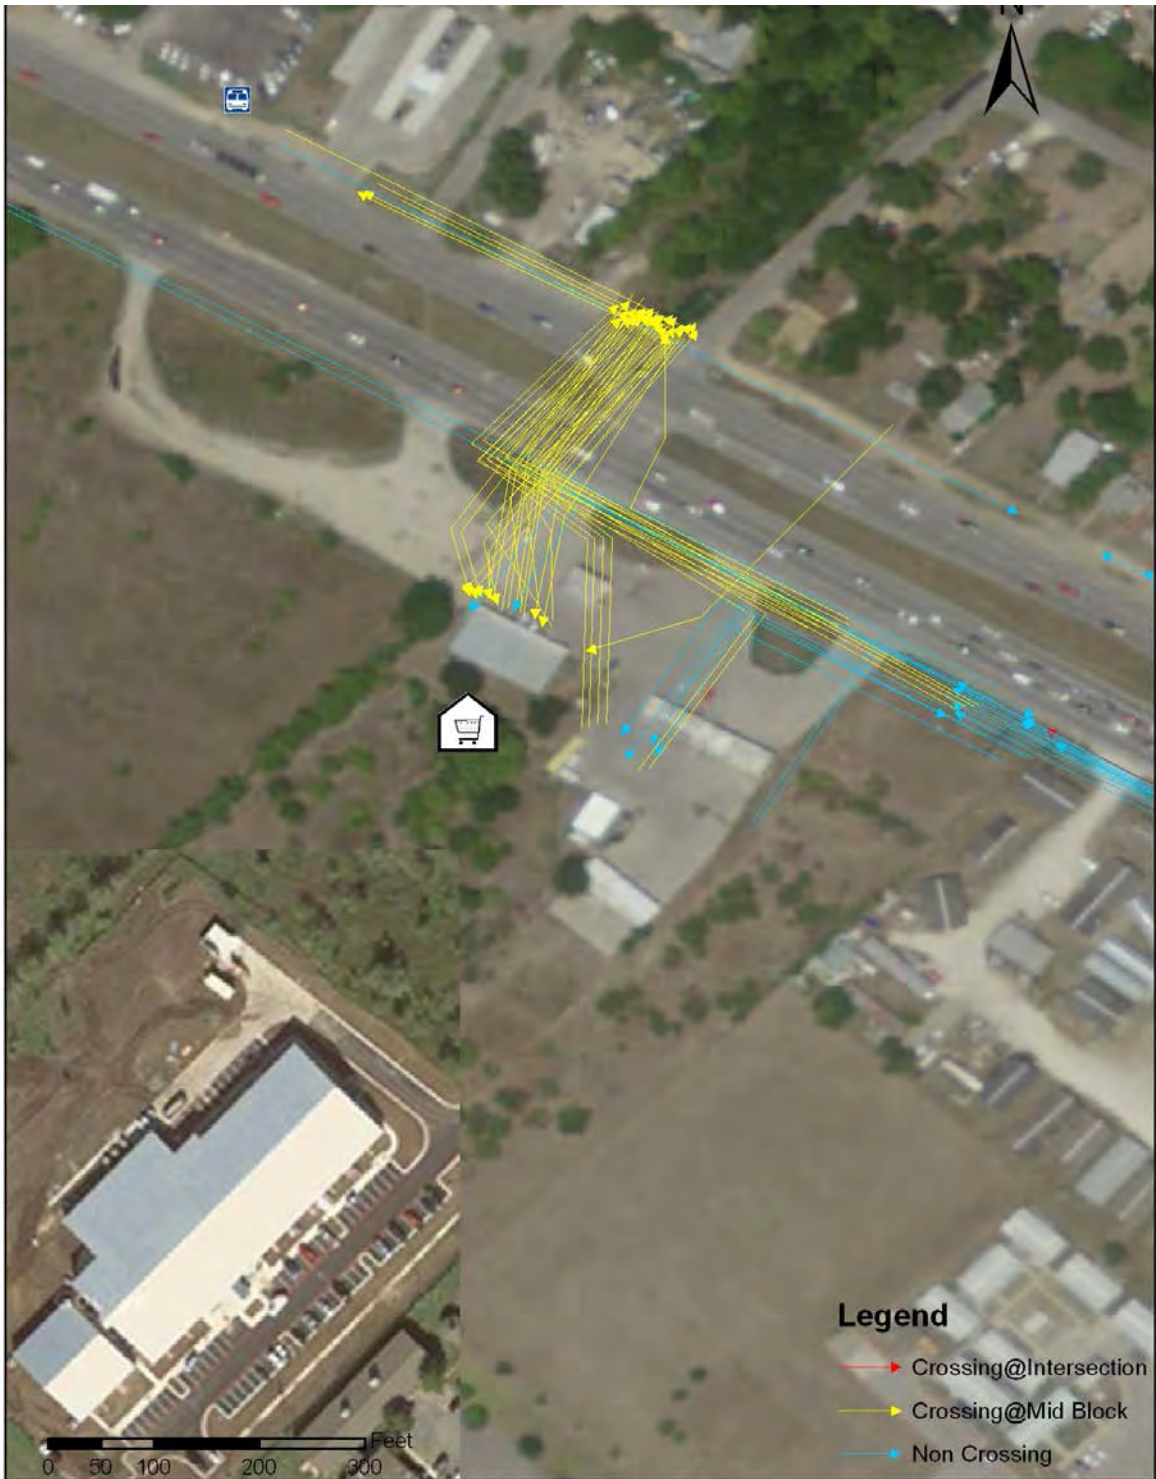
Figure 22. SH 71 at Royster Avenue

Morning Period - 6-10AM

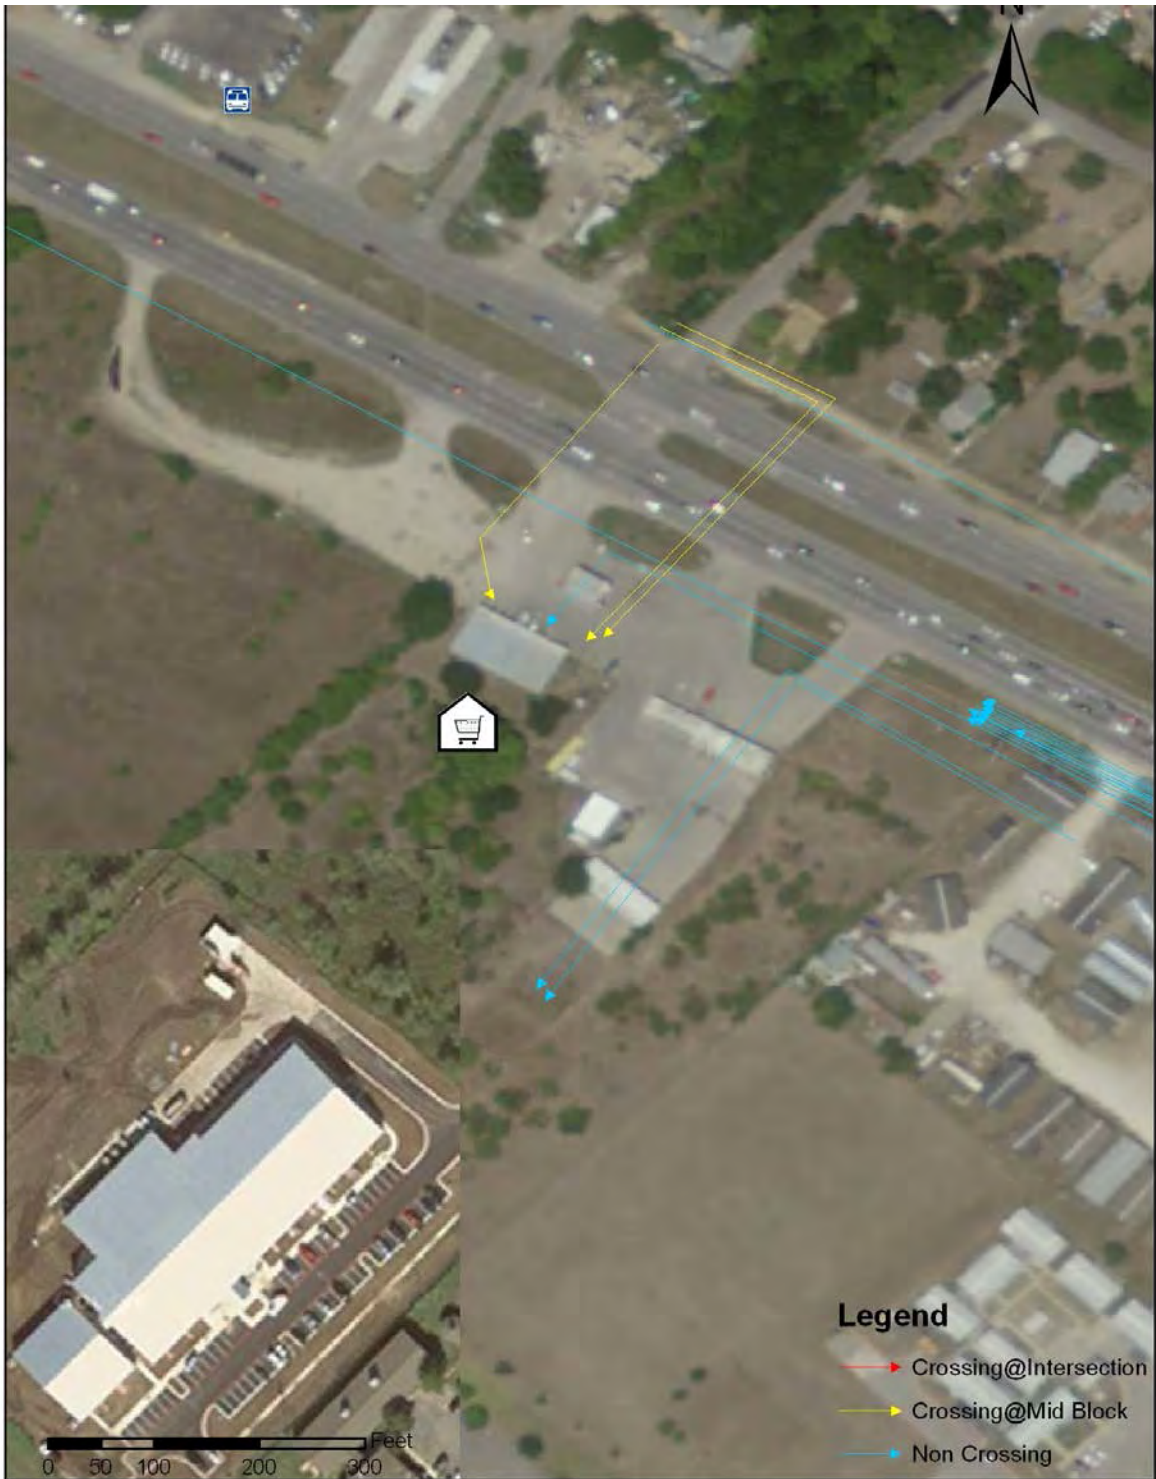
Figure 24. SH 71 at Royster Avenue
Afternoon Period – 4-6PM

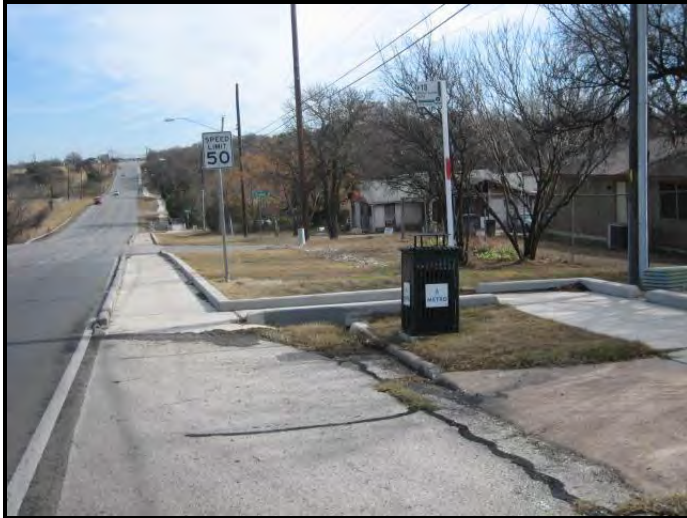
Figure 25. Bus Pull-Out on FM 969

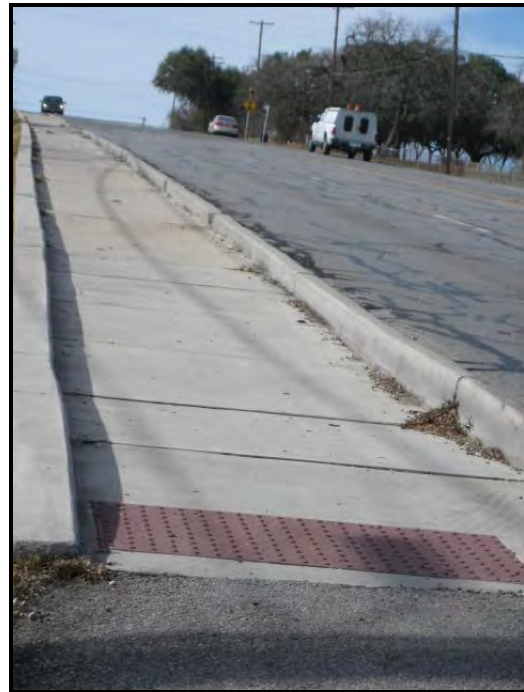
Figure 26. Sidewalk on FM 969 Eastbound

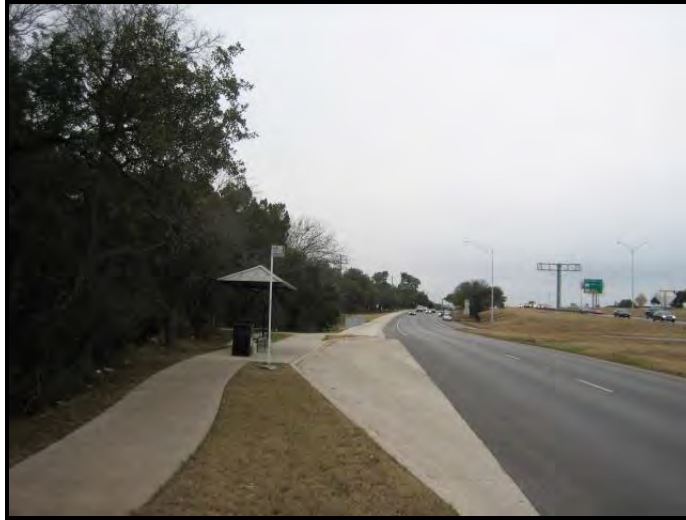
Figure 28. Loop 1 EFR north of RM 2244 (good example)
