# **TEXAS' TRUSS INVENTORY (PRIORITIZATION & PRESERVATION)**

**Jamie Griffin, P.E & Niyi Arowojolu, P.E.**

April 25, 2025

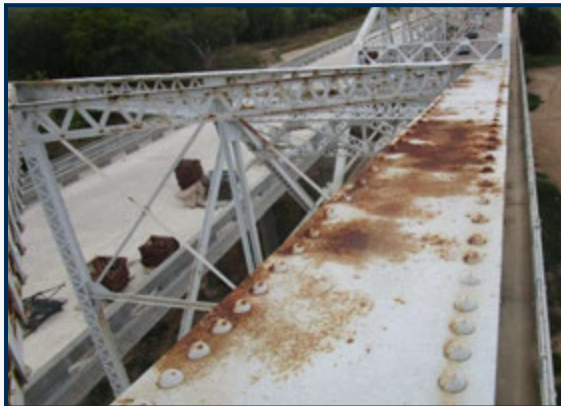
**Upper Chord**

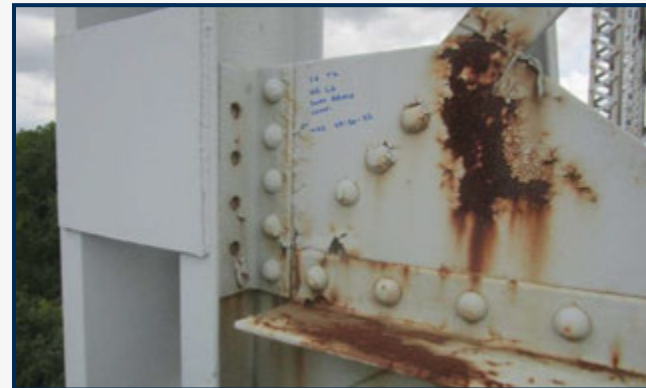
**Gusset Plate**

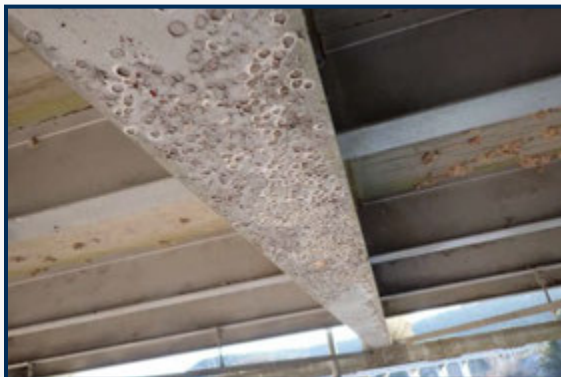
**Floor Beam**

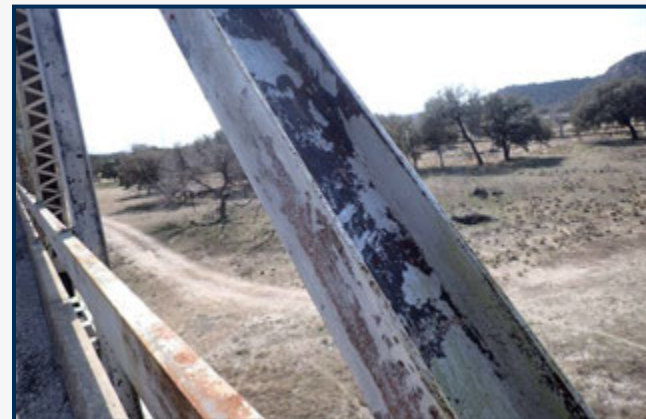
**Diagonal**

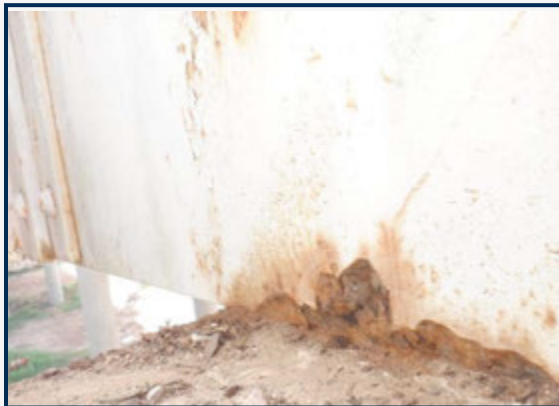
**Severe corrosion on the Floor Beam around the Bearing**

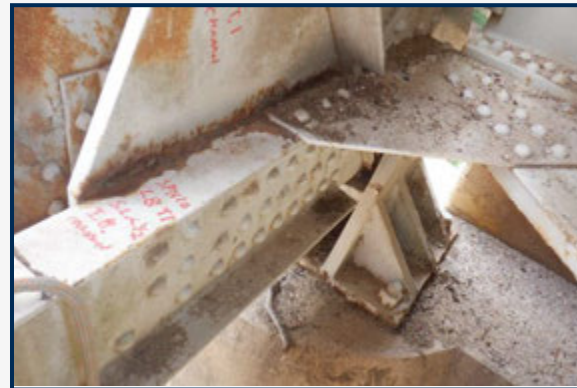
**Severe corrosion on Gusset Plate around the Bearing**

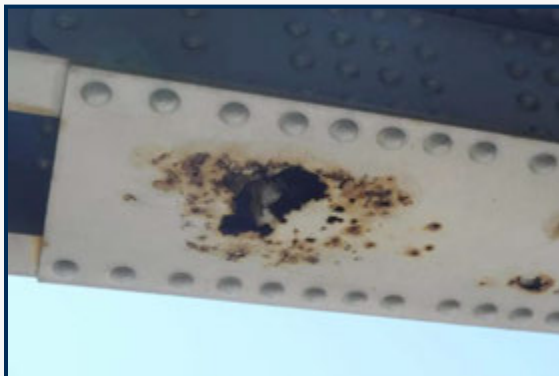
**severe corrosion on lower chord batten plates**

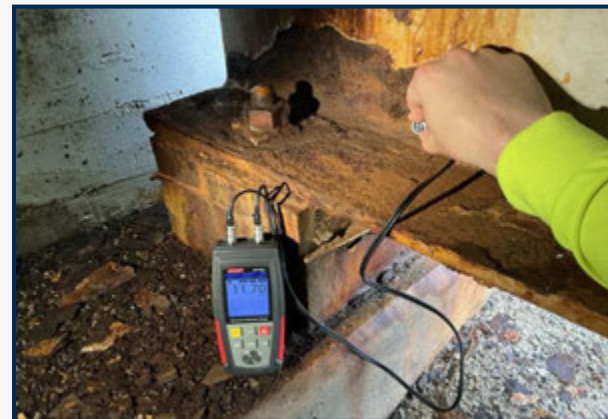
**Corrosion with Section Loss in Floor Beam Web**

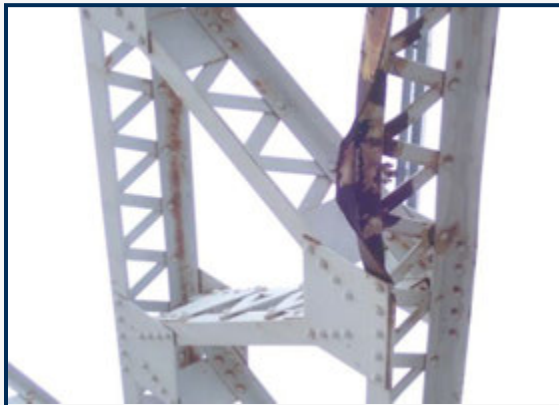
***Impact Damage on Truss Bracing***

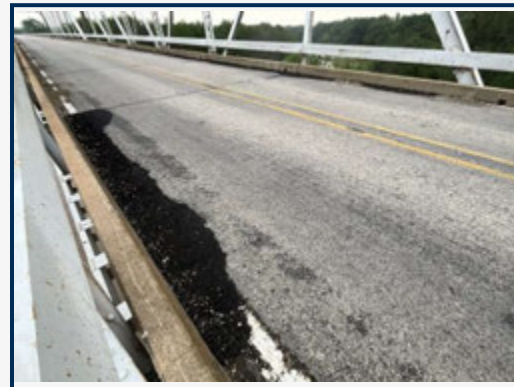
***Poor Condition of Deck Riding Surface***

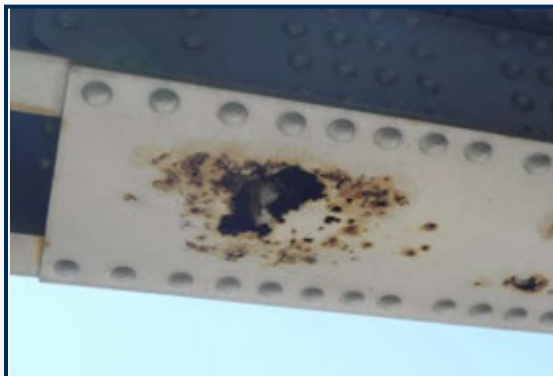
***severe corrosion on lower chord batten plates***

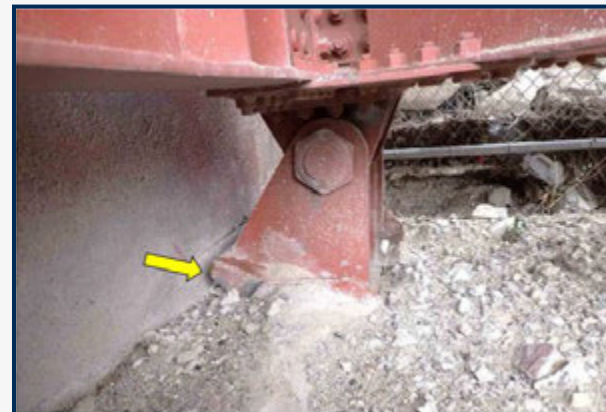
***Excessive rotation (21.5°) of Truss bearing due to shifted rocker***

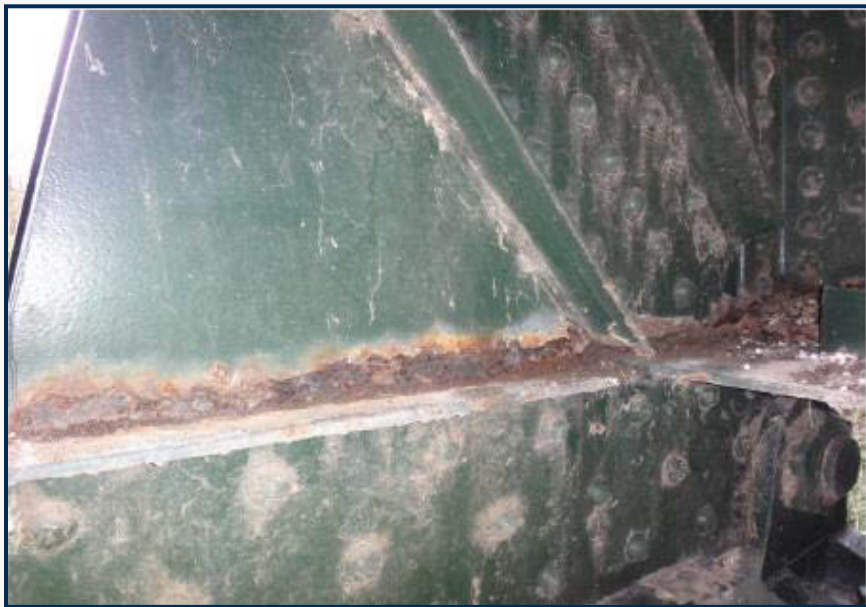
*Up to 3/16" deep x 1" high x 30" long section loss to L0 inboard gusset plate along interface with a lower chord of the Truss (before blasting)*

- Gusset Plate: Consider Load rating and evaluate the condition of the bearing (if attached)

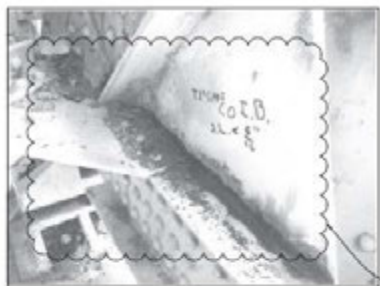
SPAN 10 TRUSS #1 AT L0 ①

① Repairs in kind gusset plates found to have more than 20% section loss. See GUSSET REPLACEMENT table for minimum requirements based on PC inspection report.

- Gusset Plate attached to Bearing: Consider replacing both the bearing and the Gusset Plate

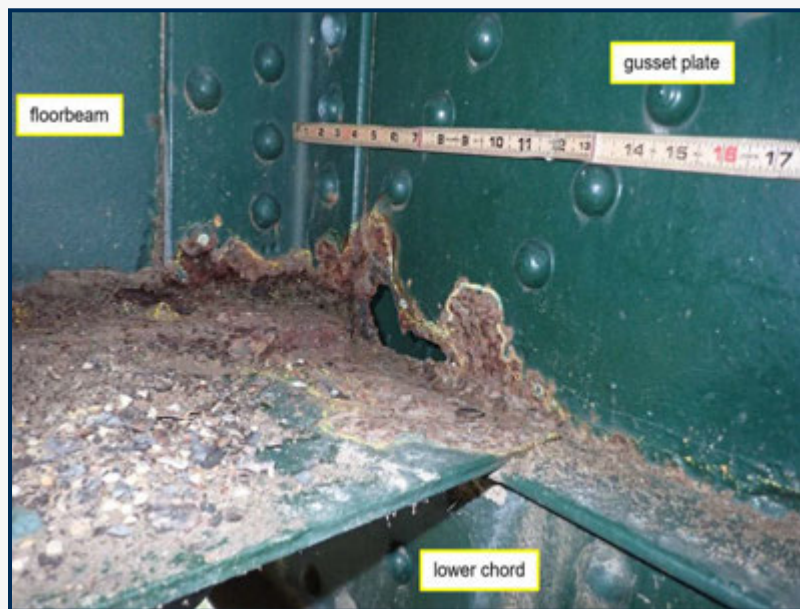
- Corrosion: Case-by-case repair details- no one-size-fits-all solution

***Before Shotblasting***
