Historic Bridge Adoption Information Packet

Tarrant County

State Highway 180 (East Lancaster Avenue) at
Sycamore Creek

State Highway 180 (East Lancaster Avenue) at
Harwood Street

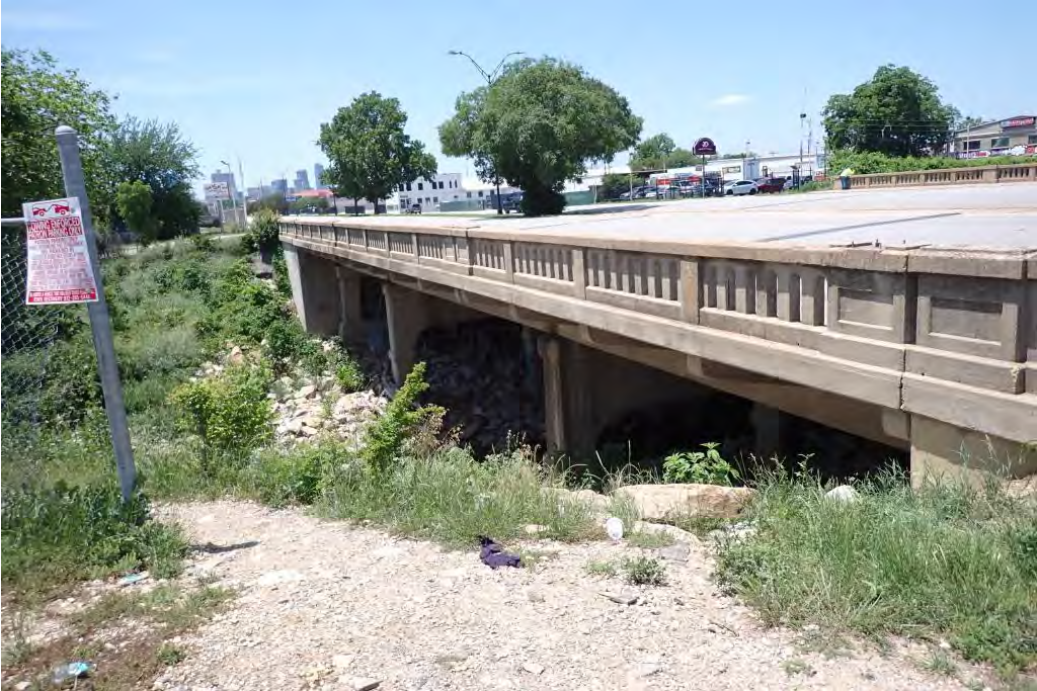
Figure 1. Side elevation of the SH 180 bridge over Sycamore Creek, looking northwest. TxDOT

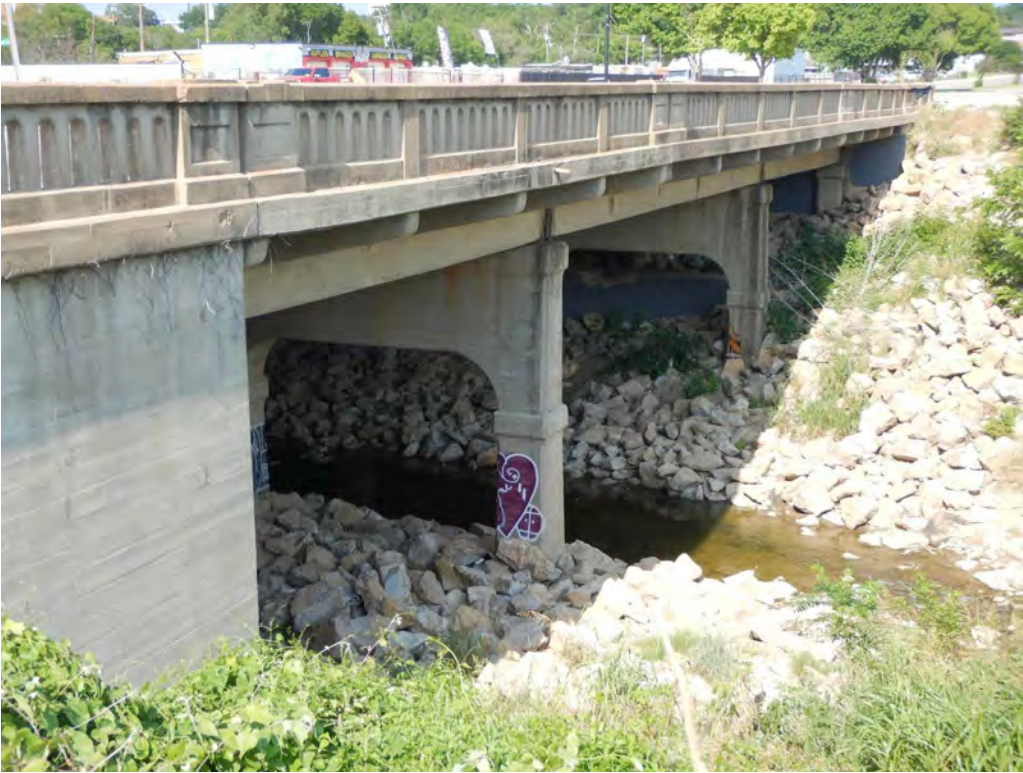
Figure 2. Side elevation of the SH 180 bridge over Sycamore Creek, looking southeast. TxDOT

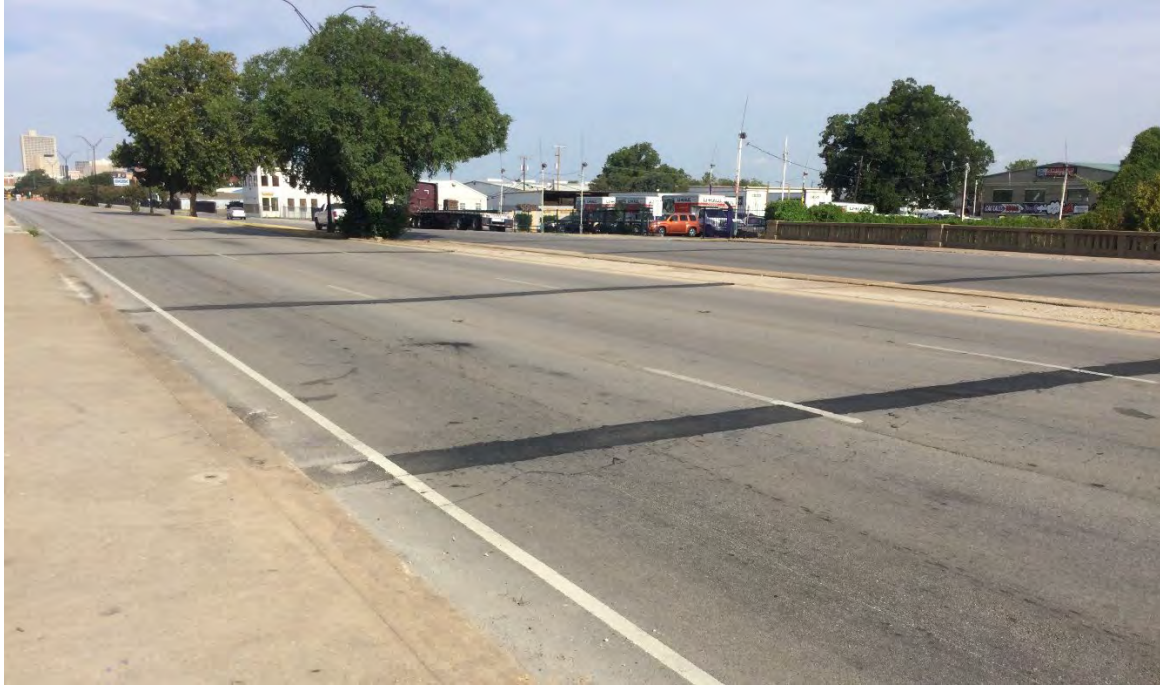
Figure 3. Road-level view of SH 180 over Sycamore Creek, looking west.
TxDOT

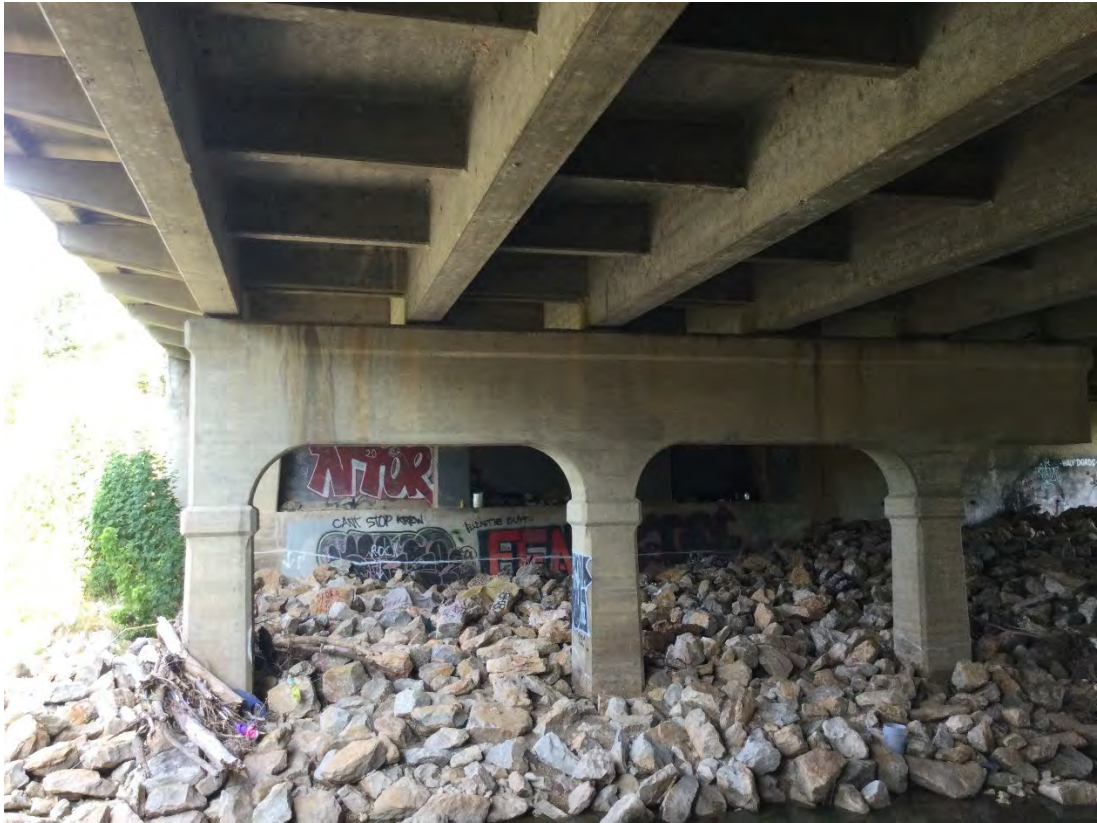
Figure 4. Underside of SH 180 bridge over Sycamore Creek, facing west.
TxDOT

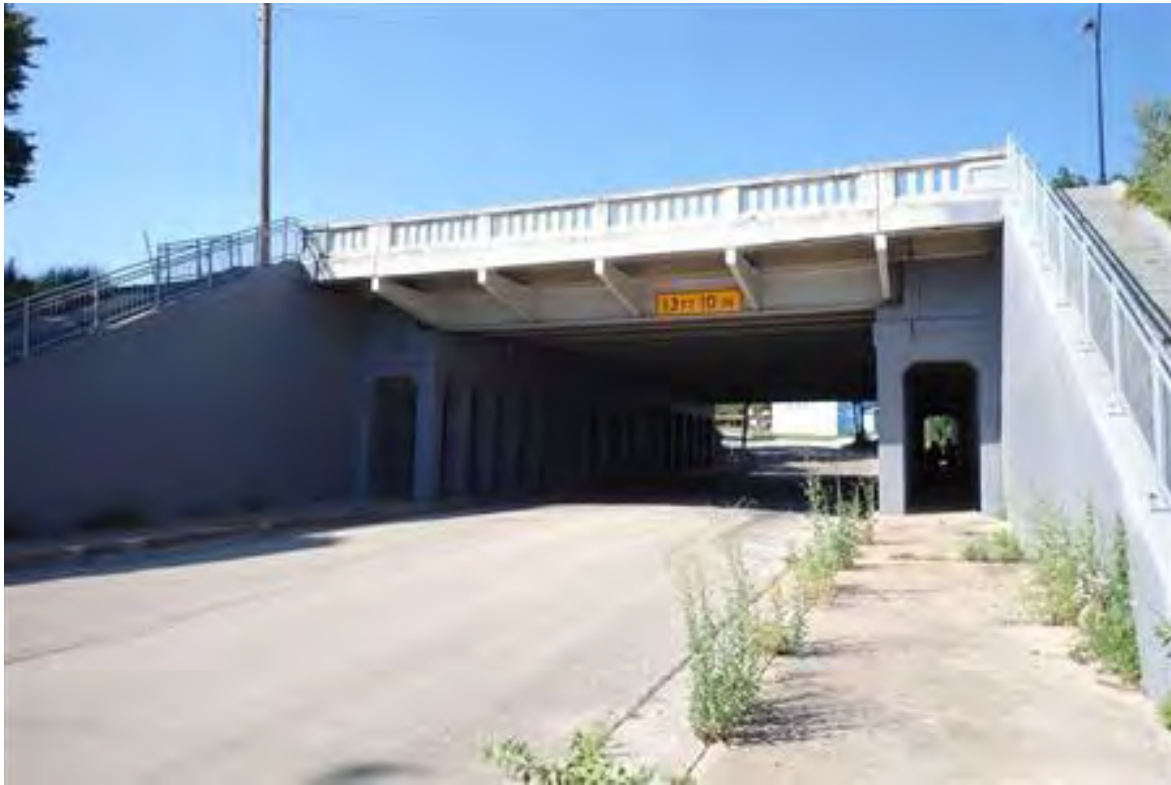
Figure 5. SH 180 bridge over Harwood Street, facing northwest. TxDOT

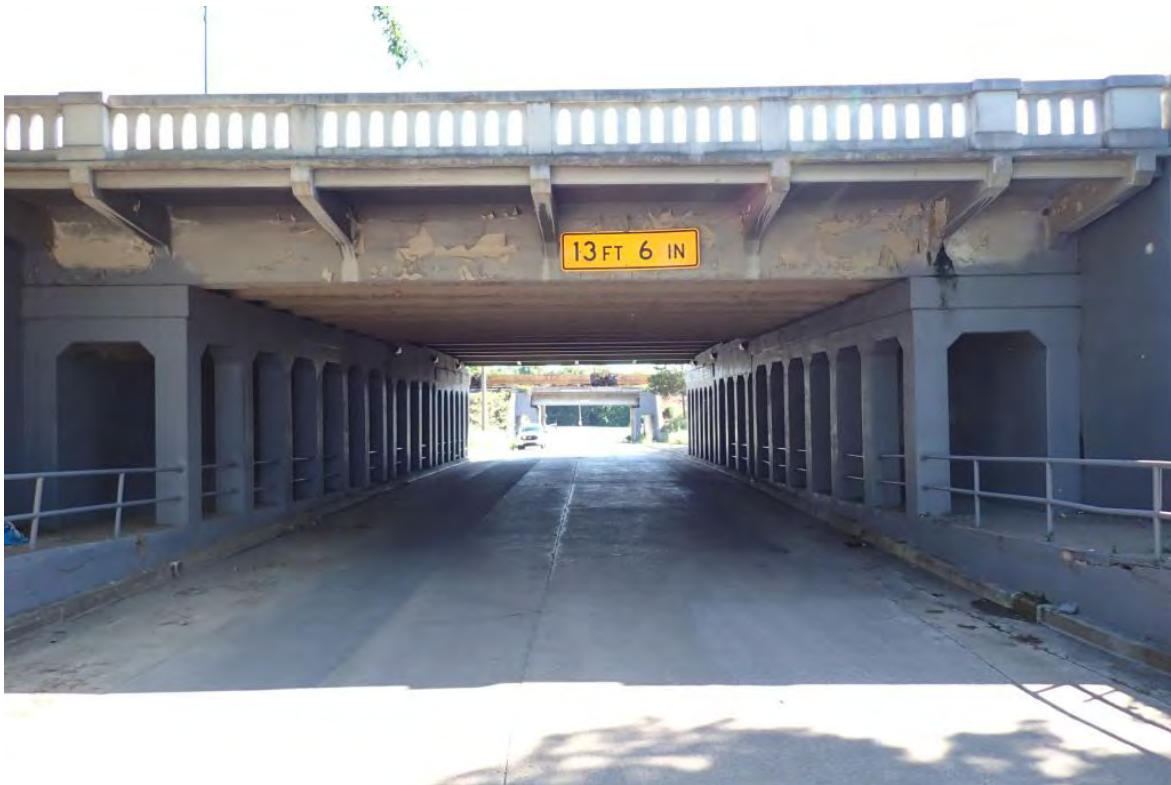
Figure 6. State Highway 180 bridge over Harwood Street, facing north. TxDOT

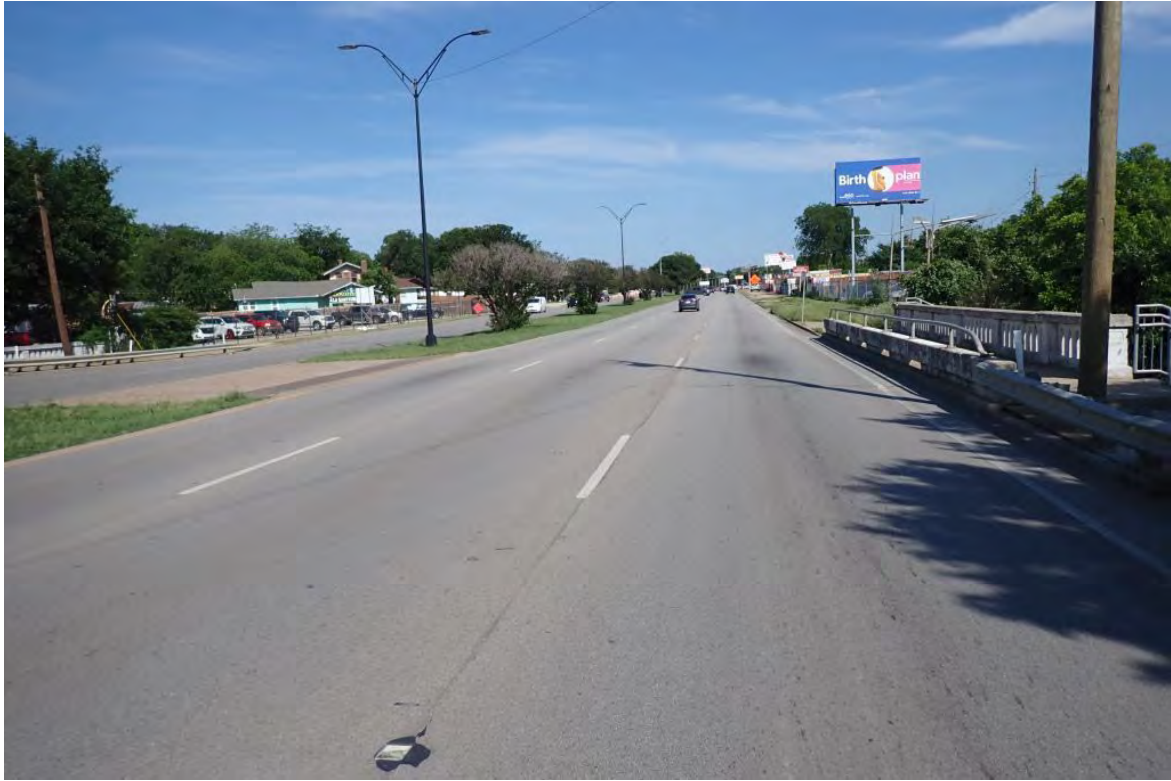
Figure 7. Street-level view of State Highway 180 over Harwood Street, facing southeast. TxDOT

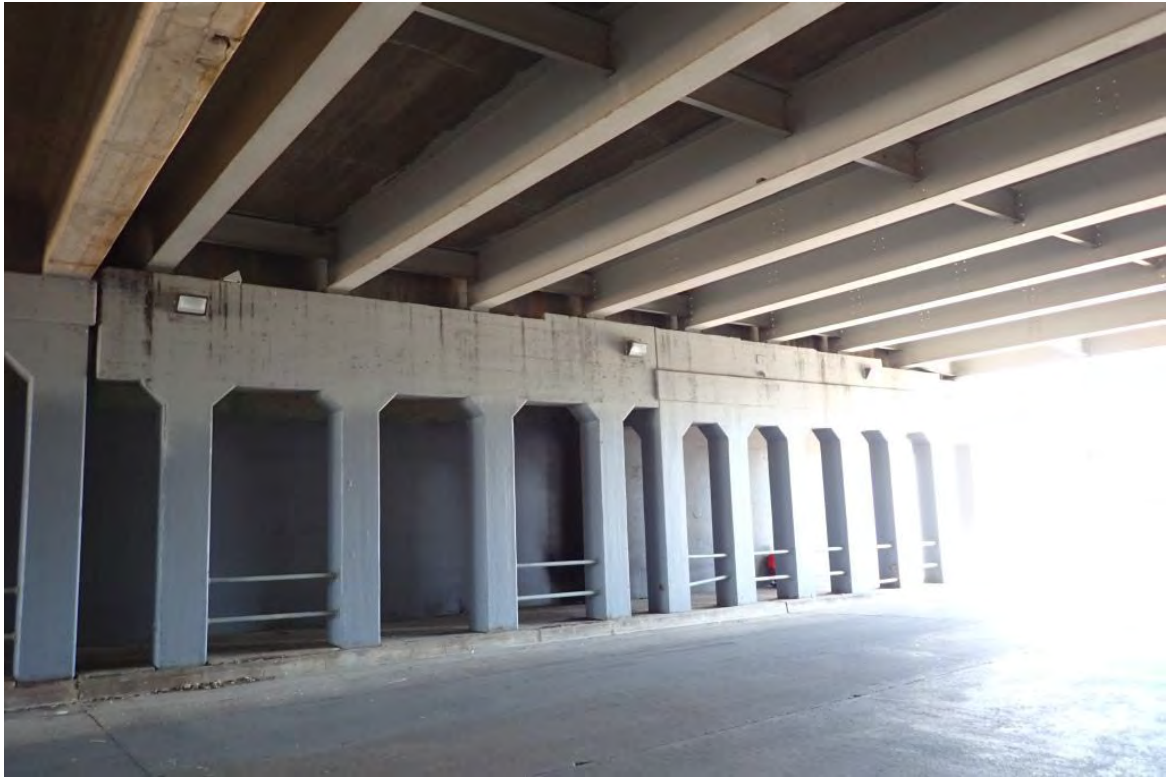
Figure 8. View of the underside of the State Highway 180 bridge over Harwood Street. TxDOT
