Historic Bridge Adoption Information Packet

Limestone County

County Road (CR) 244

Tehuacana Creek

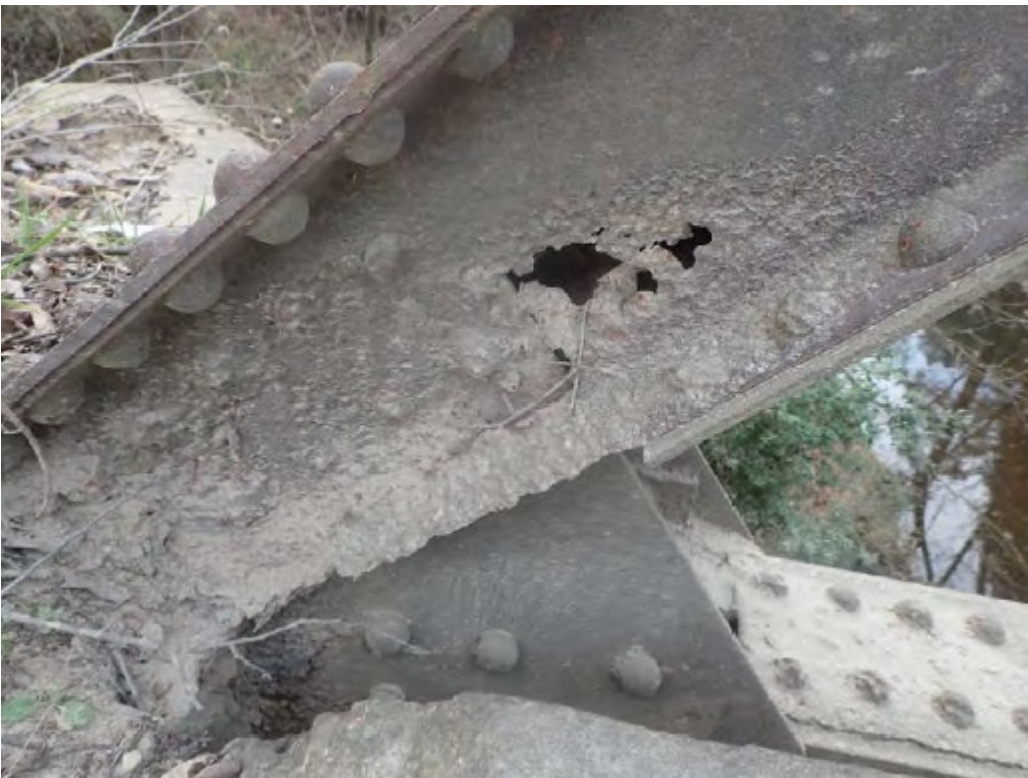
Photo 1: Truss End Post

The end posts have severe section loss to the inboard webs/flanges and a few locations with severe corrosion resulting in holes. The damage must be cleaned and painted, and the section restored. These repairs can be completed after moving the truss but must be completed prior to converting the truss to pedestrian use.

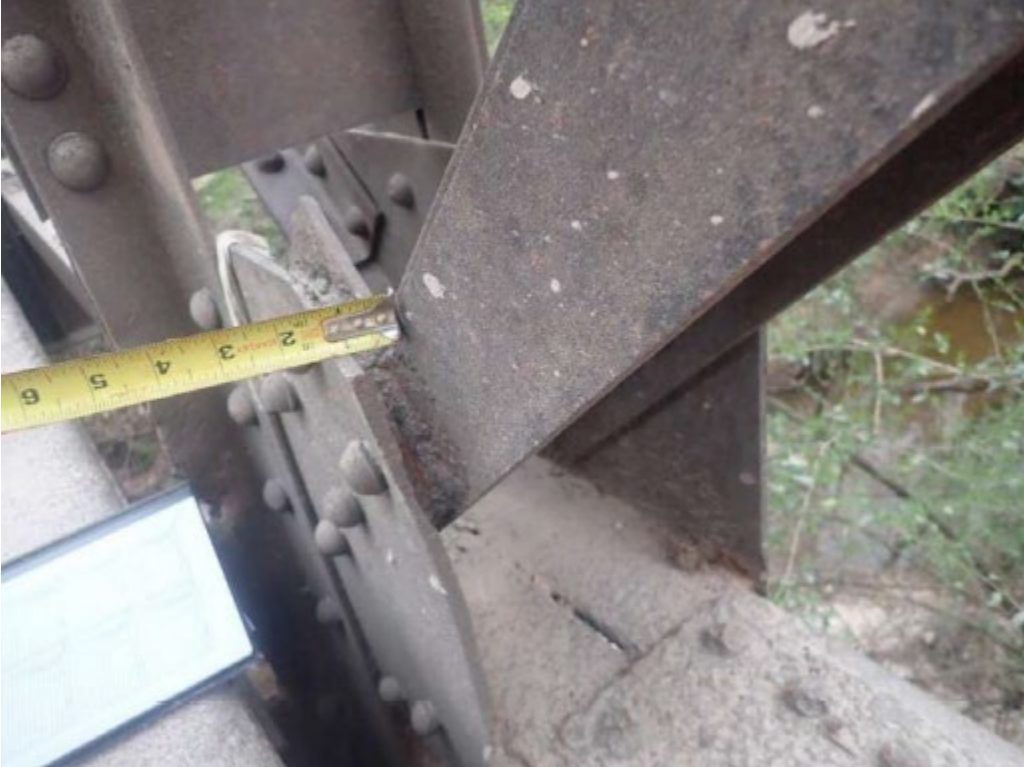
Photo 2: Truss Connections

Pack rust between lower chord gusset plates and truss members is typically 1/2" thick, with isolated locations up to 1", resulting in bowing of the gusset plates. Upper chord gusset plates also exhibit similar pack rust. These repairs can be completed after moving the truss and can be deferred further if needed. However, corrosion will continue until addressed by cleaning, painting, and sealing areas of deformation where water will collect. TxDOT highly recommends cleaning and painting the entire structure.

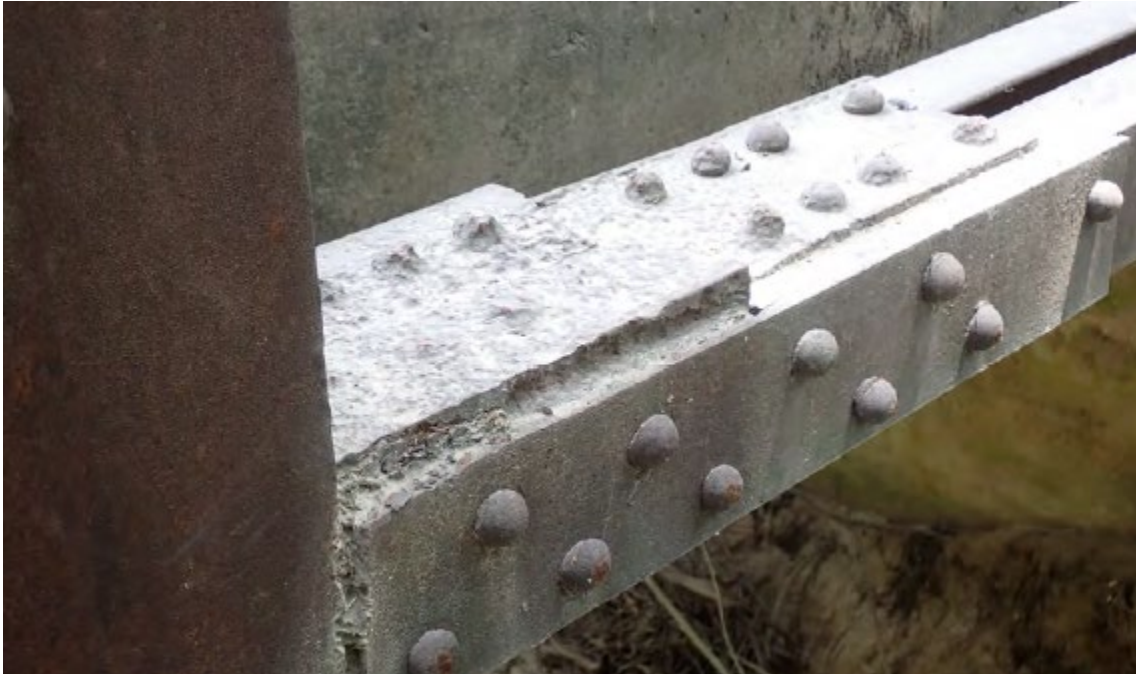
Photo 3: Corrosion at bottom chord with section loss

Lower chord members, horizontal angle legs; locations of 100% section loss, and pitting up to 5/16" deep in isolated locations. Pitting is also typical within the panel points. The damage must be cleaned and painted, and the section restored. These repairs can be completed after moving the truss but must be completed prior to converting the truss to pedestrian use.

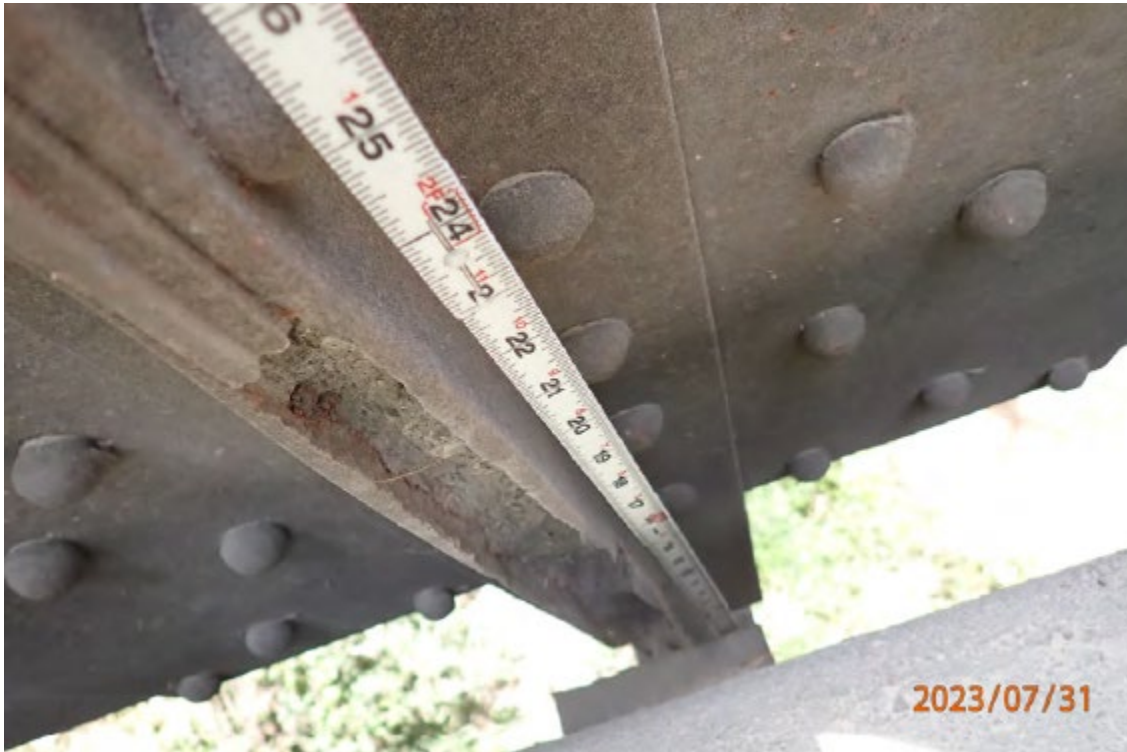
Photo 4: Pack rust on vertical members

The vertical members have pack rust up to 1-5/8" thick for a 19" length above the floorbeam connections. These repairs can be completed after moving the truss and can be deferred further if needed. However, corrosion will continue until addressed by cleaning, painting, and sealing areas of deformation where water will collect.

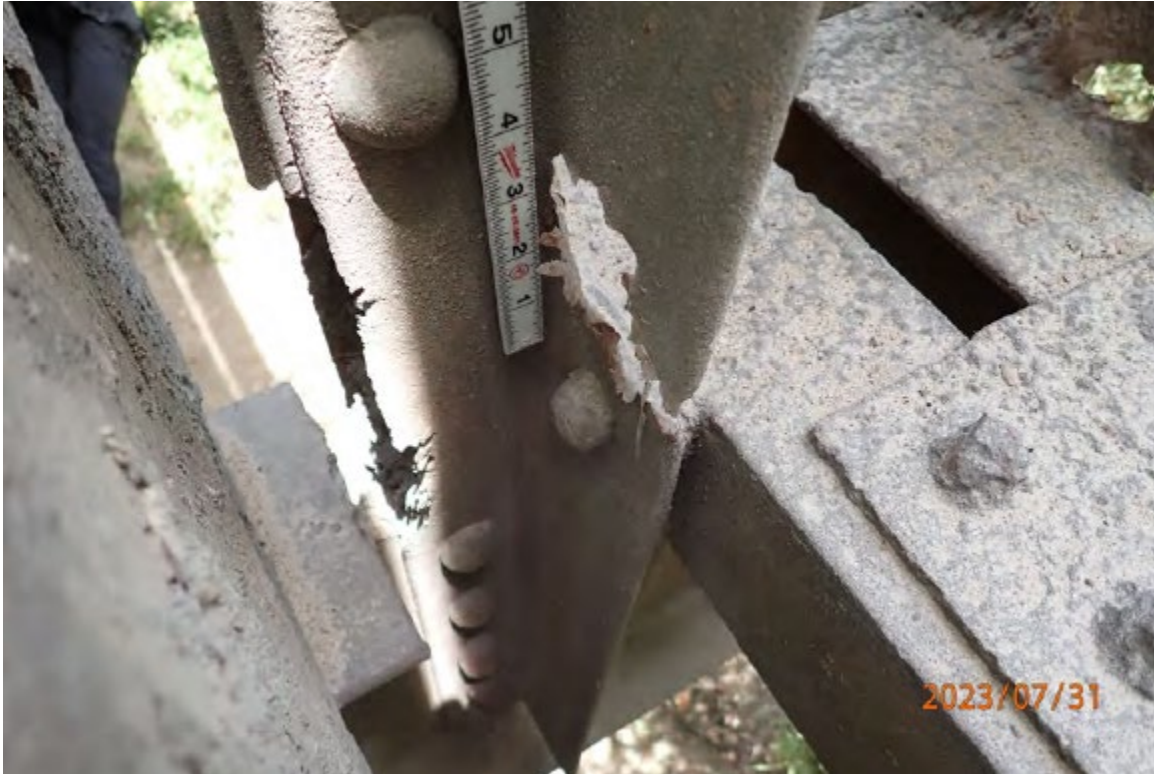
Photo 5: Section loss on vertical members

Vertical members exhibit up to 100% section loss in isolated areas throughout the structure. The damage must be cleaned and painted, and the section restored. These repairs can be completed after moving the truss but must be completed prior to converting the truss to pedestrian use.
