Waters of the U.S. Delineation Report-Draft

I-35 Capital Express Central Project from
US 290 to SH 71
(CSJ: 0015-13-388)

Texas Department of Transportation, Austin District

April 2023

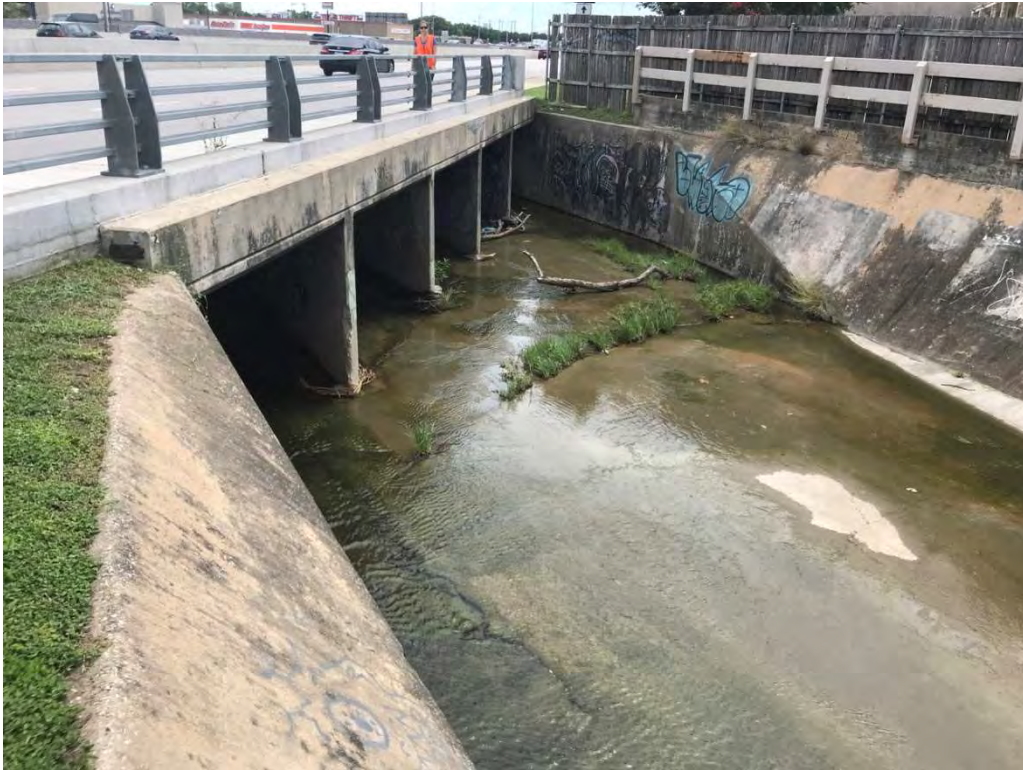
Photo 1: Tannehill Branch (S-1) facing southwest.

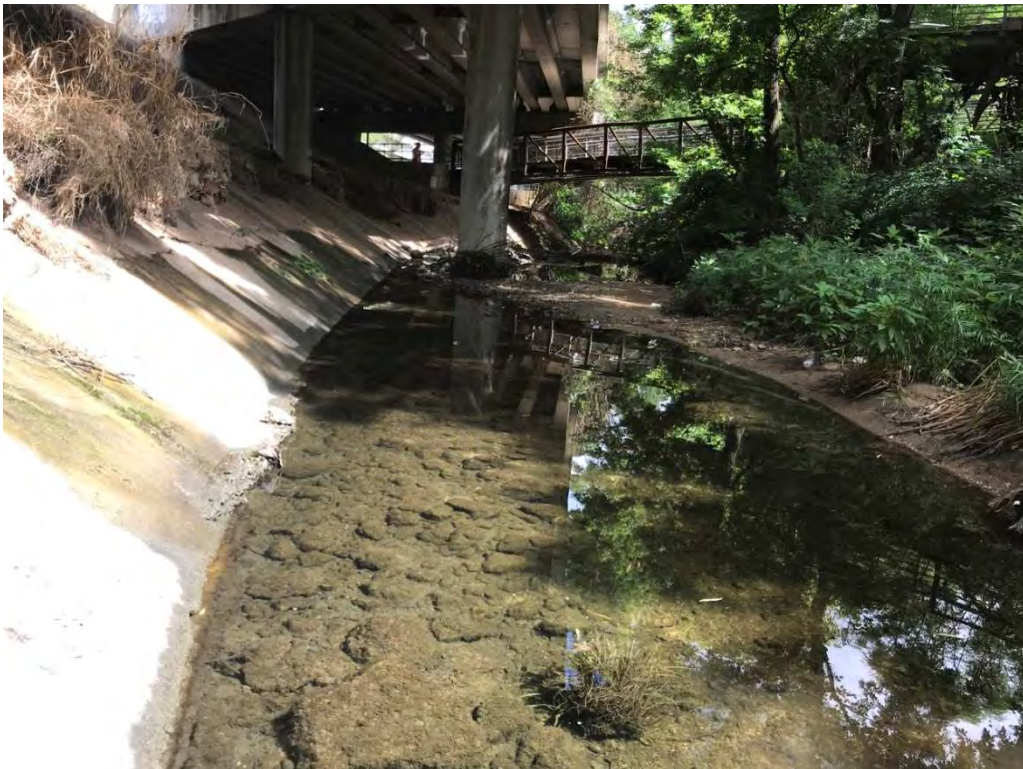
Photo 2: Harpers Branch (S-2) near Lady Bird Lake facing north.

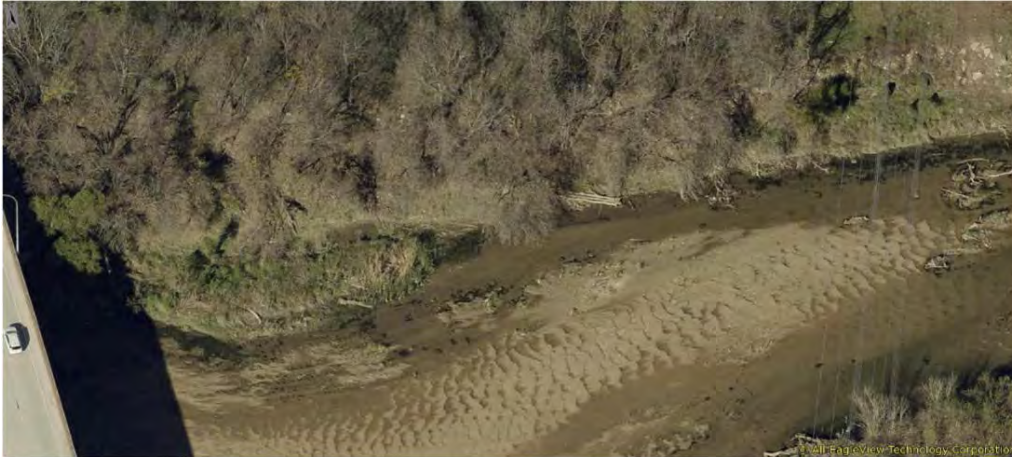
Photo 3: Colorado River (S-3) at proposed stormwater outfall location, aerial view.

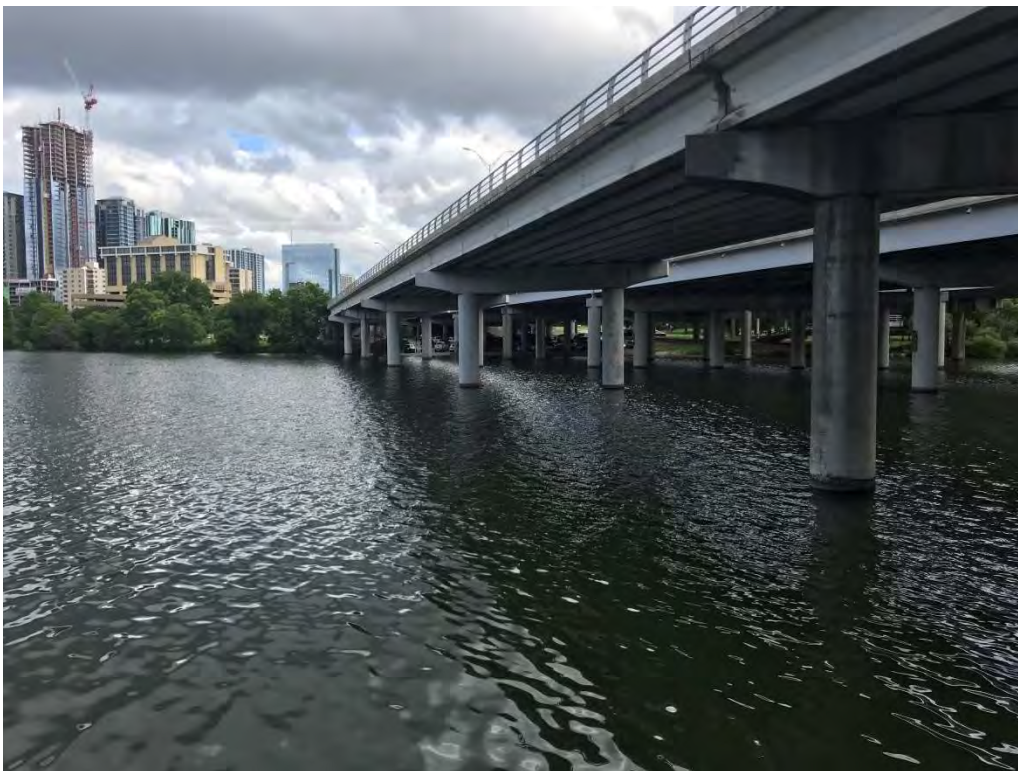
Photo 4: Lady Bird Lake (OW-1) facing north.

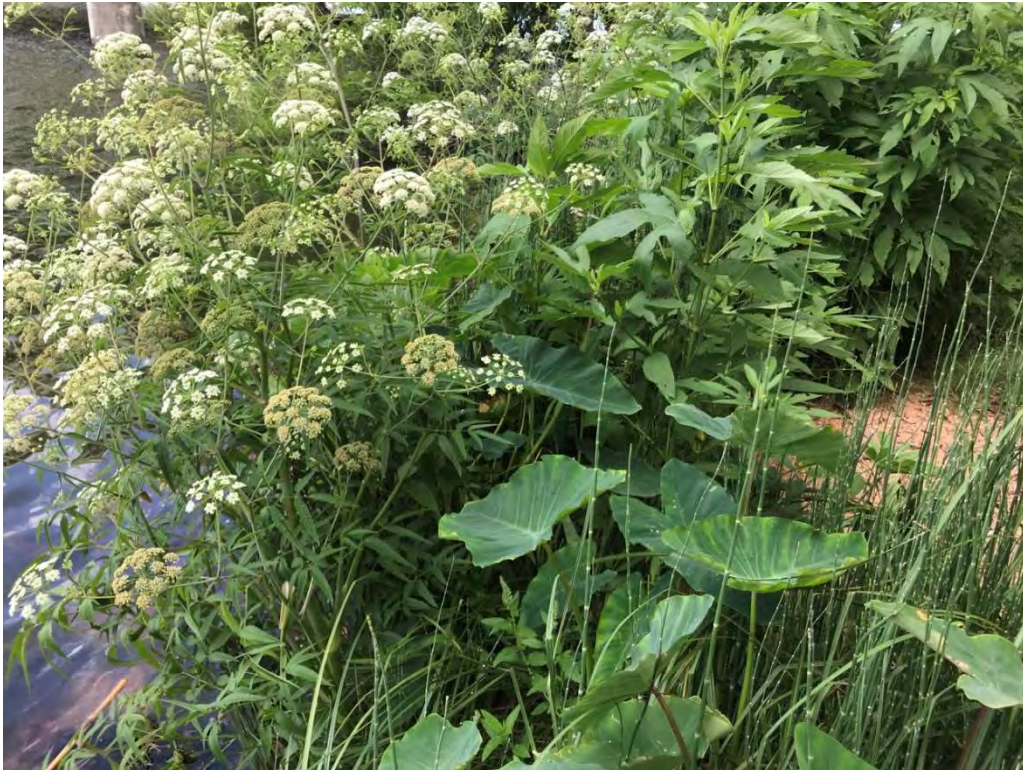
Photo 5: Typical vegetation along Lady Bird Lake (OW-1).

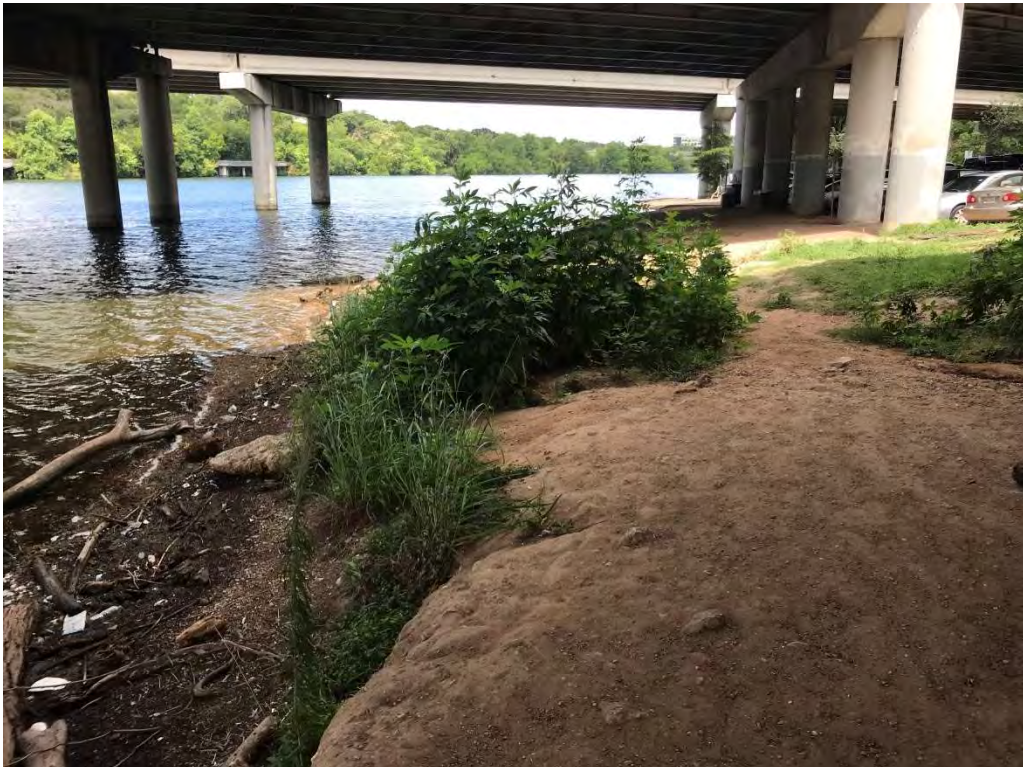
Photo 6: Typical condition of southern shoreline at Lady Bird Lake (OW-1).

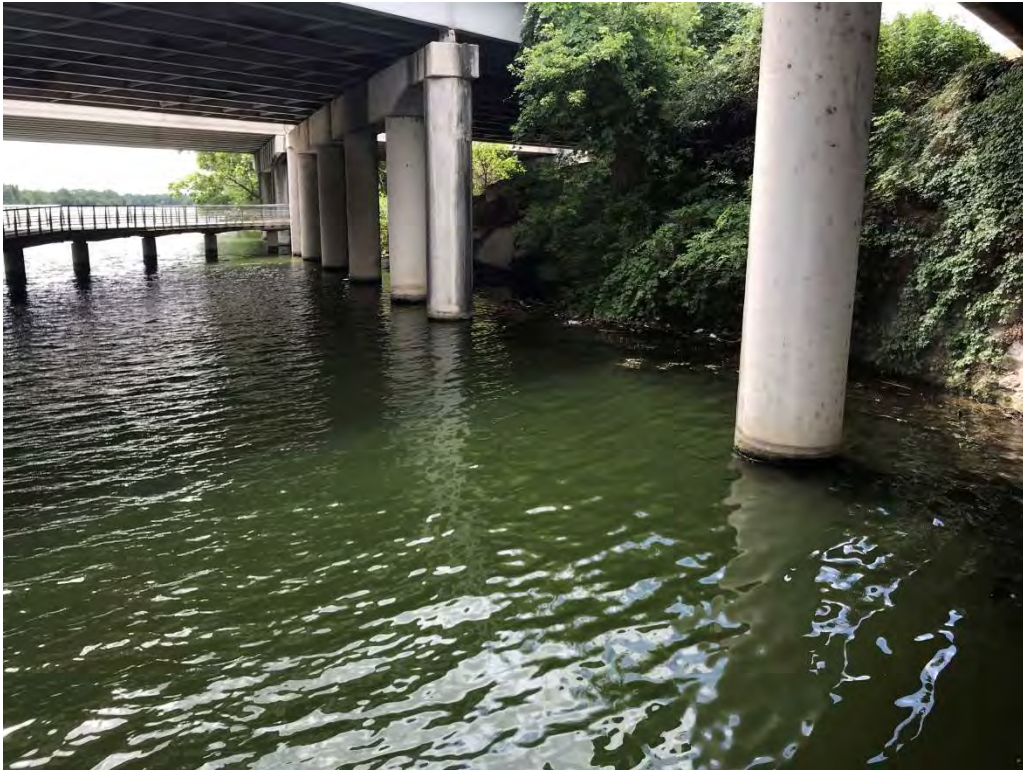
Photo 7: Typical condition of northern shoreline at Lady Bird Lake (OW-1).

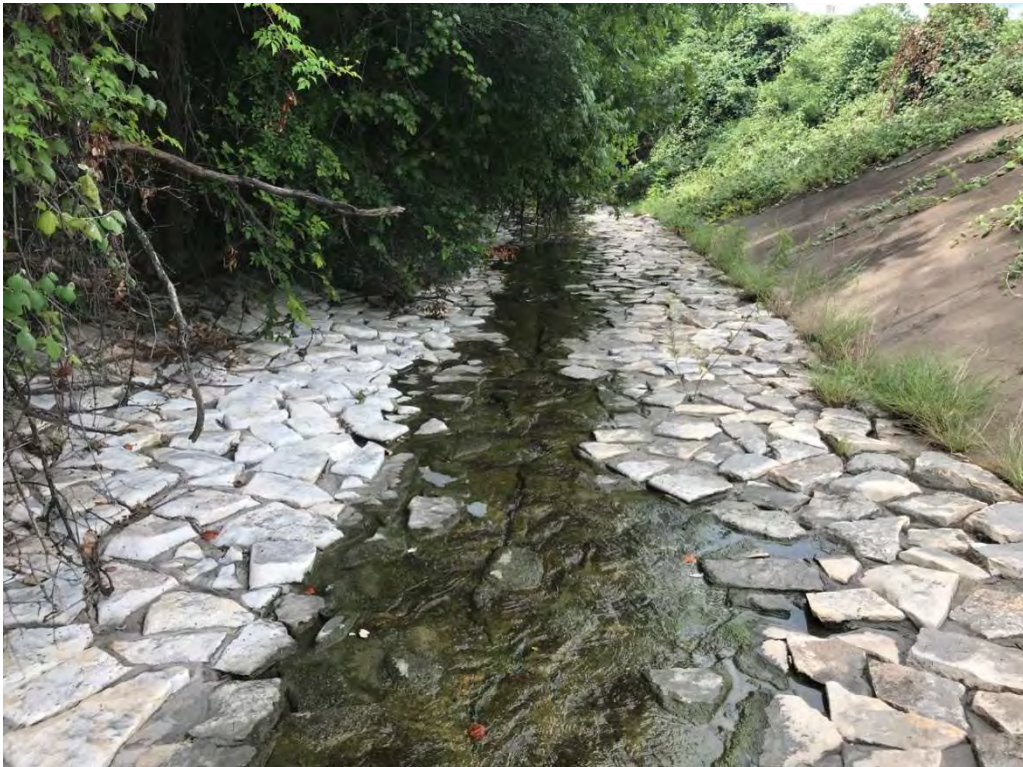
Photo 8: Harpers Branch (NJD-1) facing south.
