# Archival Documentation Package

Capital City Conoco / Dura Tune Service Station  
3810 North Interstate Highway 35  
Austin, Travis County, Texas

October 2024

This report provides archival documentation of the Dura-Tune service station (originally Capital City Conoco), located at 3810 North Interstate Highway (I-) 35, in Austin, Travis County, Texas. The documentation has been completed as mitigation for the building's removal as part of the I-35 Capital Express Central project.

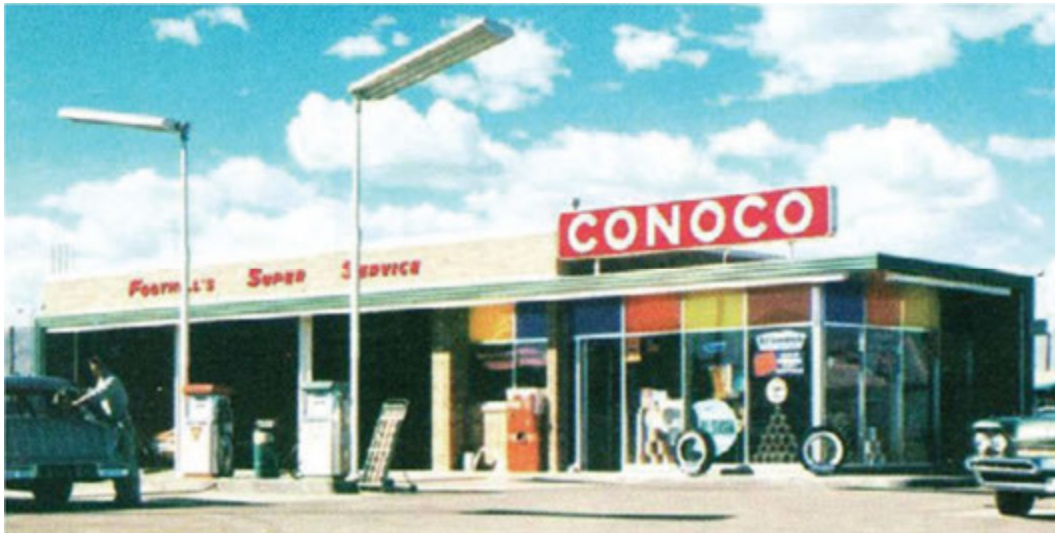
*Figure 1. Example of a 1950-1970 standard-design Conoco station (without canopy) showing character-defining features listed above, from TxDOT's A Field Guide to Gas Stations in Texas.<sup>3</sup>*

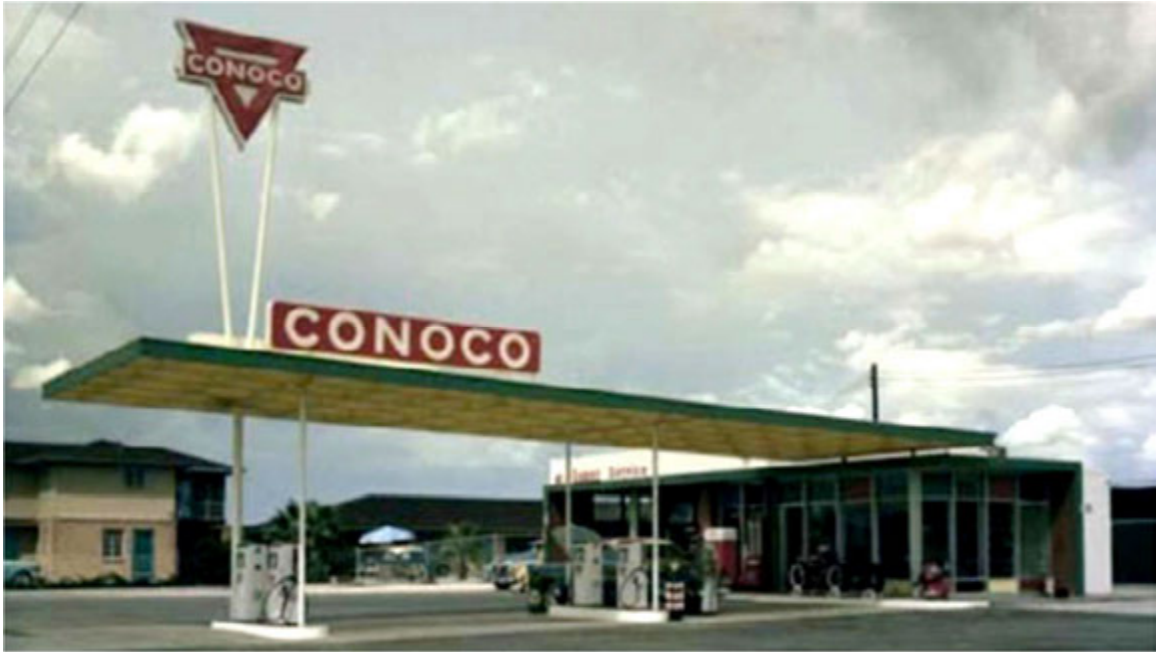
Figure 2. Example of a 1950-1970 standard-design Conoco station (with canopy) showing character-defining features listed above, from TxDOT's Field Guide to Gas Stations in Texas.<sup>4</sup>

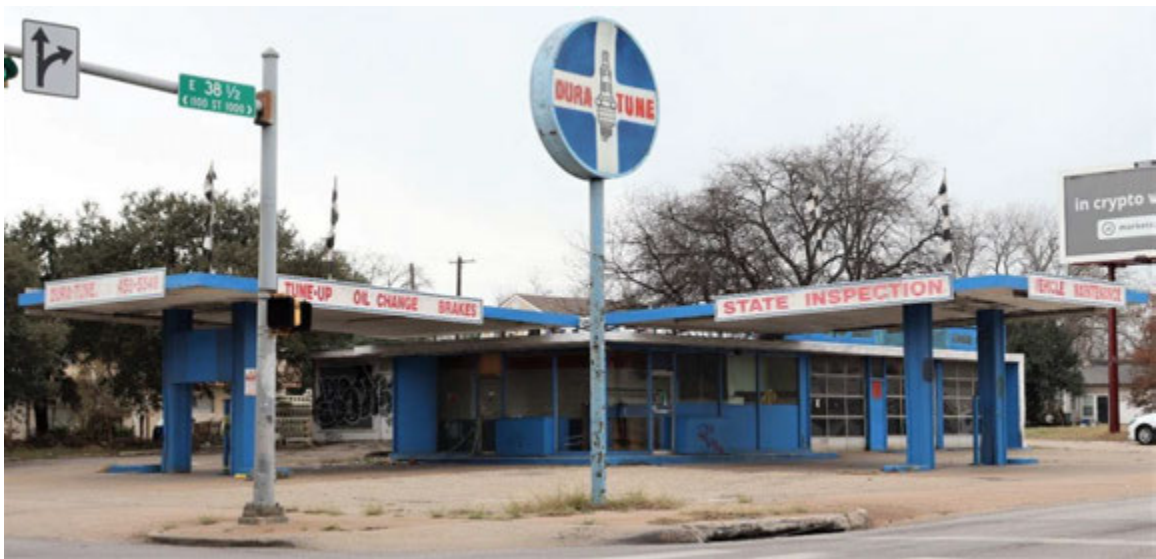
Figure 3. Dura Tune service station showing the character-defining features of the standard Conoco design and alterations as described above, view facing west-southwest, January 2022.

The building also has several non-standard features, including dual canopies (both original) and display windows without transoms. Alterations include the removal of the original fuel pumps, paint applied to lower portions of display windows, and replacement of the original Conoco signage. Also of note is the apparent encapsulation of the original round canopy supports with square hollow columns. Visible denting of the columns indicates they are hollow cosmetic applications, likely covering the original metal supports. Figures 1 through 4 demonstrate comparisons between the property type's original features and those present on the current Dura Tune property, as well as alterations.

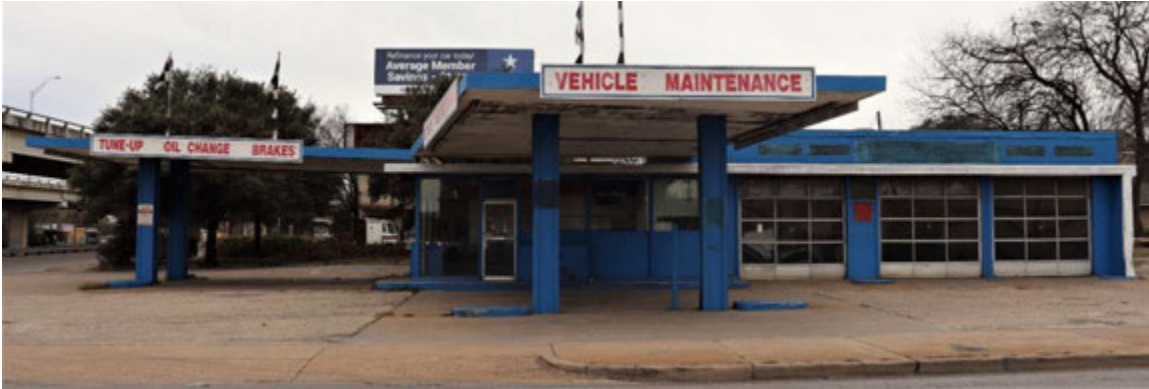
Figure 4. Dura Tune service station showing the character-defining features of the standard Conoco design and alterations as described above, view facing south-southwest, January 2022.

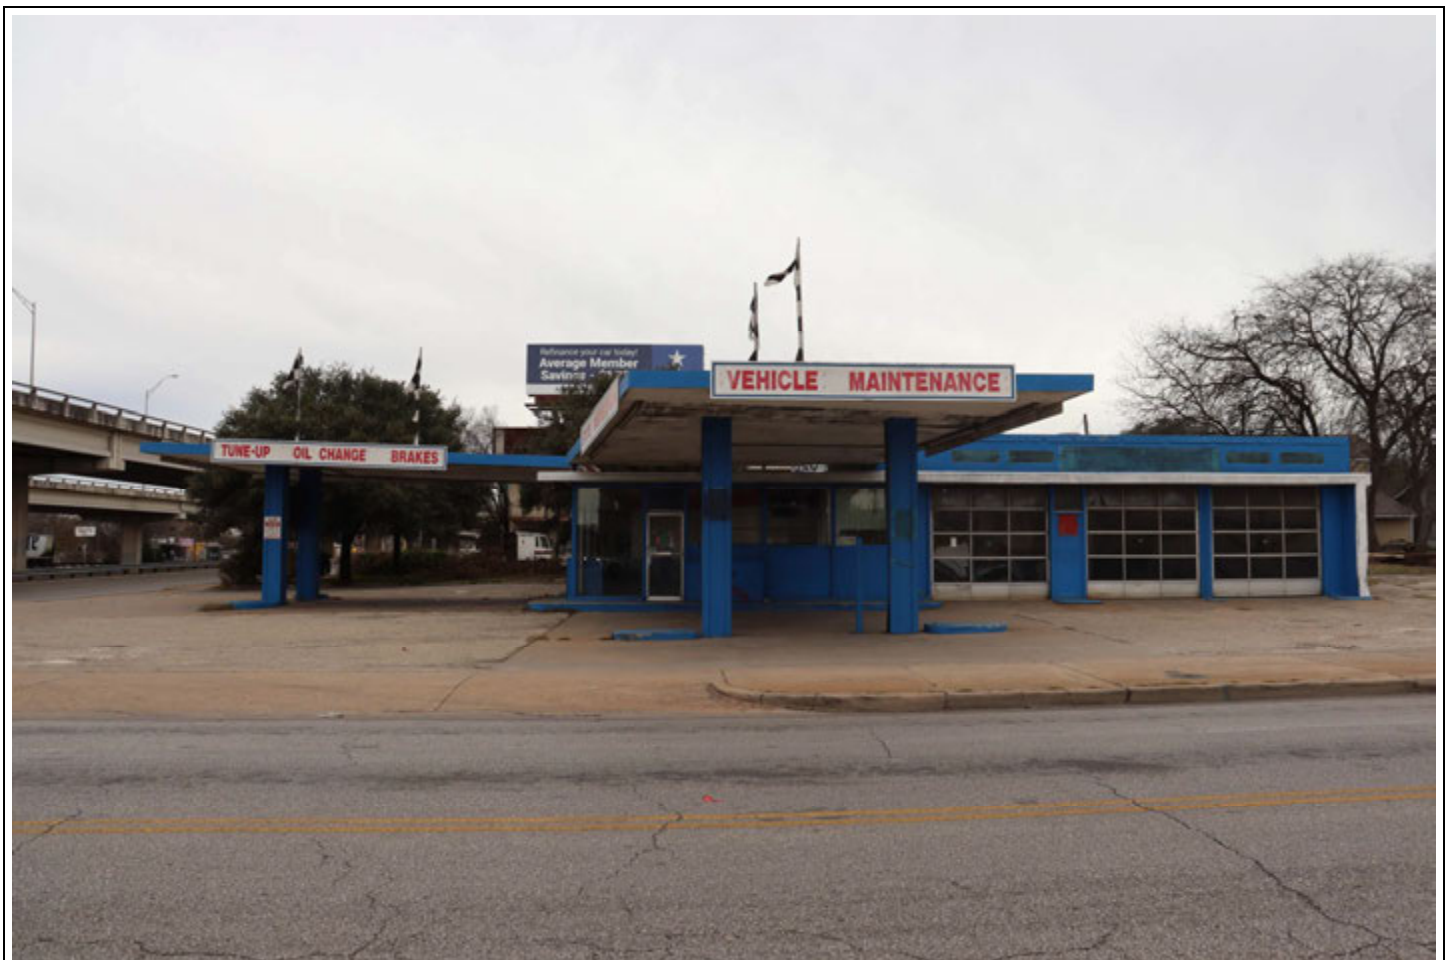
Integrity Considerations:	Alterations are limited to altered canopy posts. Despite these limited alterations, Resource 200 retains all aspects of integrity.

*View facing southwest.*

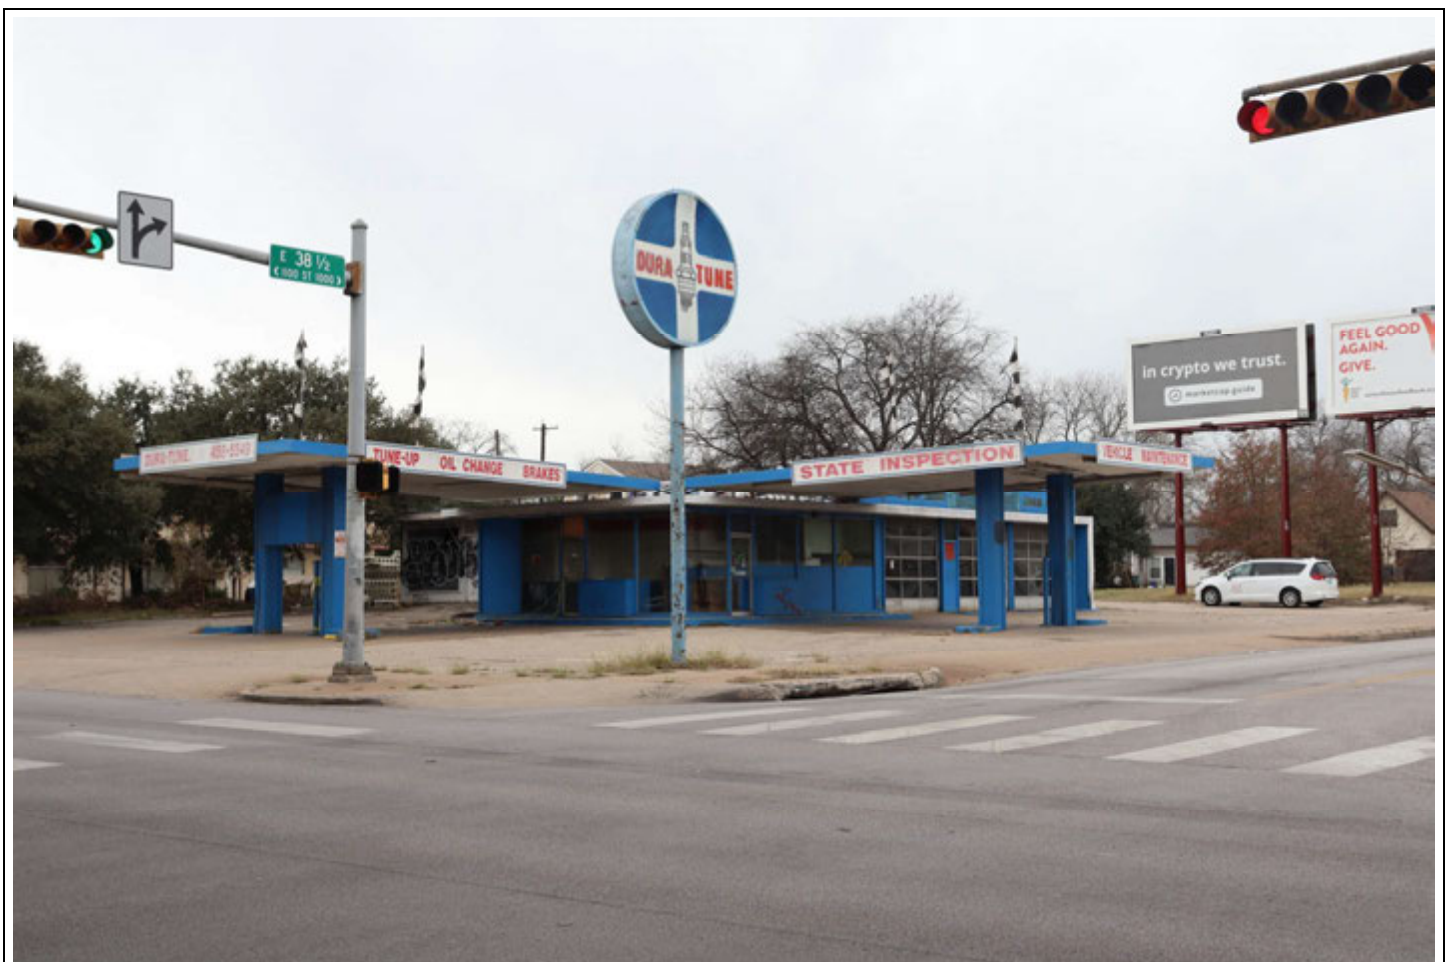
*View facing west. Showing relationship of building (rear) to historic-age sign (front).*

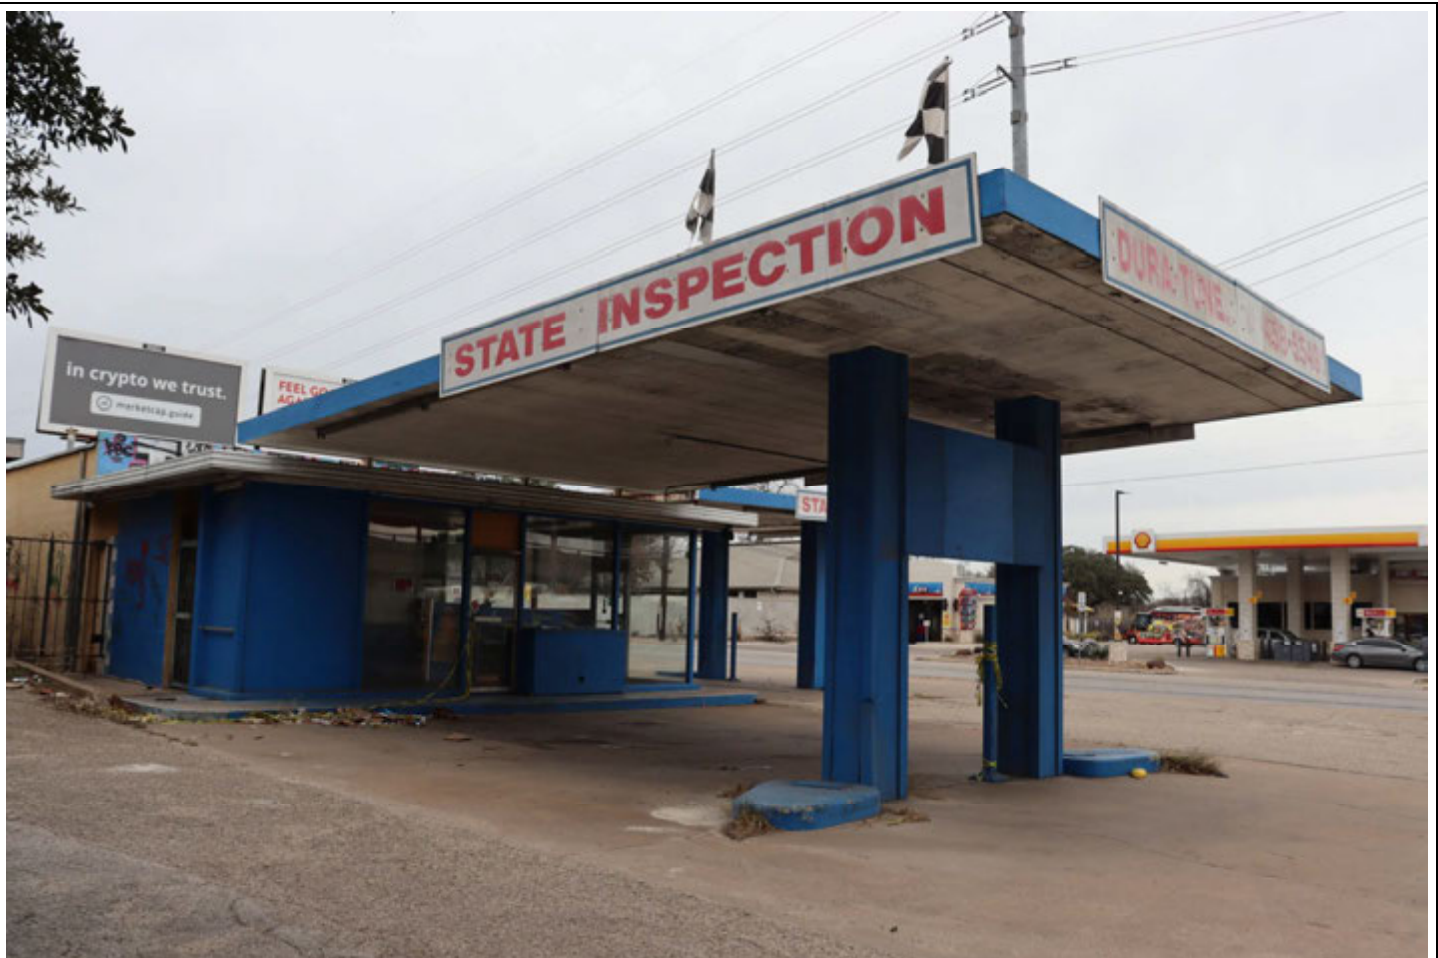
*View facing north.*
