Hazardous Materials Technical Report

U.S. Highway 290 (US 290) / State Highway (SH)
71 West from State Loop 1 (MoPAC) to
Ranch-to-Market (RM) 1826 and SH 71 to
Silvermine Drive
Travis County, Texas
CSJ # 0113-08-060 and 0700-03-077
October 2017

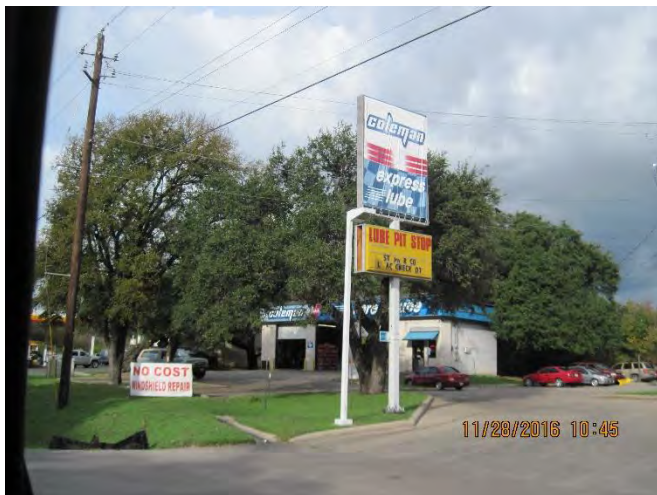
Photo 3: Coleman Lube facing northwest from US 290 frontage road.

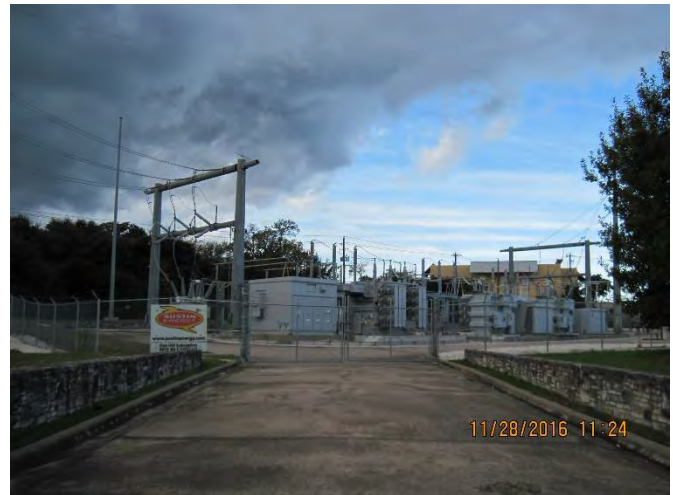
Photo 4: Electrical substation on McCarty Lane just south of project corridor. Photograph taken facing west.

substation was present adjacent to the project corridor; all transformers were in good condition and the substation was well covered with gravel. The substation was located off Joe Tanner Lane. Electrical transmission lines were present within the project corridor along portions of the north side of US 290 and near the electrical substation.
