Waters of the United States Technical Report

North Houston Highway Improvement Project

From US 59/I-69 at Spur 527 to I-45 at Beltway 8 North

Prepared by: TxDOT Houston District

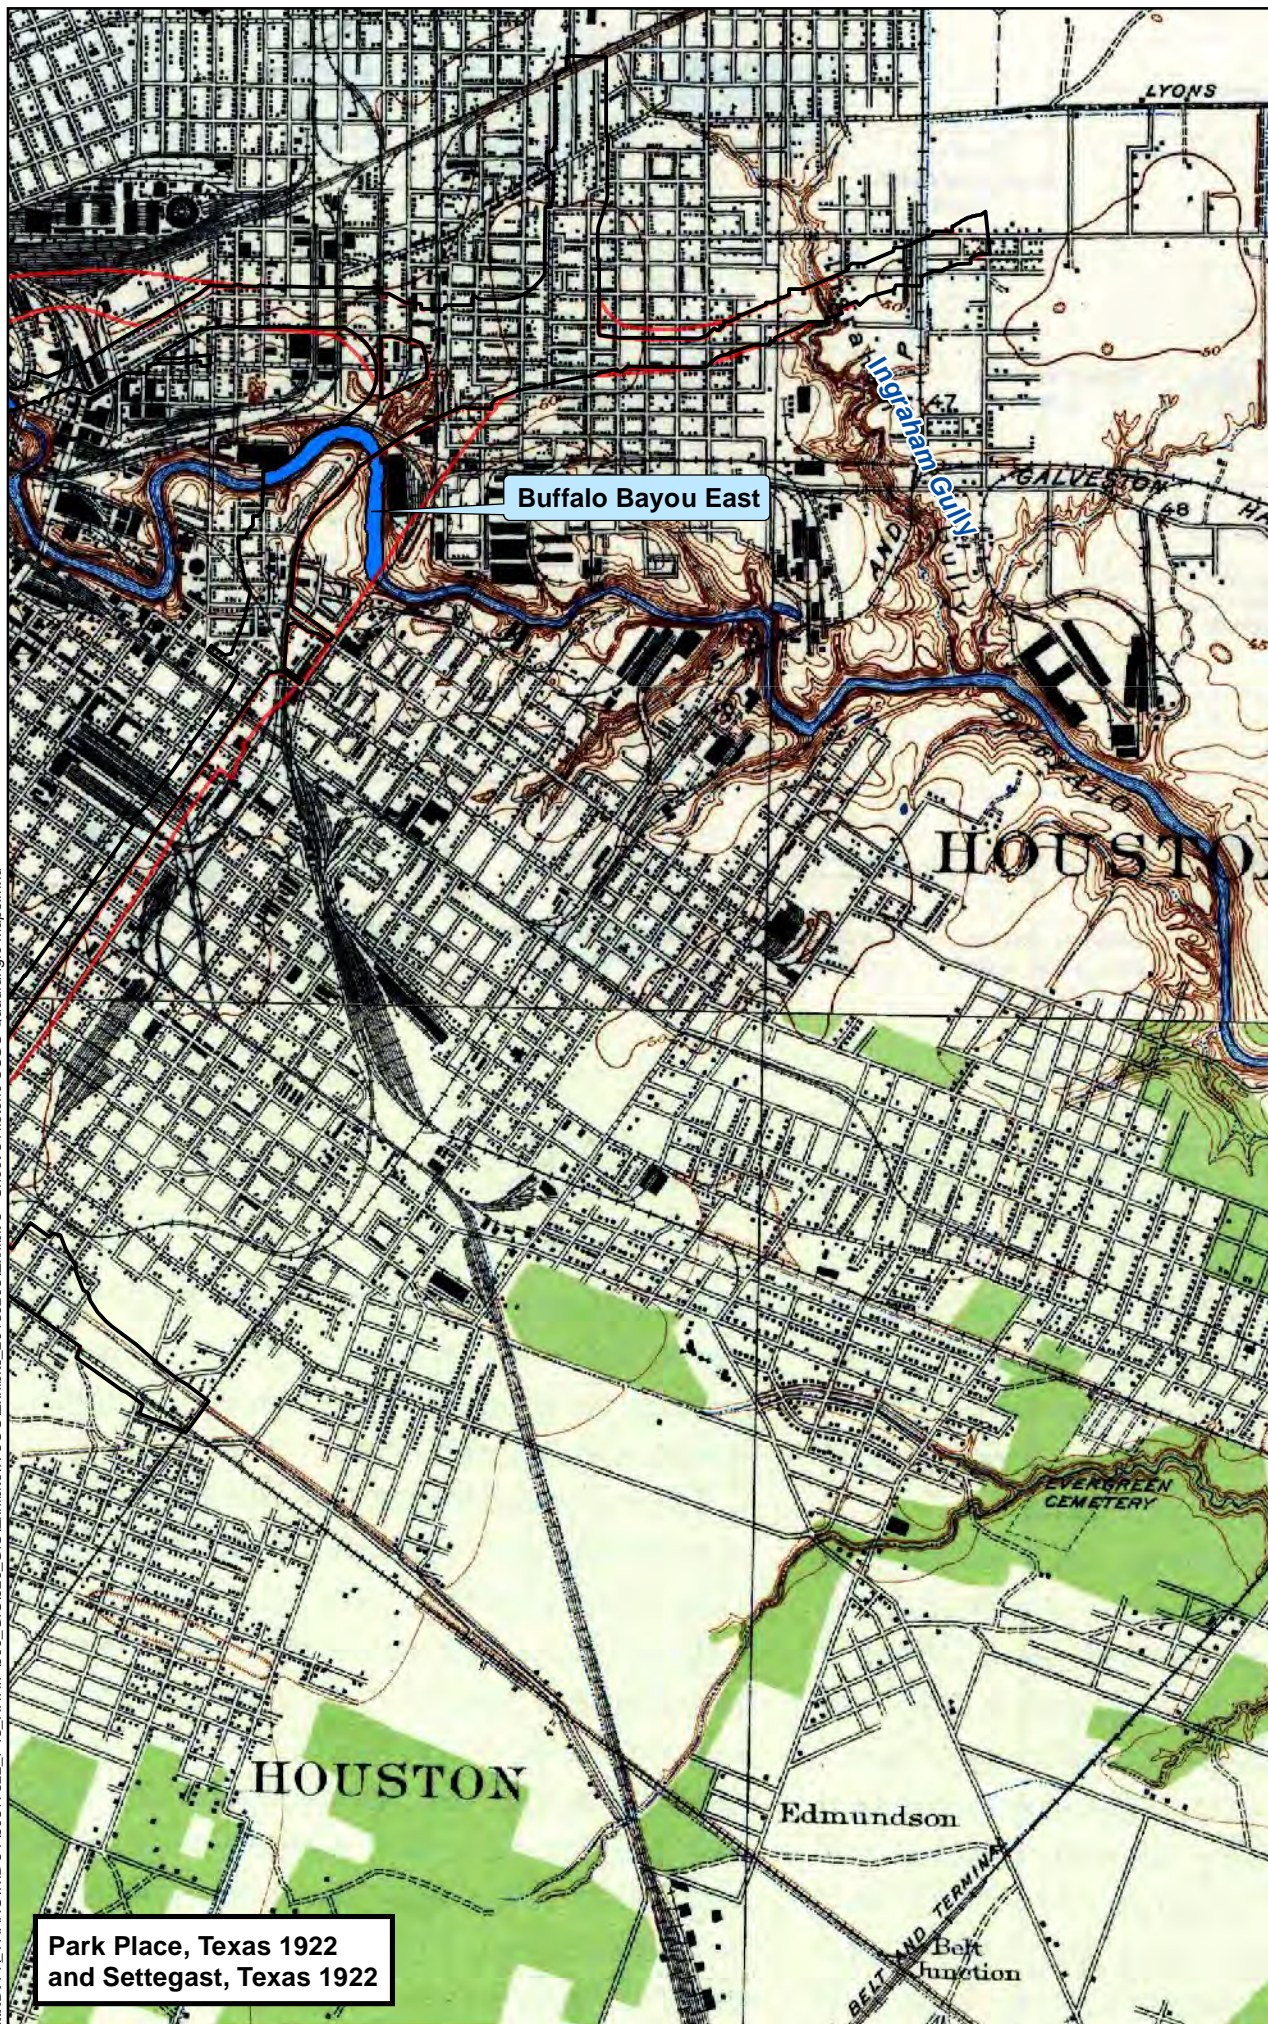
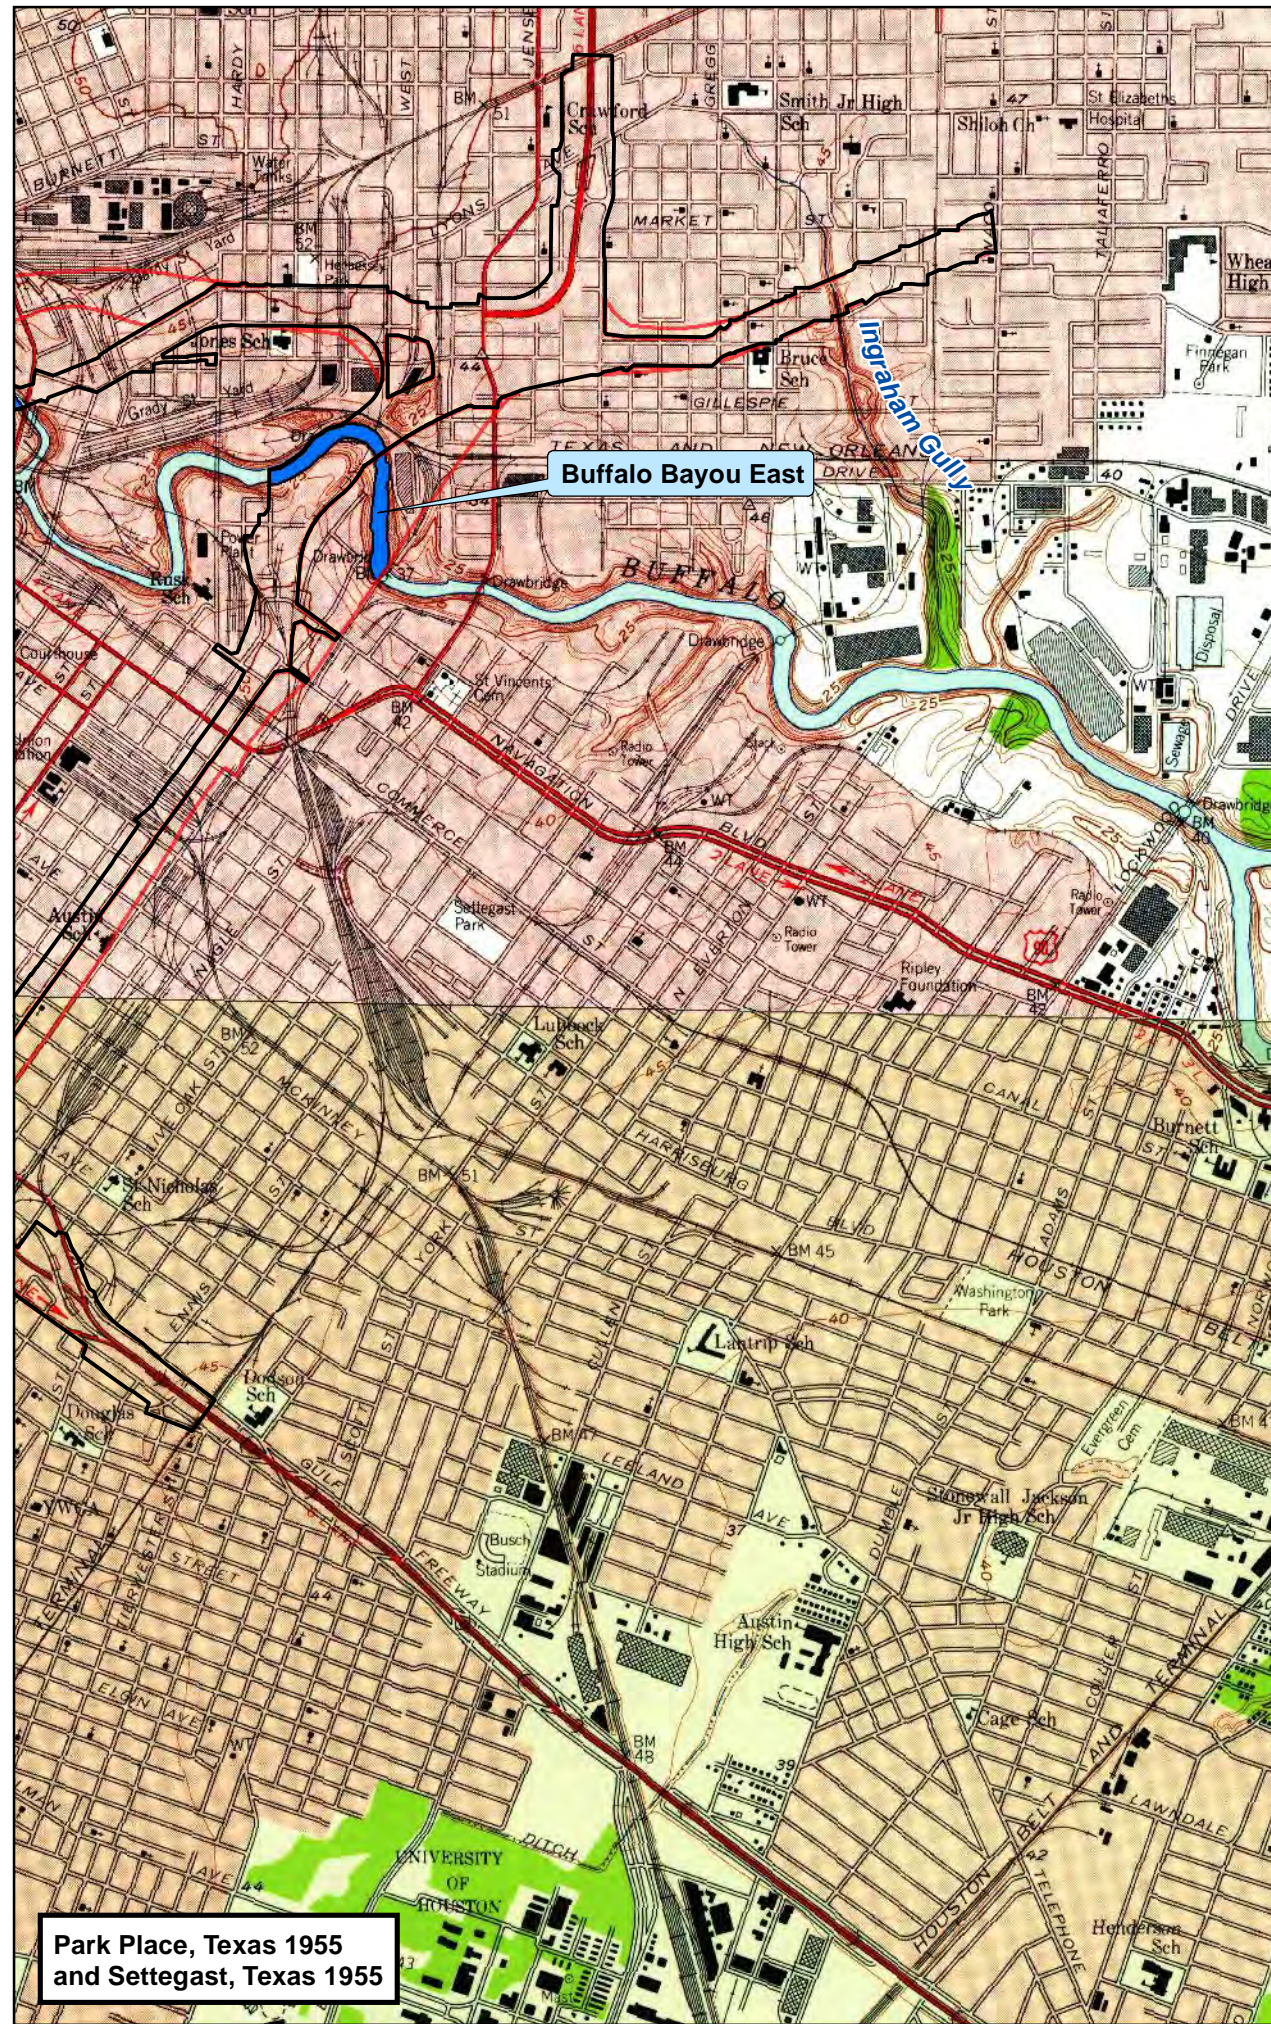
Park Place, Texas 1922
and Settegast, Texas 1922

Park Place, Texas 1955
and Settegast, Texas 1955

White Oak Bayou is shown on the 1922 and 1955 Settegast, Texas topographic quadrangle maps (*Exhibit 3, Sheets 3 and 4*). Within the existing ROW, White Oak Bayou is a rectified channel. Approximately 1,900 linear feet of the upstream portion of the channel that is within the project area is concrete-lined. The concrete lining is visible in aerial photographs, and was observed during the site visits (*Exhibit 2, Sheets 3 and 4; Exhibit 4, Sheets 3 and 4; Appendix A, Exhibit 5, Photos 21, 22, 23, 24, and 25*). Within the project area, White Oak Bayou is bridged 11 times, as determined from review of aerial photographs.

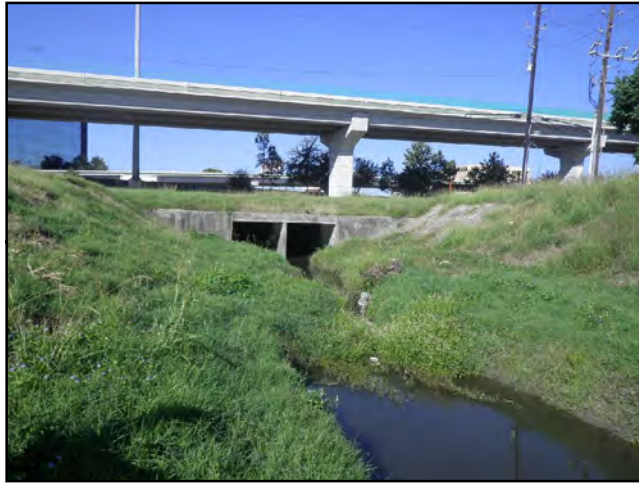
Photo 1 - Looking west at culverts of Drainage Ditch 113251601 at eastern boundary of ROW

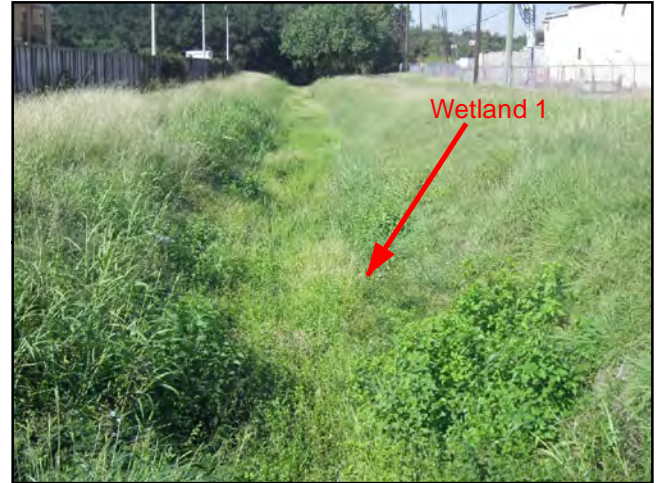
Photo 2 - Looking west at Drainage Ditch 113252111 and Wetland 1

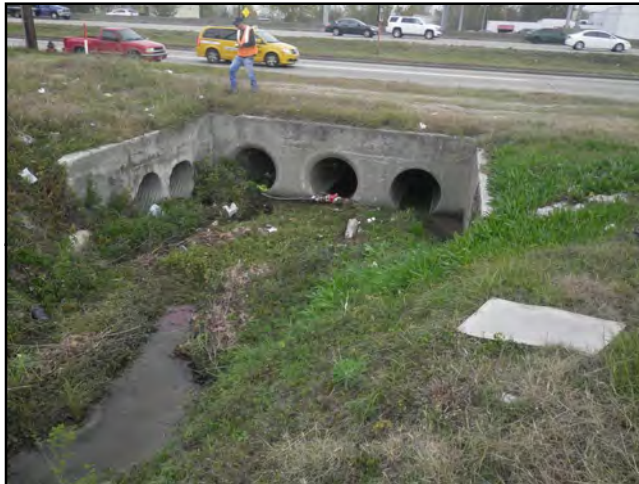
Photo 3 - Looking east at Drainage Ditch 113252111

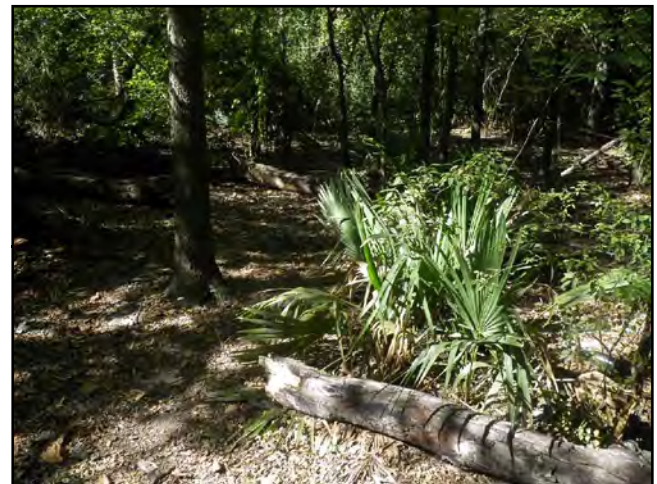
Photo 4 - Looking west within Wetland 2

Wetland 2 is not shown on the 1916 or 1954 Aldine, Texas topographic quadrangle maps, or on the U.S. Fish and Wildlife Service (USFWS) National Wetlands Inventory (NWI) mapping (*Exhibit 3 Sheet 1; Exhibit 4, Sheet 1*). Wetland 2 is a forested wetland situated within the one-percent Annual Exceedance Probability (AEP), or 100-year, Flood Hazard area of Halls Bayou (*Exhibit 4, Sheet 1; Appendix A, Exhibit 1, Photo 4*).

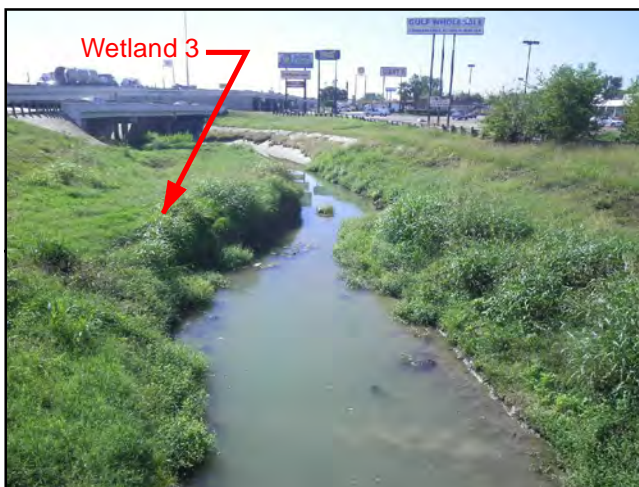
Photo 5 - Looking southeast at Halls Bayou and Wetland 3 west of existing I-45 frontage road

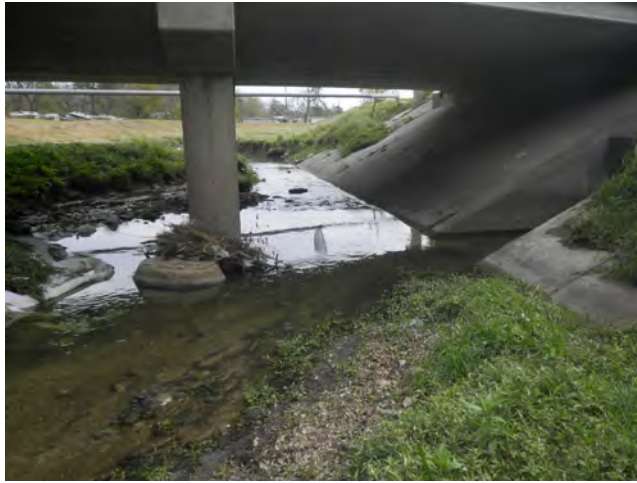
Photo 6 - Looking east under the I-45 roadway at Halls Bayou

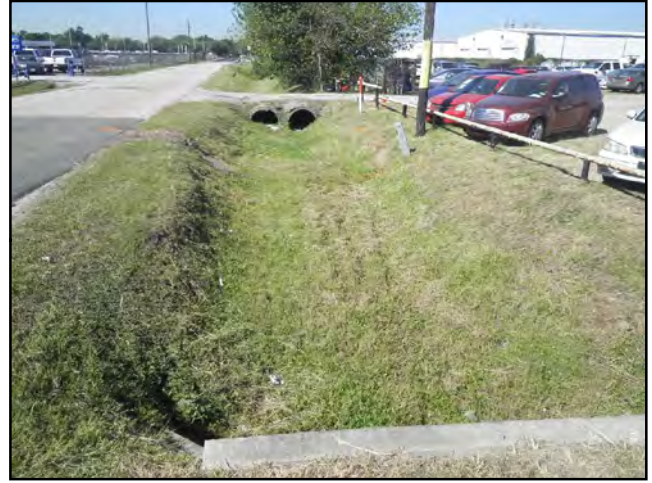
Photo 7 - Looking west at Drainage Ditch 113252481 (grass-lined) in the proposed ROW

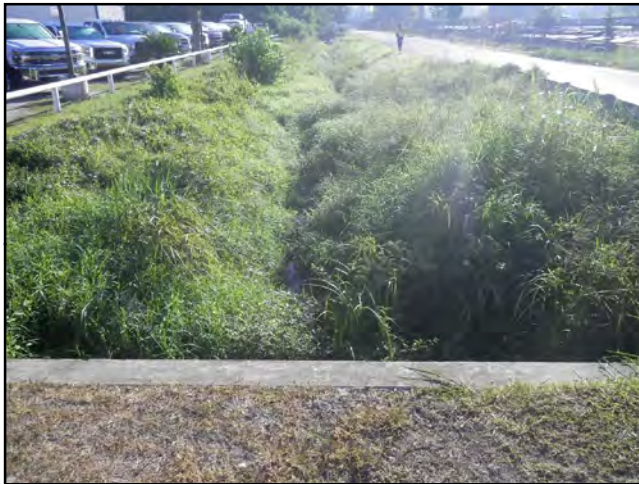
Photo 8 - Looking east at Drainage Ditch 113252481 west of the existing I-45 frontage road

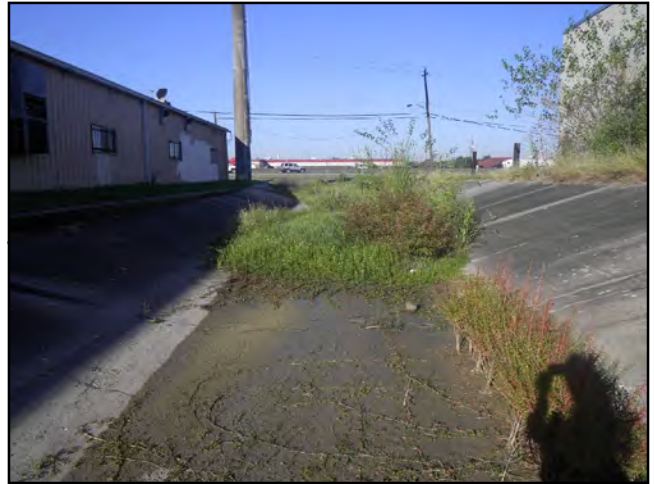
Photo 9 - Looking west at Drainage Ditch 113252861 (concrete-lined)

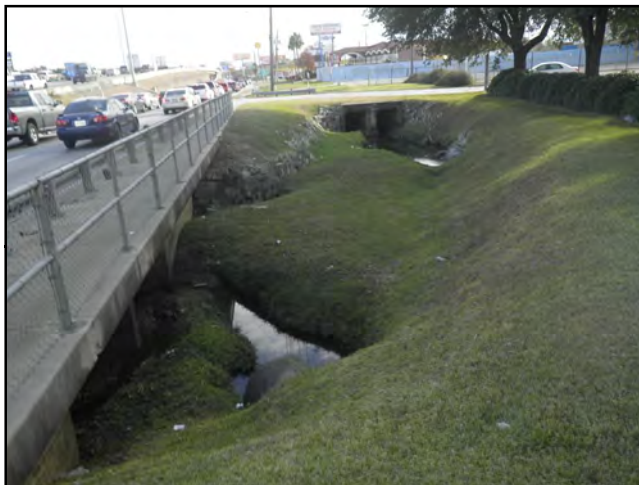
Photo 10 - Looking south at Wetland 4 (culverts and sediment deposits in channel)

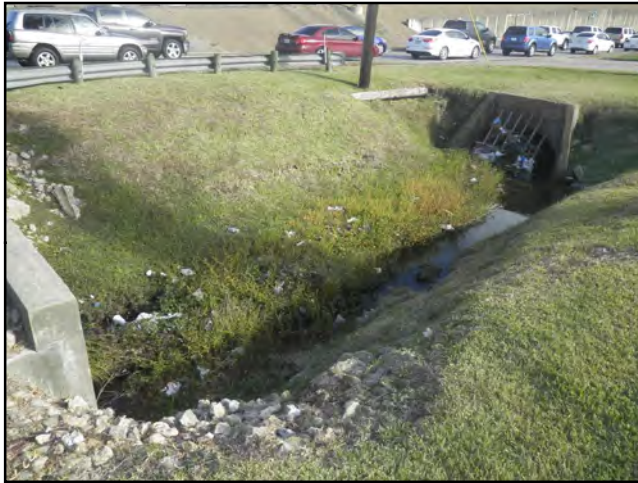
Photo 11 - Looking north at Wetland 5 (culverts and wetland vegetation)

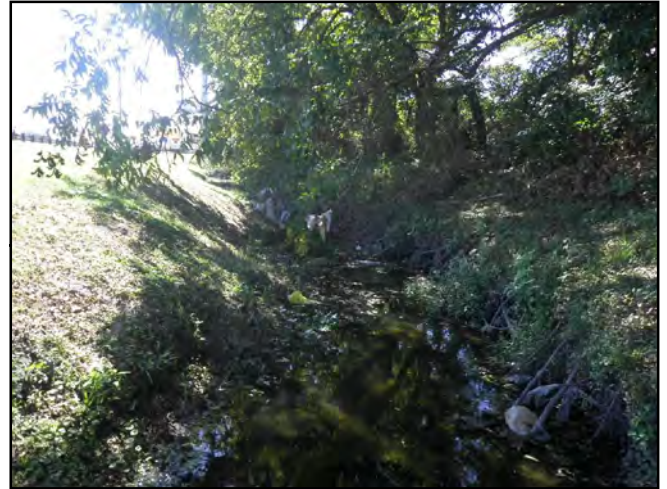
Photo 12 - Looking southeast at Drainage Ditch 113253277

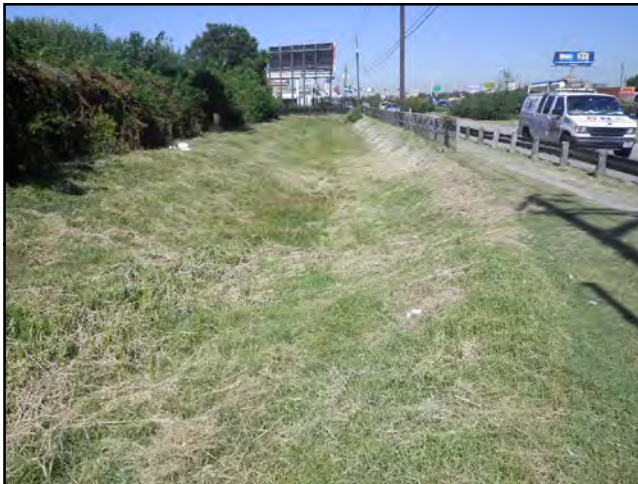
Photo 13 - Looking northwest at Drainage Ditch 113253377 (grass-lined channel) from East Burrell Street

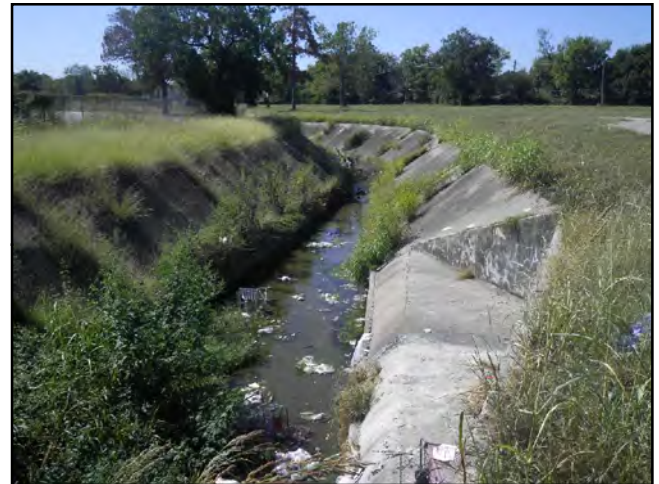
Photo 14 - Looking southwest at Drainage Ditch 113253359 (concrete-lined) from I-45 frontage road outfall

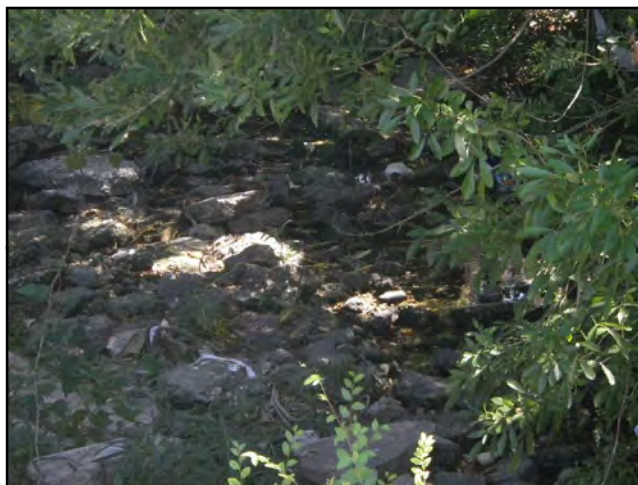
Photo 15 - Looking east at Janowski Ditch (riprap in channel bottom)

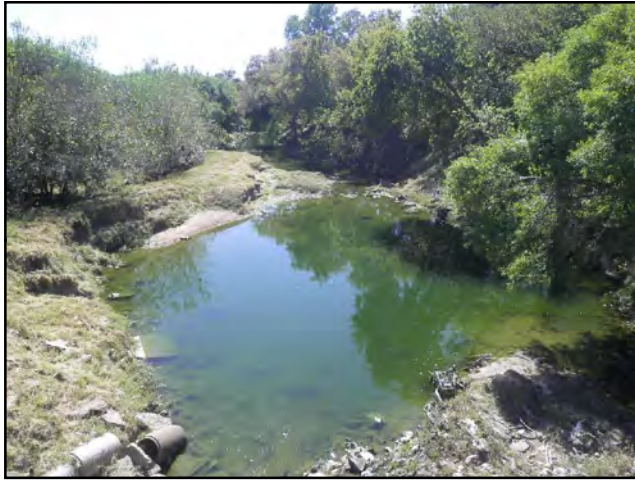
Photo 16 - Looking south from Stokes Road bridge at Little White Oak Bayou 1

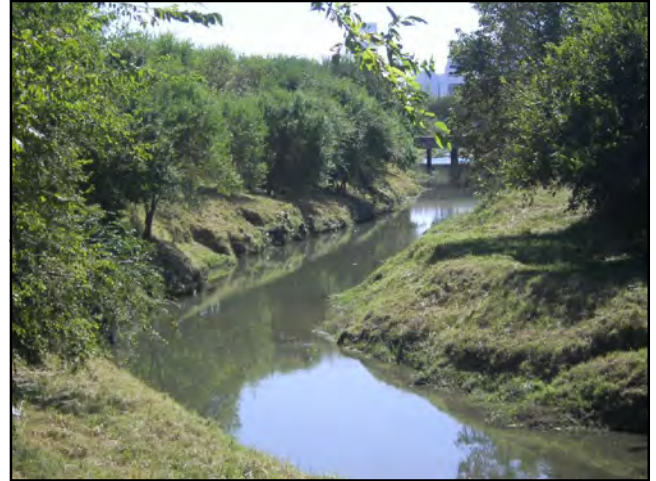
Photo 17 - Looking south at Little White Oak Bayou 2

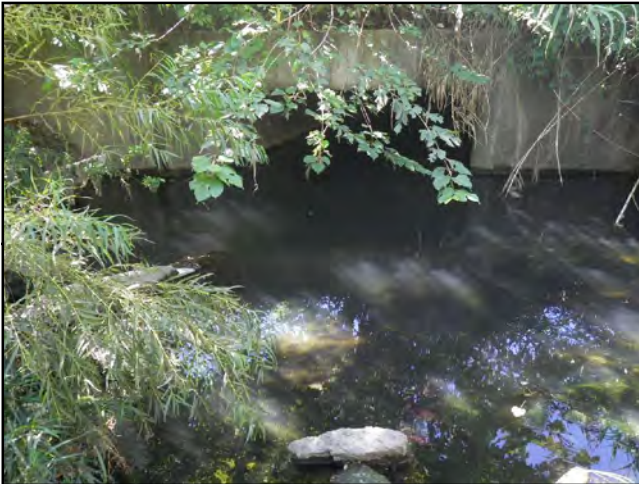
Photo 18 - Looking west at outfall of Un-named Ditch 2

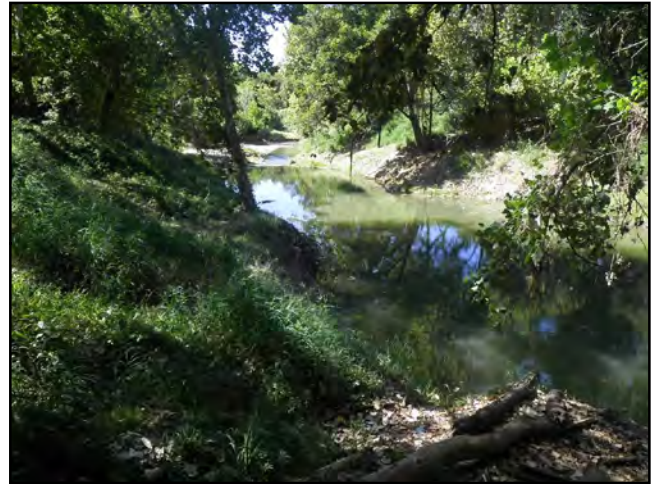
Photo 19 - Looking west at Little Oak Bayou 4 from outfall west of I-45 frontage road

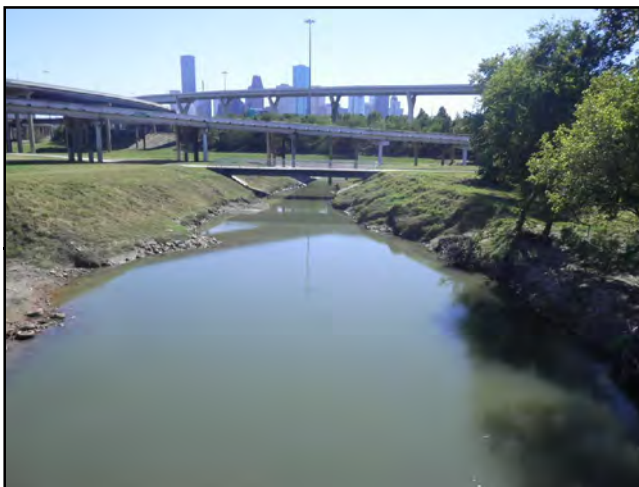
Photo 20 - Looking south at Little White Oak Bayou 5 from White Oak Drive bridge

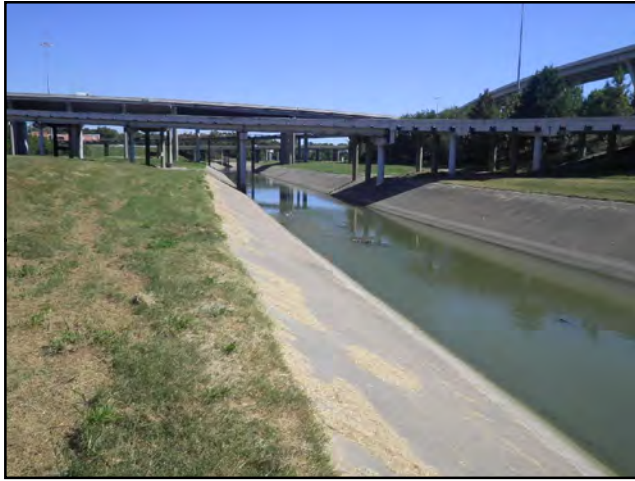
Photo 21 - Looking east at White Oak Bayou (concrete-lined) upstream of the confluence with Little White Oak Bayou 6

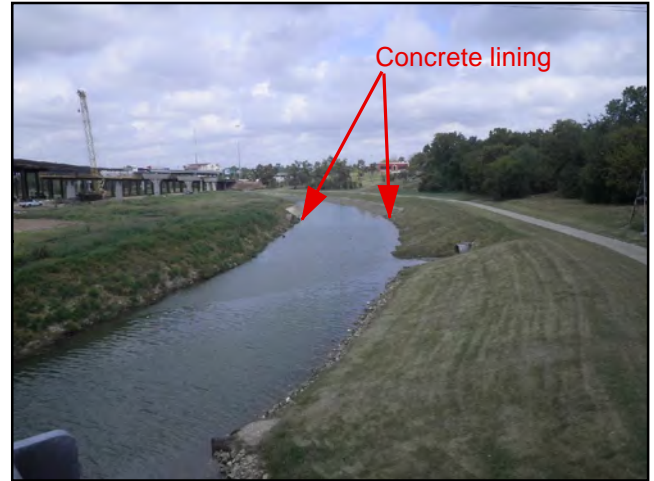
Photo 22 - Looking north from bicycle path bridge at White Oak Bayou (riprap-lined banks in foreground to concrete-lined banks in background)

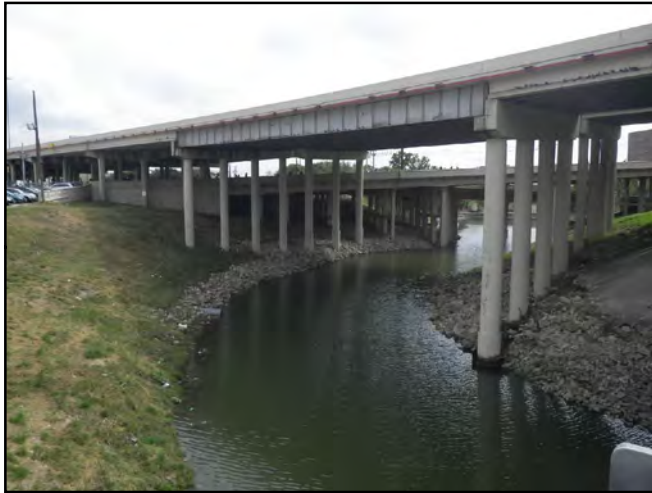
Photo 23 - Looking southeast at I-10 crossing of White Oak Bayou (riprap along banks)

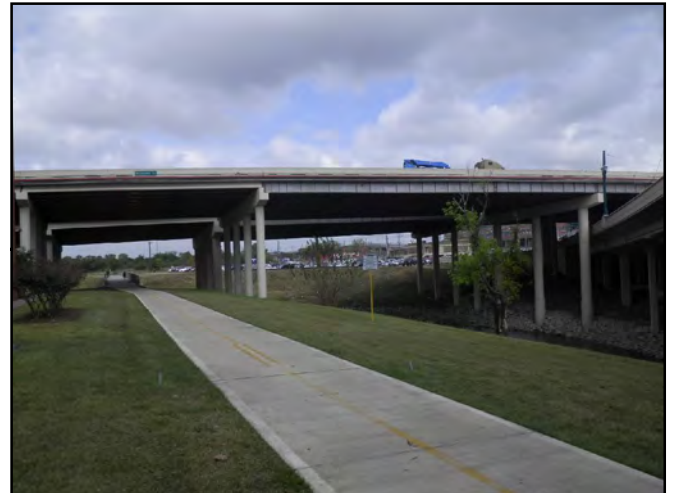
Photo 24 - Looking northwest at I-10 crossing of White Oak Bayou

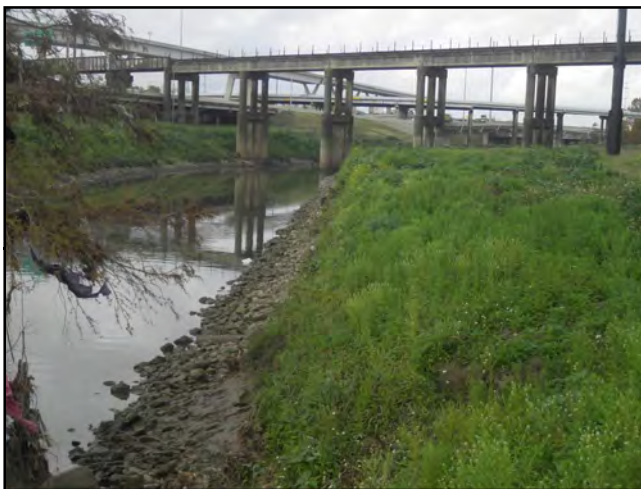
Photo 25 - Looking northwest at rail crossing of White Oak Bayou; I-45 and I-10 in background

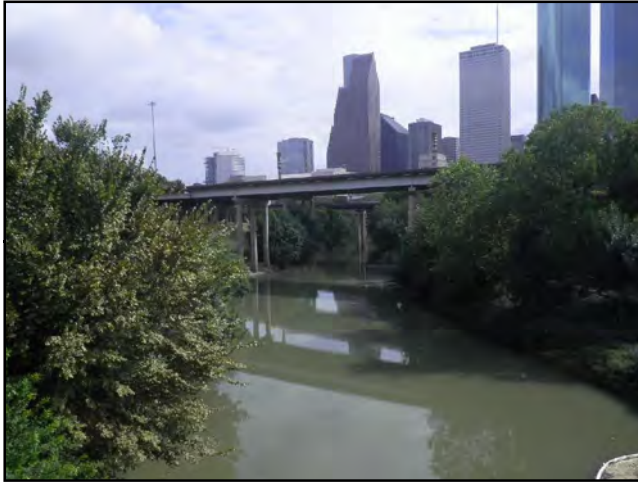
Photo 26 - Looking east at I-45 crossing of Buffalo Bayou West 2 from Sabine Street bridge

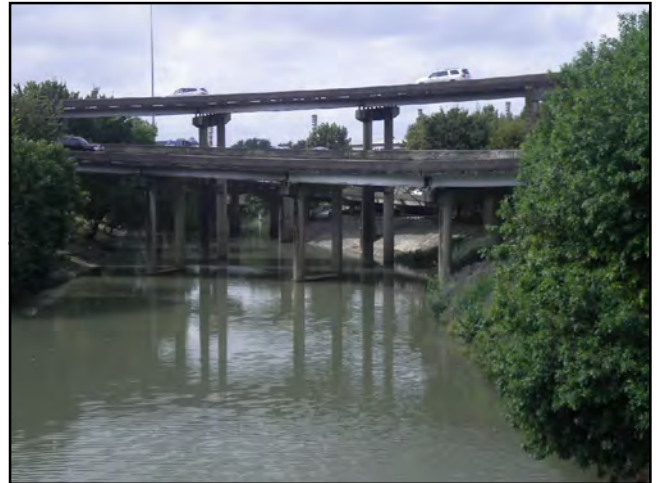
Photo 27 - Looking southwest from pedestrian bridge at I-45 crossing of Buffalo Bayou West 2

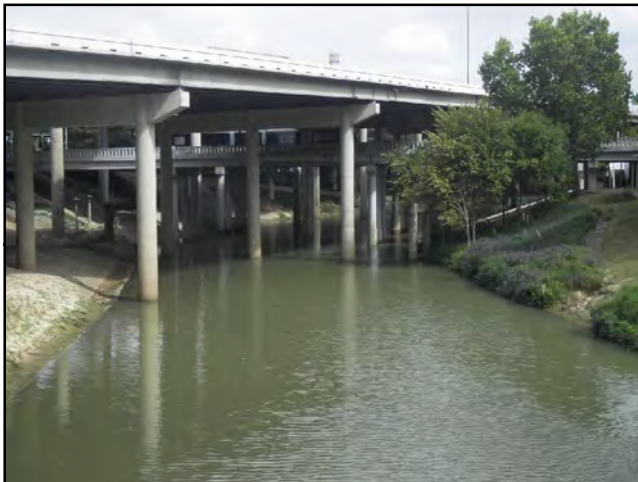
Photo 28 - Looking northeast from pedestrian bridge at I-45 Crossing of Buffalo Bayou West 1

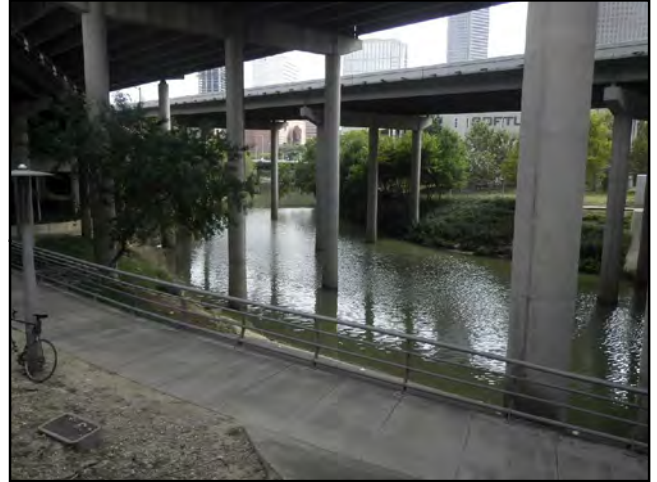
Photo 29 - Looking east at I-45 crossing of Buffalo Bayou West 1 near Rusk Street and Memorial Drive intersection

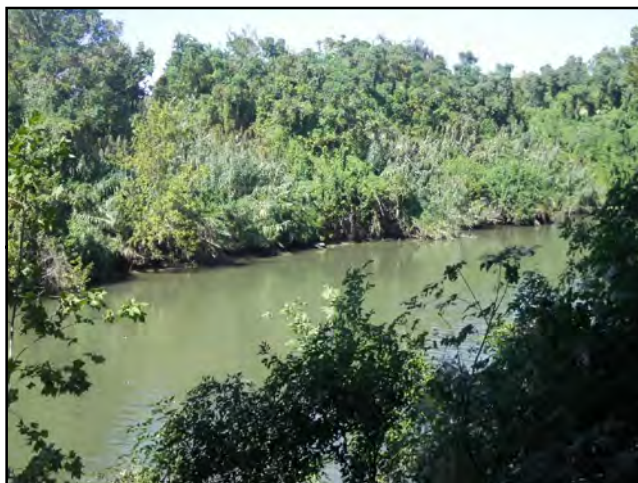
Photo 30 - Looking north at Buffalo Bayou East from under US 59/I-69 bridges

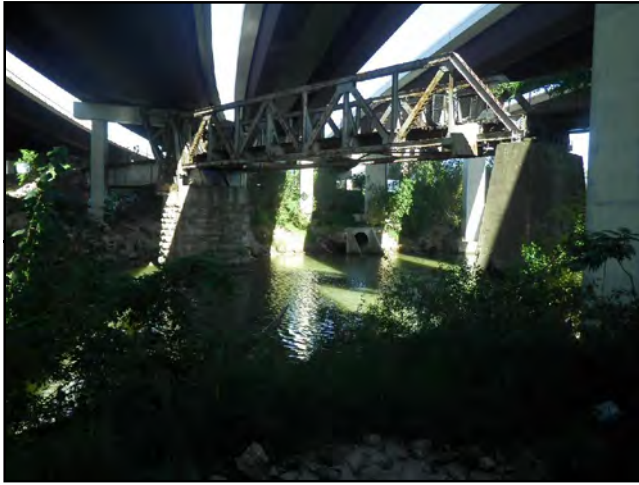
Photo 31 - Looking northeast at Buffalo Bayou East from under US 59/I-69 bridges

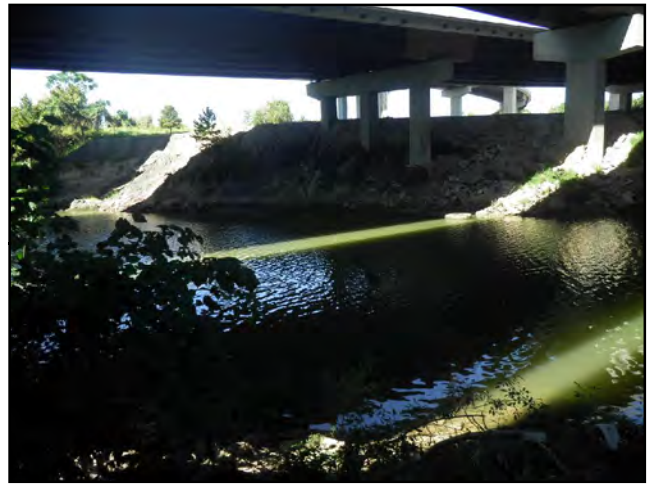
Photo 32 - Looking north at Buffalo Bayou East underneath US 59/I-69 bridges

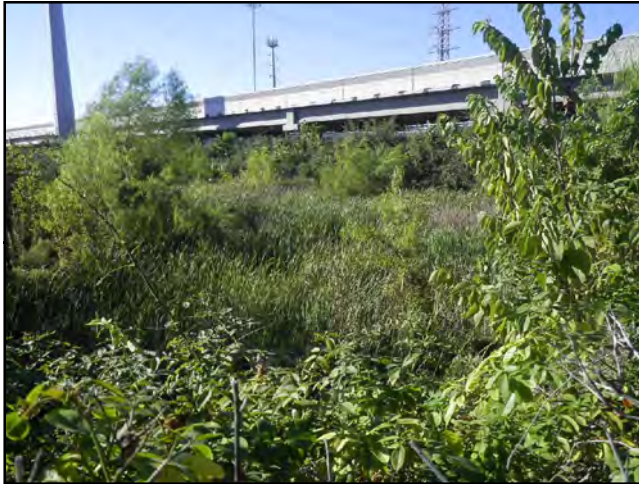
Photo 33 - Looking northwest at Detention Basin 2 from Main Street
