## Central Texas Turnpike System 2002 Project

# Annual Inspection Report Fiscal Year 2012

# Annual Inspection Report

For the fiscal Year ending August 31, 2012

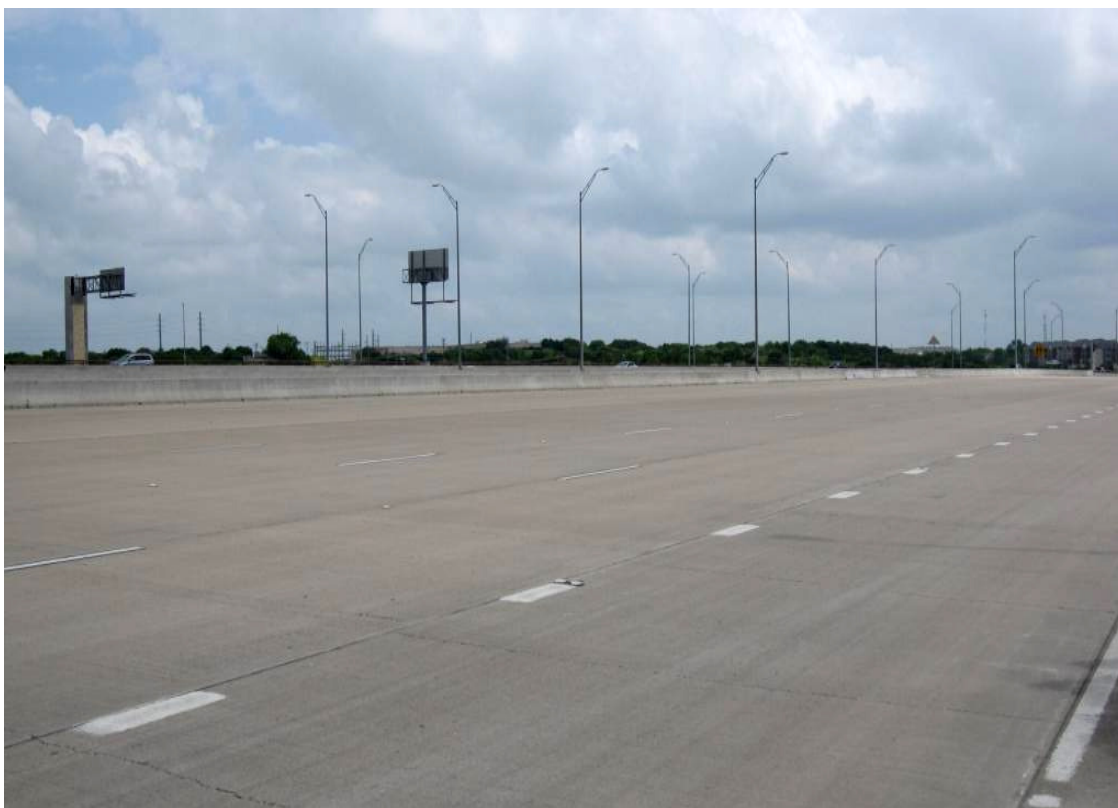
**Figure 3 - Typical Roadway Section**

The pavement category includes; rutting, cracking, pavement failures, ride rating, edges and shoulders. Pavement throughout the CTTS was generally found in like new condition and achieved an overall score of 95. The lowest pavement element score, cracking, received a score of 77 and was noted on Loop 1. There were no major deficiencies on any of the three roadway systems reported by the annual inspection.

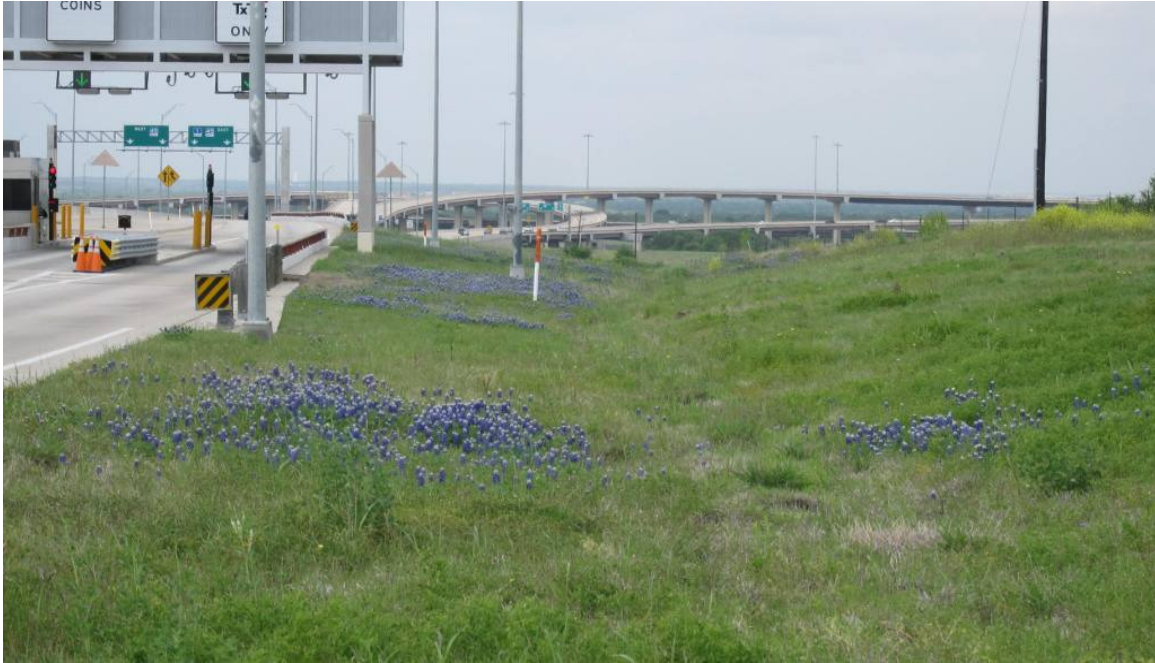
**Figure 7 – Desired Shoulder and Turf Condition**

The determination of the Roadside score for roadside features is generally based upon the consideration of vegetation management, litter removal, drainage structures, and other elements located outside of the paved travel way (Figure 2). The roadside category is in excellent condition and has achieved an overall score of 98. There were no characteristics that rated lower than 94. The lowest element, vegetation management, was found on SH 130.

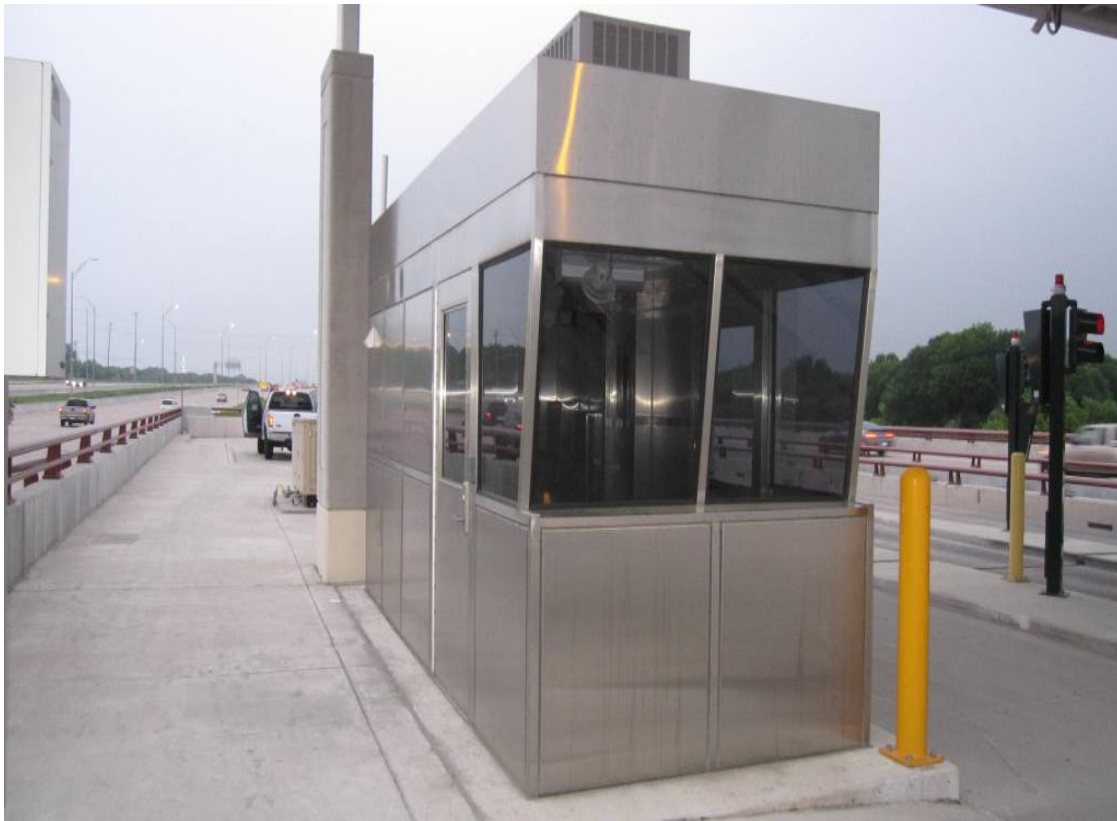
Figure 11 - Tollbooth

All tollbooths, including forty that have been decommissioned, were inspected during the FY 2012 inspection. Tollbooths and related subcomponents were noted in excellent condition throughout the CTTS. A typical tollbooth configuration is pictured below in Figure 9. The condition of the elements and the corresponding deficiencies for each of these categories is summarized in Tables 9 through 11, with a system-wide summary shown in Table 12.

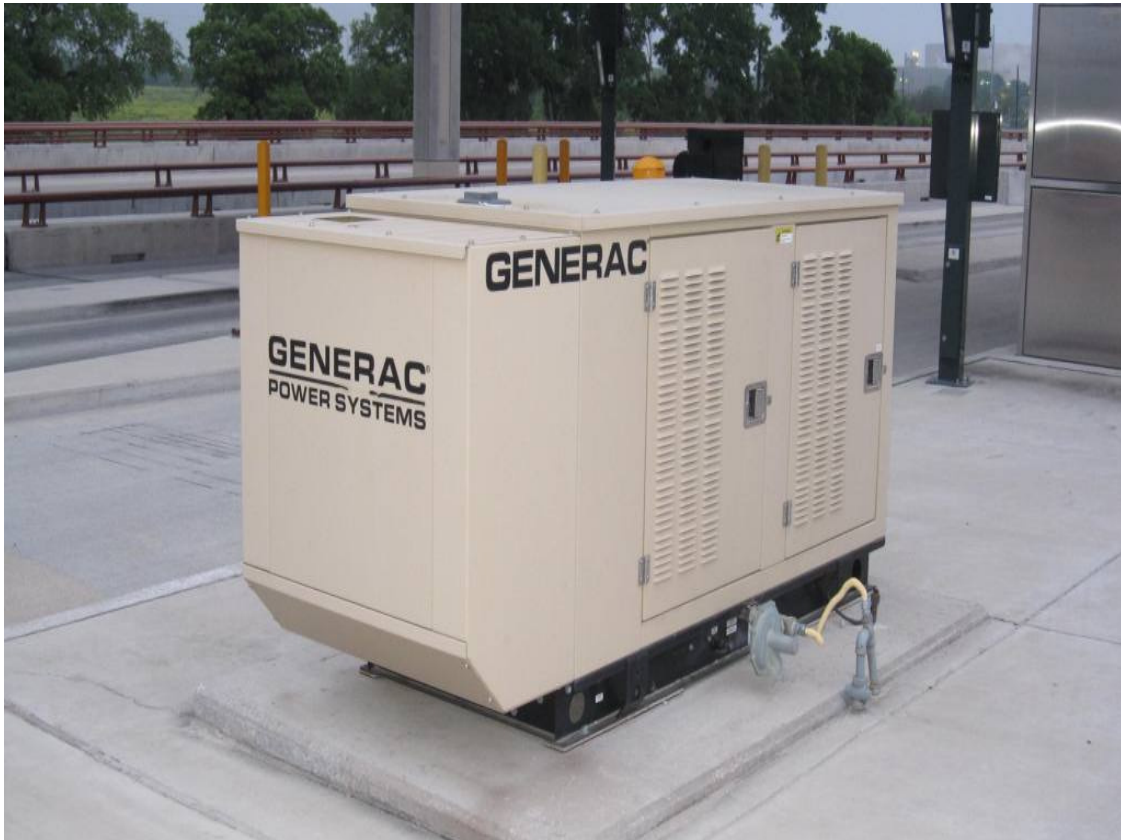
Figure 12 – Facility Generator

Of the 895 total elements in the electrical category, only nine elements were noted as deficient for an overall deficiency rate of 1.00%. A majority of the deficient elements were non-functioning GFI receptacles located throughout the system. No generators were found to be deficient.
