Historical Resources Survey Report

Reconnaissance Survey

Project Name: Downtown 10

Project Limits: Interstate Highway 10 (I-10) from Executive Center Boulevard to State Loop 478

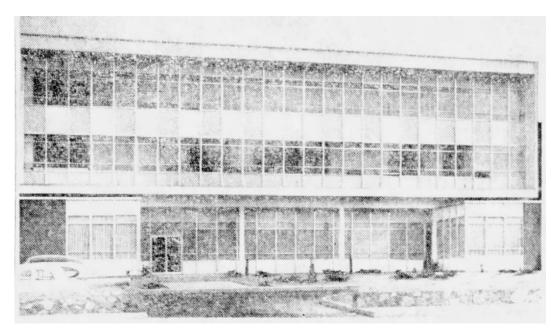
1961 image of building showing original configuration of first level (image courtesy of *The El Paso Times*, December 16, 1961, page 13).

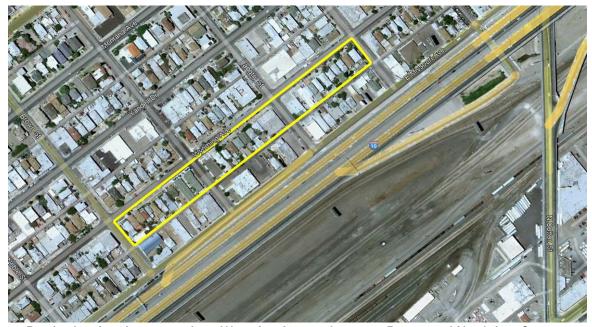
Box is showing the areas along Wyoming Avenue between Brown and North Lee Streets.

One area with a concentration of houses that required closer review is located between Brown Street and North Lee Street on the south side of Wyoming Avenue (see yellow highlighted area below).

This area has consecutive buildings that are somewhat intact in the middle of each of the three blocks. At the end of each block, however, are non-historic-age, heavily modified resources, or vacant/parking lots. As a result, these resources are isolated from each other and the continuity between the blocks is lost. Examples of the intrusions at the corners of these blocks is illustrated below.

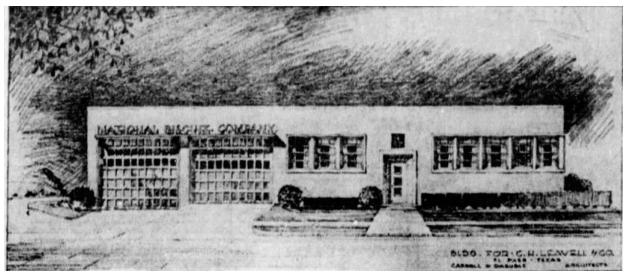
Drawing of Resource No. 303, the El Paso Branch of the National Biscuit Company (image courtesy of *The El Paso Times*, November 17, 1947, page 3).

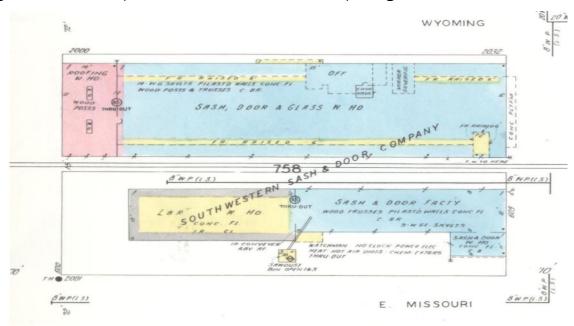
1954 Sanborn map (side streets are Eucalyptus and Willow on the left and right, respectively).

Resource No. 312 was cited as a property of concern in the consulting party comments as the Former Southwestern Sash and Millwork Company. Sanborn maps indicated that Resource Nos. 312 and 313 were part of the Southwestern Sash and Door Company (as shown on the Sanborn maps and in newspaper advertisements). As early as the 1910s, the Southwestern Sash and Door Company based out of Phoenix, Arizona consistently advertised in the newspapers for El Paso-based workers to come to Arizona. In March 1922, the company had operations in Phoenix and Tucson and came to El Paso when a local businessman, L.W. Hoffecker, wanted to retire and sold his glass business to the Arizona-based company. ²⁰⁰

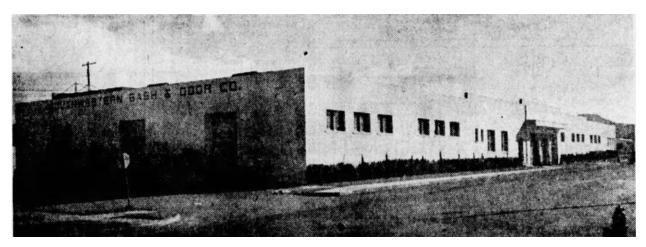
Resource No. 312 in 1951; note the fenestration is different from the appearance of the building today, including the infill of the original windows and the new pedestrian entrance (image courtesy of *El Paso Herald Post*, March 17, 1951, page 18).

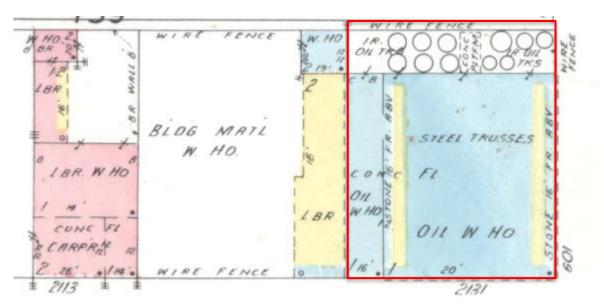
1954 Sanborn Map, the red outline shows Resource No. 320.

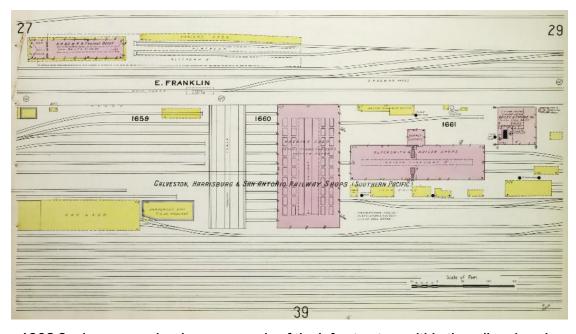
1908 Sanborn map, showing an example of the infrastructure within the railroad yards.

Sanborn maps, historic aerials, and research illustrate that the railroad yards east of downtown were a central location for the El Paso & Southwestern and Southern Pacific Railroads, with the former located directly north of the Southern Pacific Railroad yards. Sanborn maps from 1908 show numerous support buildings in the railroad yards of both companies, including car sheds, machine shops, blacksmith shops, freight sheds, and a large roundhouse.

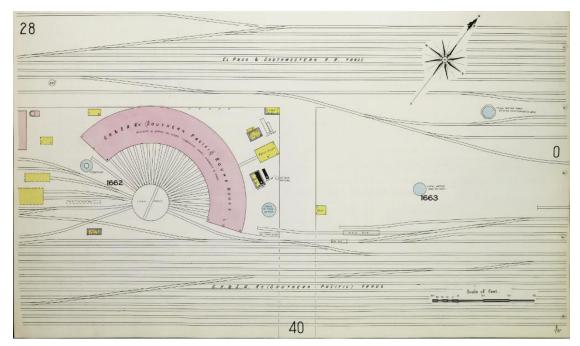
1908 Sanborn map, showing the location of a non-extant roundhouse near the western end of the yards.

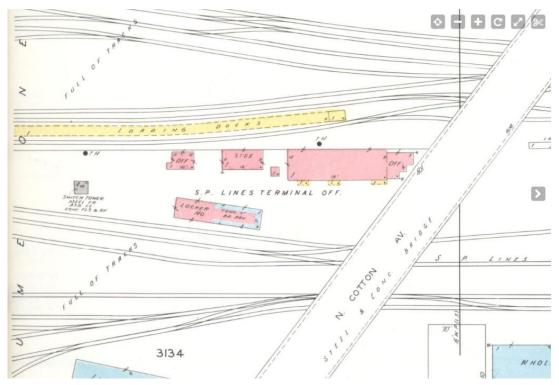
1954 Updated Sanborn map showing the west side of Cotton Street south of the current I-10 alignment with terminal offices and support buildings.

By the 1940s, Southern Pacific took over the entirety of the railroad yards, maintaining a wide area. Sanborn map updates from 1954 show that infrastructure remained in the railyards, including office buildings and other support structures like raised loading docks.

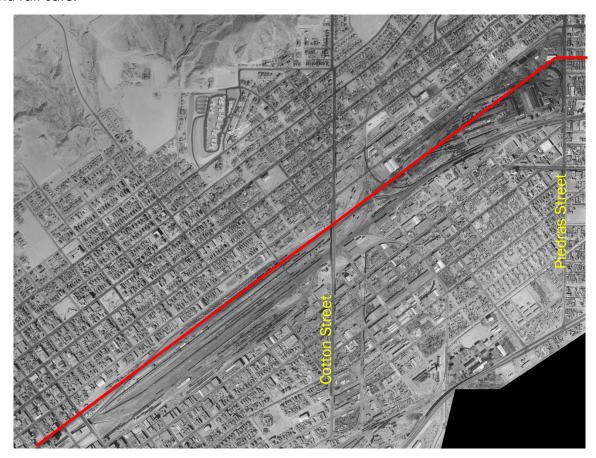
1955 historic aerial showing the railroad yards and large building complex on the east side of Cotton Street, the red line shows the approximate location of present-day I-10 for reference.

While the Sanborn maps did not provide coverage for all of the railroad yards, the 1955 aerial shows the full extent of the Southern Pacific Railroad yards. As seen in the historic aerial photograph below, the railroad yards included a significant amount of infrastructure to support railroad transportation, with a very large and dense building complex at the northeast end of the railroad yards between Cotton and Piedras Streets, in the 1950s. This building complex had a roundhouse and numerous maintenance shops to fix and maintain engines and rail cars.

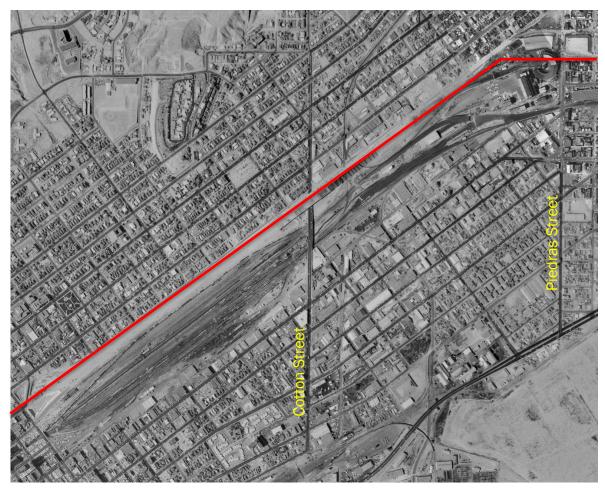
1967 historic aerial showing that many of the buildings in the railroad yards on the east side of Cotton Street are being demolished as I-10 is being built; the red line shows the approximate location of present-day I-10 for reference.

As noted in the historic context, railroad transportation declined during the 1950s and 1960s as the widespread ownership and use of trucks to move goods provided a more affordable and flexible scheduling for transportation of goods. As seen in the 1967 historic aerial below, there are fewer buildings in the railroad yard, illustrating that the need for the maintenance facilities was reduced. The main support facilities left in the railroad yards by 1967 appear to be a handful of shops and the roundhouse, which is the mainstay of any railroad yard.

By 1984, the interstate occupied the northern portion of the former railroad yards and the holding yards extended to the south. Additionally, the cornerstone of the railroad yards, the roundhouse, was demolished and nearly all pre-1967 support structures on the property were gone.

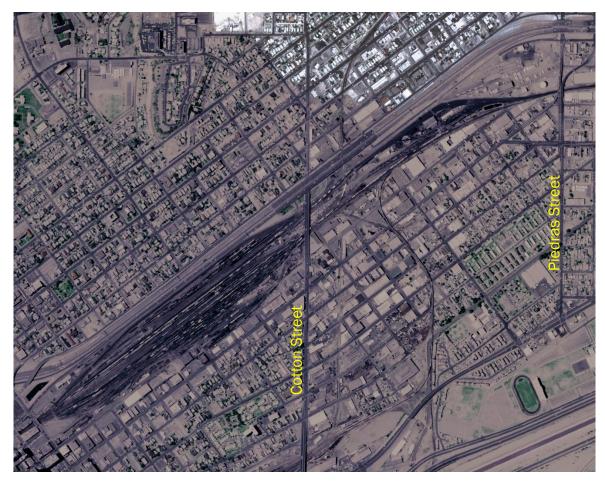
1984 historic aerial showing very few infrastructure resources located in the railroad yards.

Today, the railroad yards retain no extant resources from the period of significance, as the railroad yards have undergone several changes since 1960. The support structures are what makes railroad yards function and illustrate their place in time and history. Without the support structures, like the maintenance shops and the roundhouse, there are no resources as a collection that can illustrate the railroad's history. Therefore, as a collection and individually, Resource Nos. 321A-321I post-date the period of significance, and are not NRHP eligible under Criterion A. There is no information that the railroad yards are associated with an important person under Criterion B, and none of the structures or the design of the yard are important from a design or engineering standpoint under Criterion C. Additionally, with all the resources post-dating the period of significance, the overall property lacks the historic integrity of feeling, association, workmanship, design, materials, and setting. Therefore, ICF recommends that Resource Nos. 120B, 321A, 321B, 321C, 321D, 321E, 321F, 321G, 321H, and 321I are not eligible for the NRHP under Criterion A, B, or C.

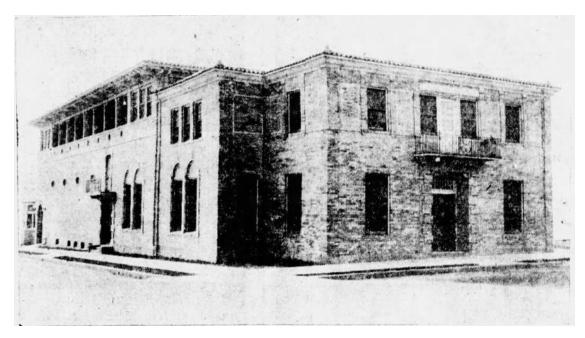
1924 photograph of Resource No. 152 after its construction, facing south (image courtesy of *El Paso Times*, January 20, 1924, page 19).

There are two funerary resources within the APE that are recommended not NRHP eligible. These are Resource Nos. 152 and 375. Resource No. 152 is the former Peak-Hagedon funeral home, built in 1924 in the Italian Renaissance style. A full-page advertisement in the *El Paso Times* after its construction notes that the building had three chapels, several private family rooms, and a garage for ambulances and hearses. Today, the building is used as part of the El Paso IDEA Public School program. Its transition to this educational use has compromised the building's historic integrity. The building's original main entrance on Montana Avenue (seen in the photograph below), has now been sealed, along with windows on the second floor of the Montana-facing façade. Additionally, new windows now punctuate the northeast elevation along North Kansas Street. Most notably, the building's main entrance has now been reoriented to the south elevation through a large three-story, L-shaped addition.

There is no evidence to suggest that the Peak-Hagedon Funeral Home was important for its innovations or advancements in mortuary science under Criterion A. Additionally, ICF did not find evidence that J.W. Peak or Barry Hagedon, original owners of the building, were important within the field of mortuary science or contributed to the history of the area in a way that meets the Criterion B. While the building was constructed as a high-style Italian Renaissance building, the changes to the building have compromised its historic integrity of design, materials, workmanship, feeling, and association. Therefore, Resource No. 152 is recommended not NRHP eligible.
