Historic Bridge Adoption Information Packet

Hamilton County

County Road (CR) 203

Leon River

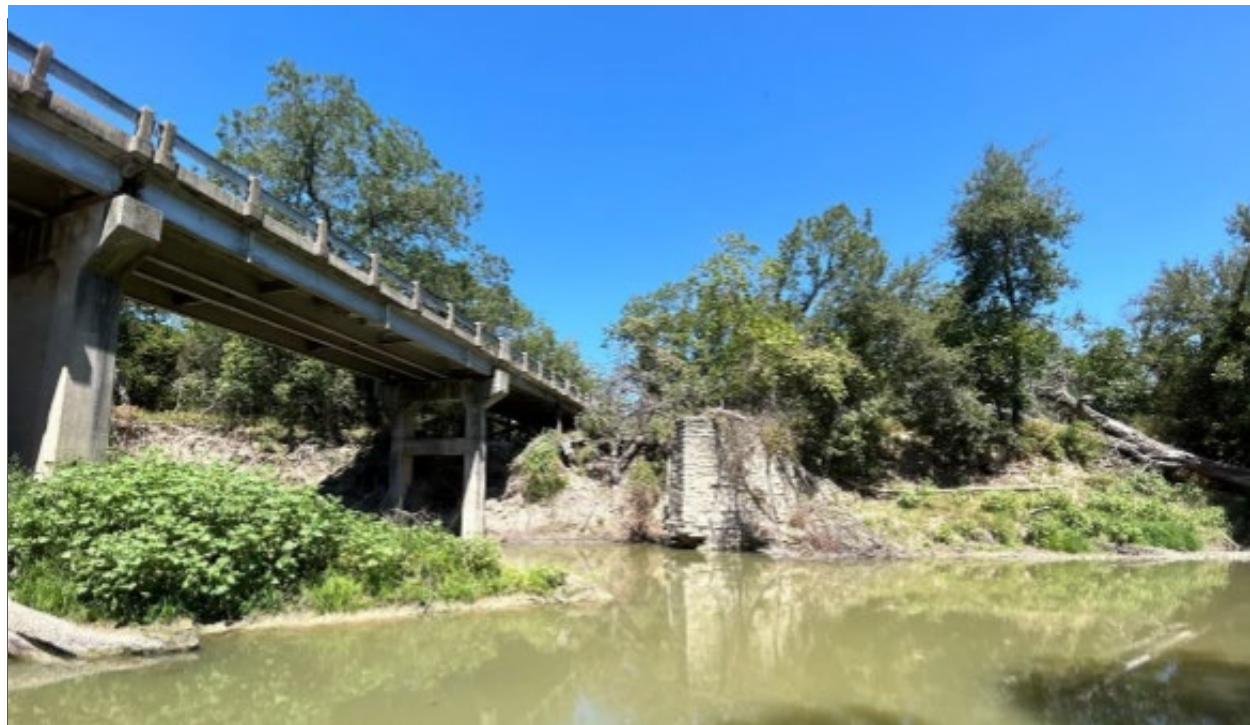
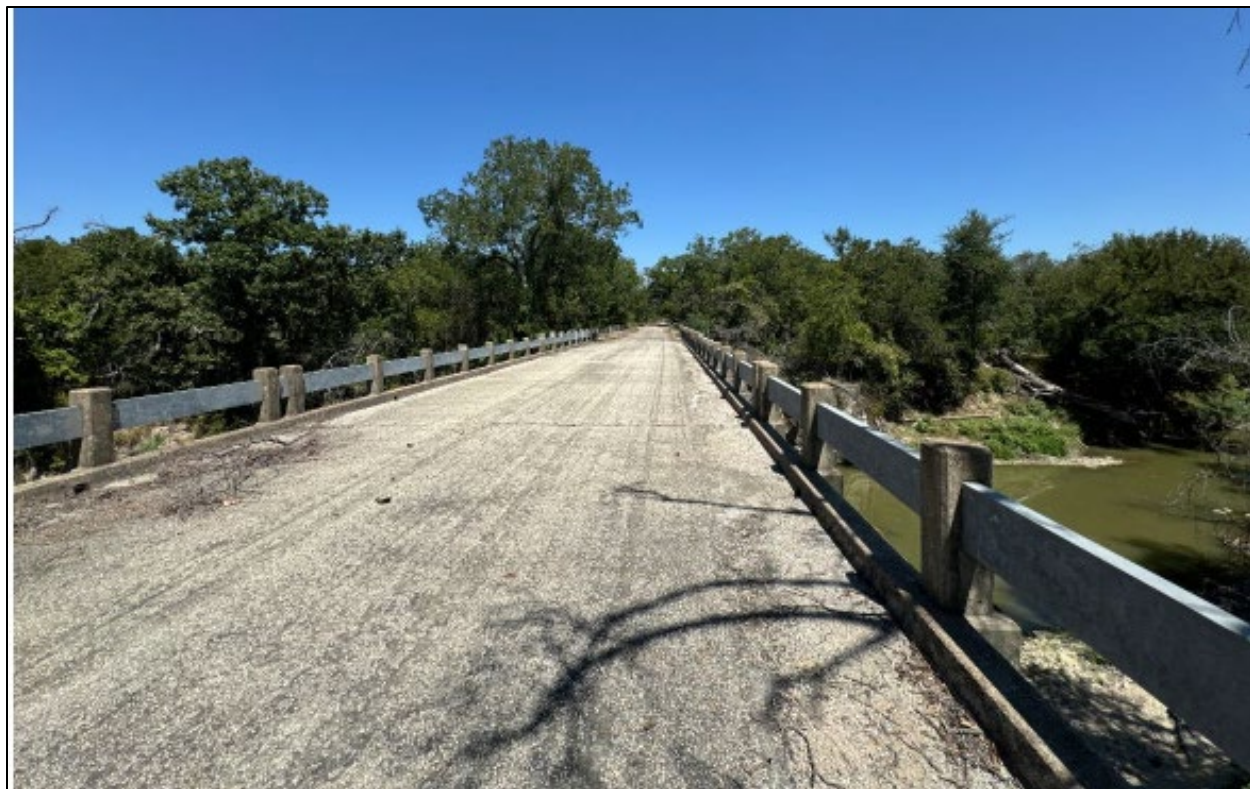
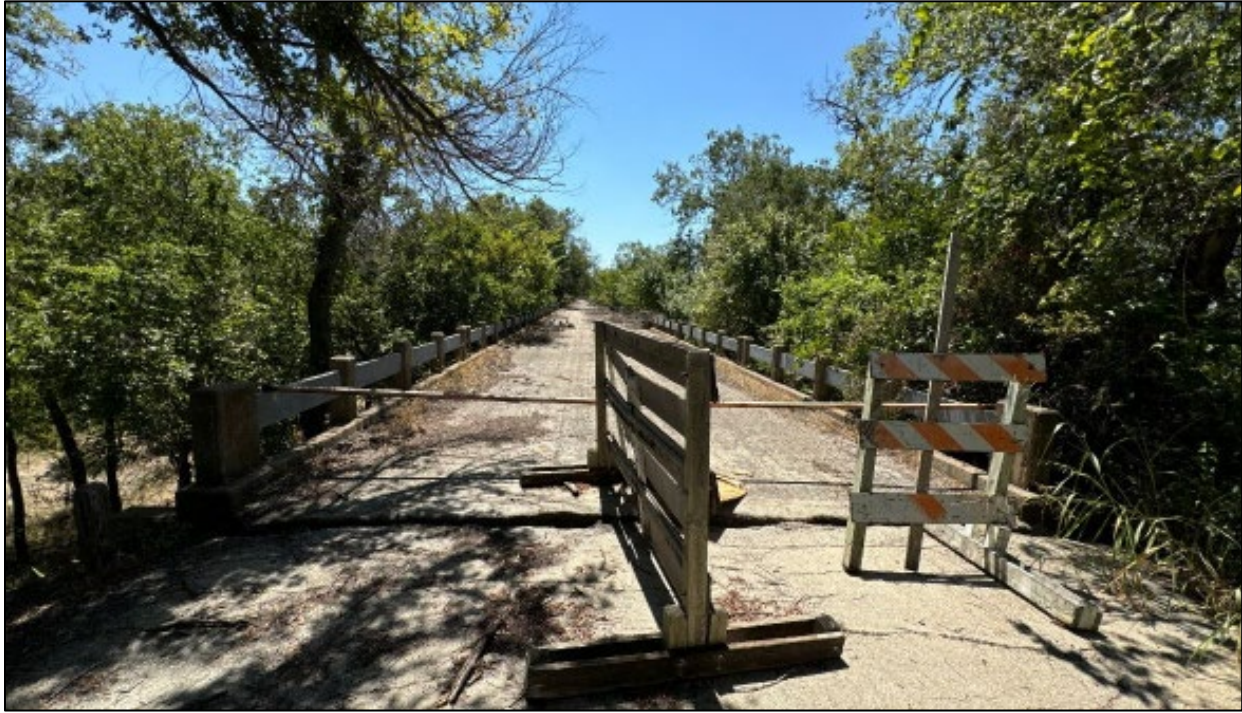
Bridge Photographs

The CR 203 at Leon River bridge is currently closed due to its condition and structural limitations. Severe section loss of the timber pilings in the substructure resulted in a poor condition rating. The span configuration has allowed debris to build-up underneath the structure, and the channel is now wider than it was originally due to scour and major erosion along the riverbank. The scour, along with the substructure condition, impacts the stability of the bridge. Additionally, the bridge is structurally deficient. At 22-feet-wide, the bridge is narrow, and it cannot safely accommodate two-way traffic.
