# Oak Hill Parkway Biological Resources Technical Report

U.S. Highway 290 (US 290) / State  
Highway (SH)  
71 West from State Loop 1 (Mopac) to  
Ranch-to-Market (RM) 1826 and SH  
71 to Silvermine Drive

Travis County, Texas

August 2017

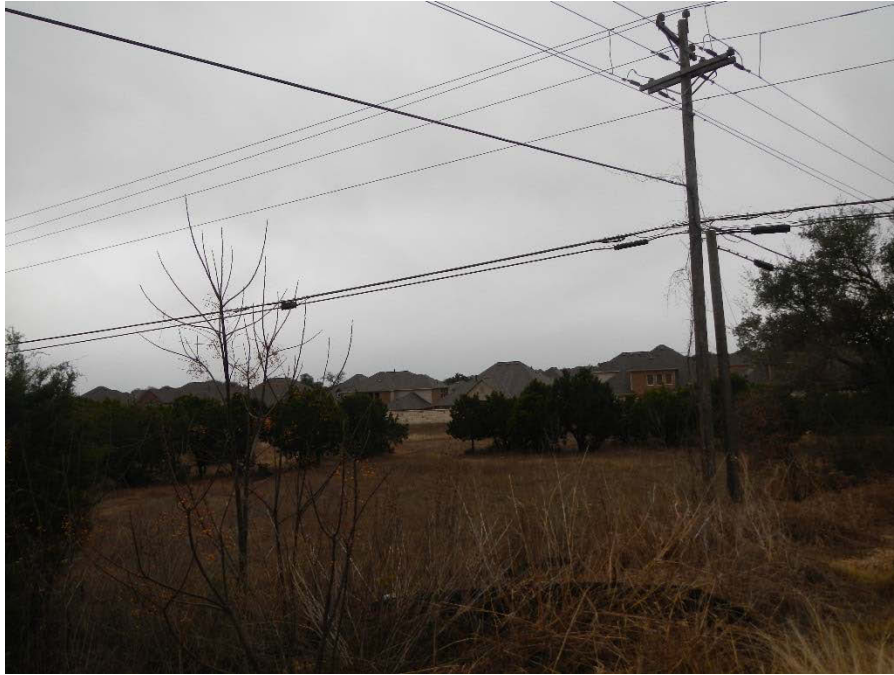
**Photograph 3:** Edwards Plateau: Savannah Grassland with juniper overstory along US 290 (foreground) and residential development in background; facing southeast.

The Edwards Plateau Savanna Grassland vegetation type is located in the project area in a small area along the US 290 corridor (**Photo 3**). The dominant species observed were plateau live oak and Ashe juniper with an understory of little bluestem, King Ranch bluestem, common Bermudagrass, and sideoats grama. This vegetation type is characterized by reduced woody cover and a grassland under story and represents a transition between prairies and woodlands.

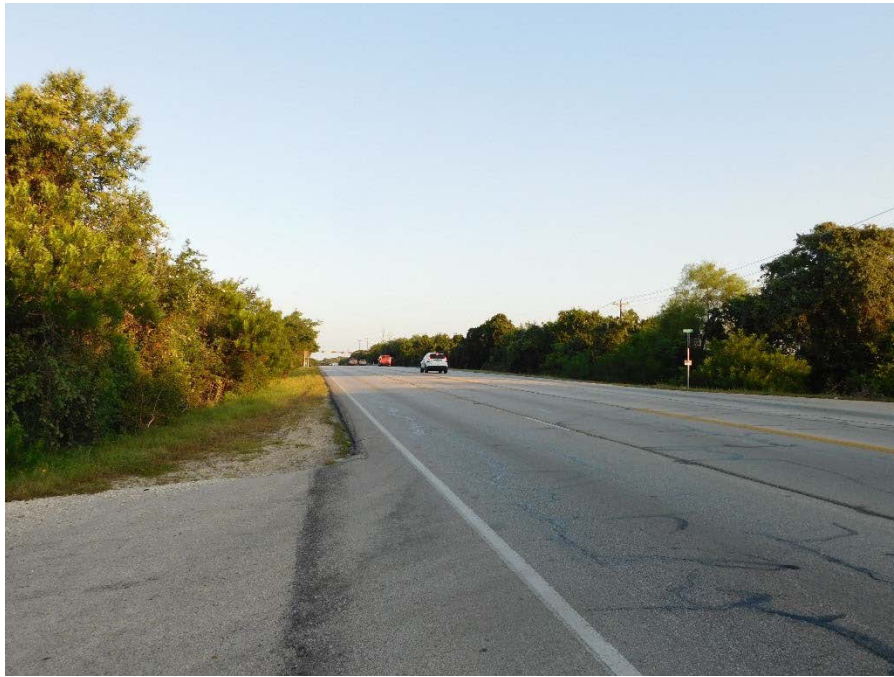
**Photograph 9:** Edwards Plateau: Deciduous Oak/Evergreen Motte and Woodland vegetation type along US 290; facing north.

The understory of the Edwards Plateau Deciduous Oak/Evergreen Motte and Woodland vegetation type is similar to that of the savanna grassland, but its canopy is primarily composed of plateau live oak mottes. This vegetation type was observed in various undeveloped areas throughout the project area, mostly along US 290 from SH 71 west towards the project terminus (**Photo 9**).

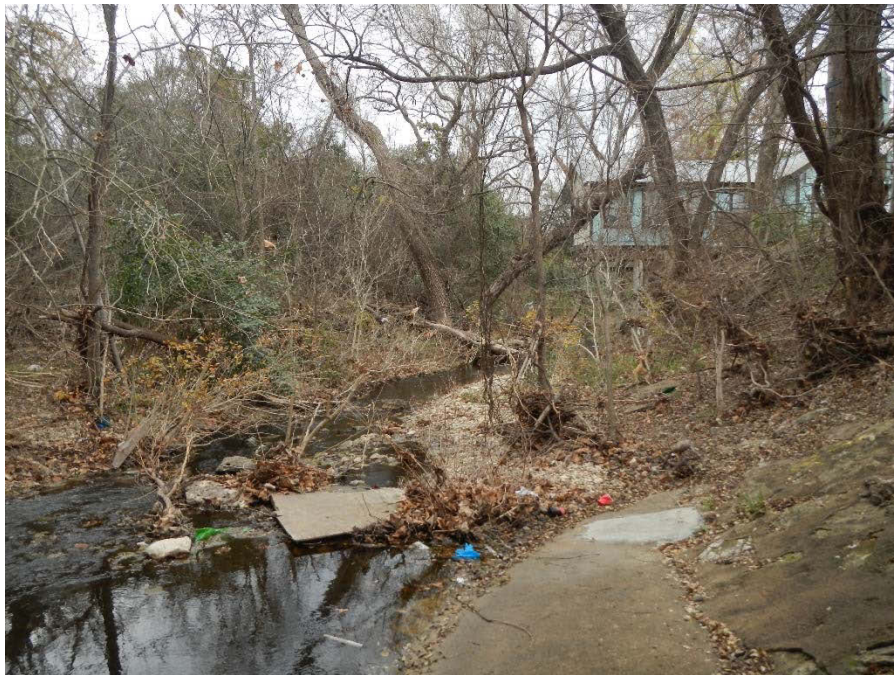
**Photograph 10:** Riparian vegetation at SH 71 Williamson Creek crossing; facing southeast.

The Edwards Plateau: Riparian Hardwood Forest vegetation type was observed in areas along Williamson Creek and its tributaries (**Photos 10, 11, and 14**). These areas are not presently maintained and may or may not be adjacent to flowing water, depending on the season and precipitation. Understory vegetation consisted of Bermudagrass, wild carrot, silverleaf nightshade, clover, Maximilian sunflower, and silver bluestem. The overstory was dominated by an array of hardwood trees consisting of primarily native species. Species observed include black willow (*Salix nigra*), plateau live oak, wax-leaf ligustrum (*Ligustrum japonica*), Ashe juniper, Texas red oak (*Quercus buckleyi*), American elm (*Ulmus Americana*), Pecan (*Carya illinoensis*), American sycamore, and sugarberry.

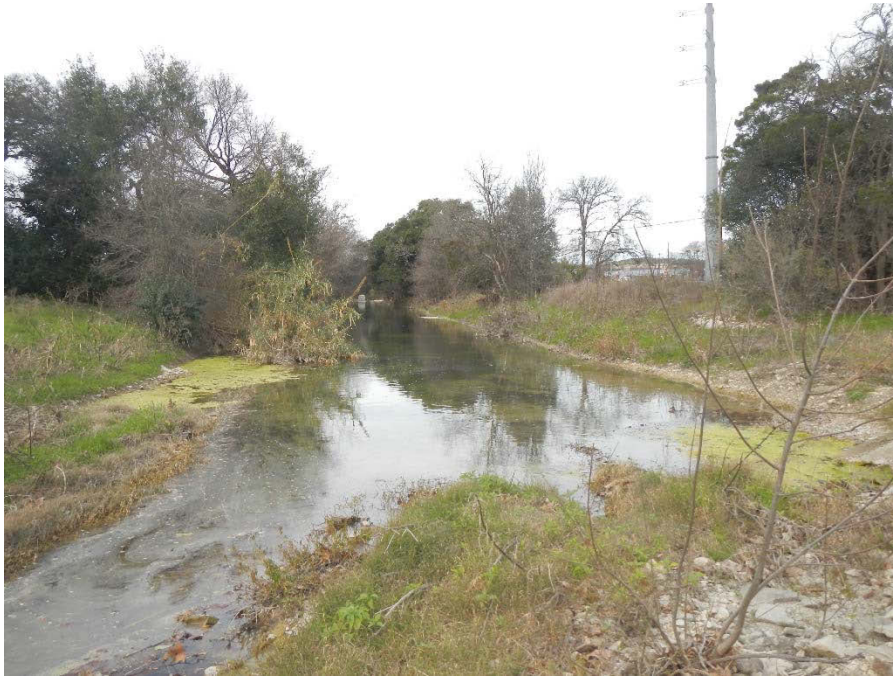
**Photograph 11:** Riparian vegetation along Williamson Creek at Joe Tanner; facing northwest towards US 290/SH71.

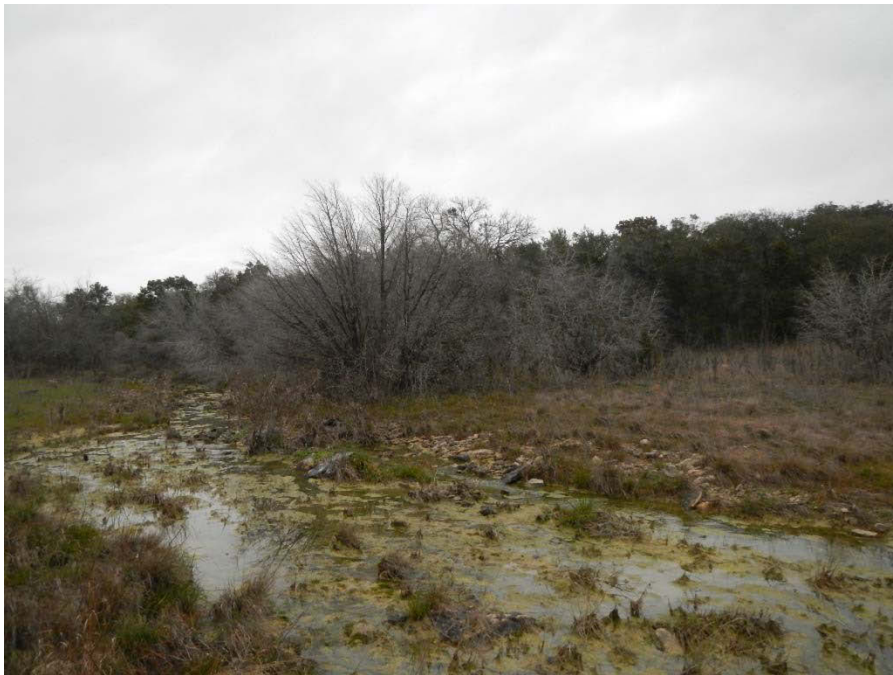
**Photograph 12:** Riparian vegetation at US 290 tributary crossing near project terminus; facing north.

The Edwards Plateau: Floodplain Ashe Juniper Shrubland vegetation community was observed at the western terminus of the project area along a tributary to Williamson Creek (**Photo 12**). This vegetation type is distinguished from the vegetation types around the other tributaries by the shrubby growth stage of the trees and variation of understory species. Ashe juniper and plateau live oak were the dominant tree species and individuals did not exceed six feet in height. Dominant understory species were Texas bluebonnets (*Lupinus texensis*), Maximilian sunflower, clover, and wild carrot.

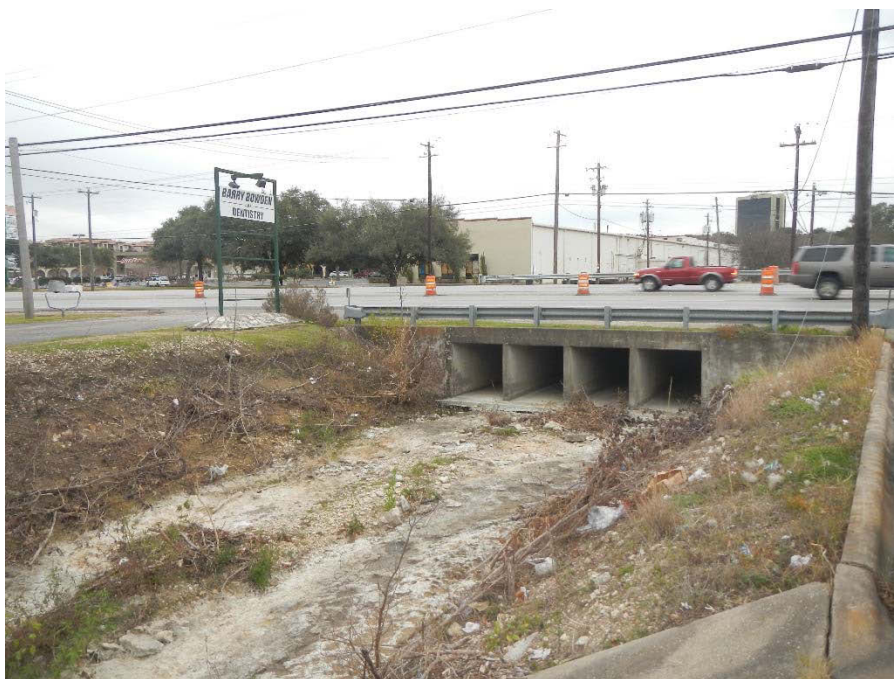
**Photograph 13:** Unnamed tributary (dry) to Williamson Creek crossing under SH 71; facing west.

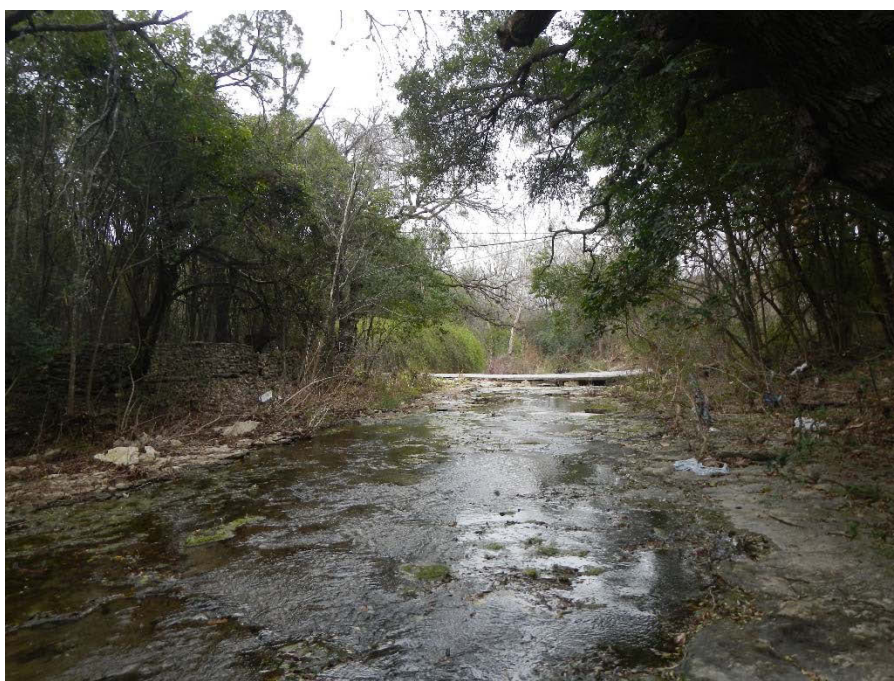
**Photograph 14:** Riparian vegetation along Williamson Creek at Old Bee Caves Road; facing east.

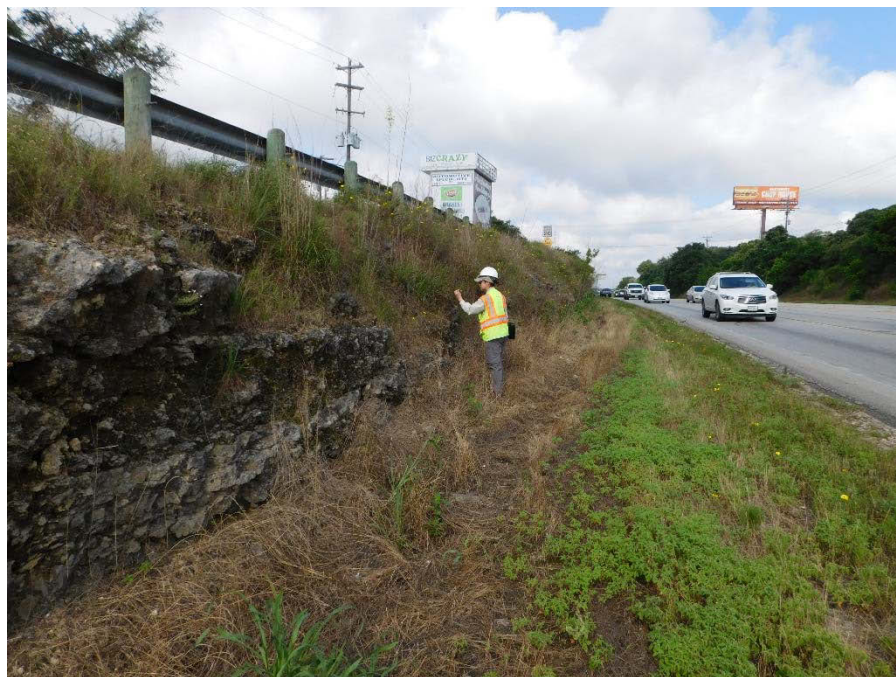
**Photograph 15;** Limestone outcrop along US 290; facing west.

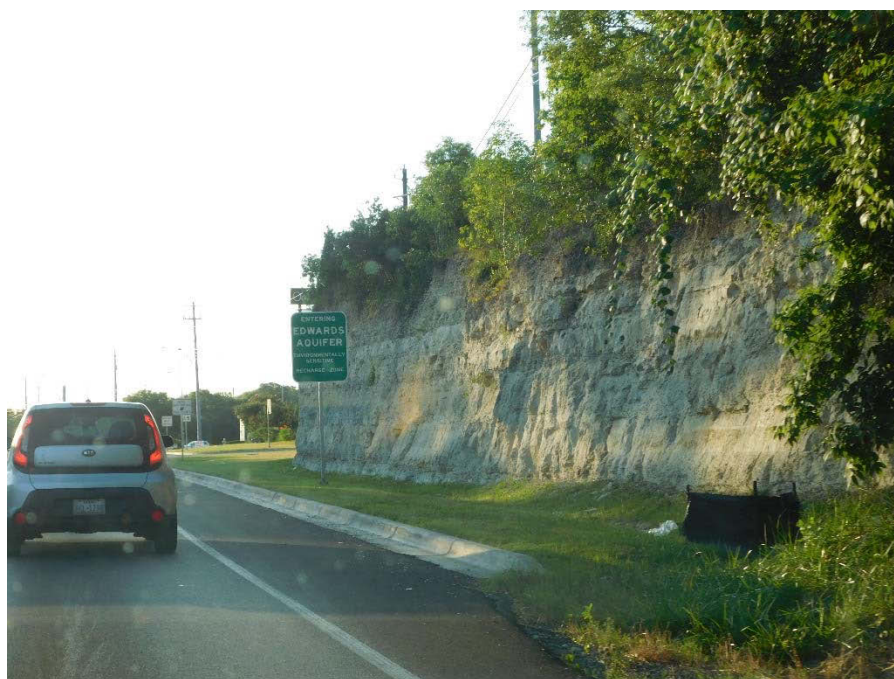
**Photograph 16:** Urban Low Intensity vegetation and limestone cliff at the start of Recharge Zone along US290/SH71 at William Cannon; facing east.

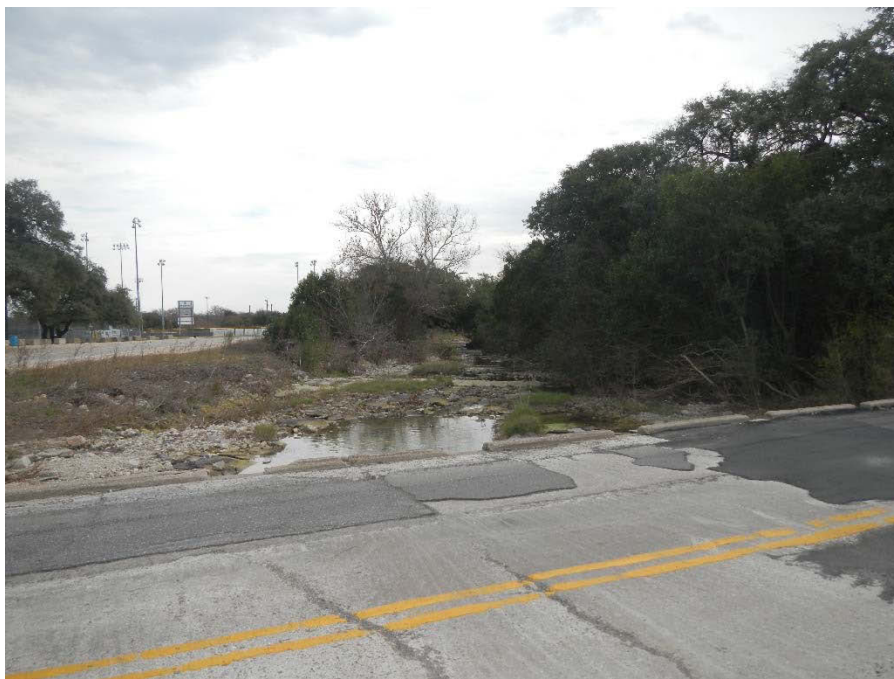
**Photograph 19:** Low water crossing of Williamson Creek at Joe Tanner Lane; facing southeast.

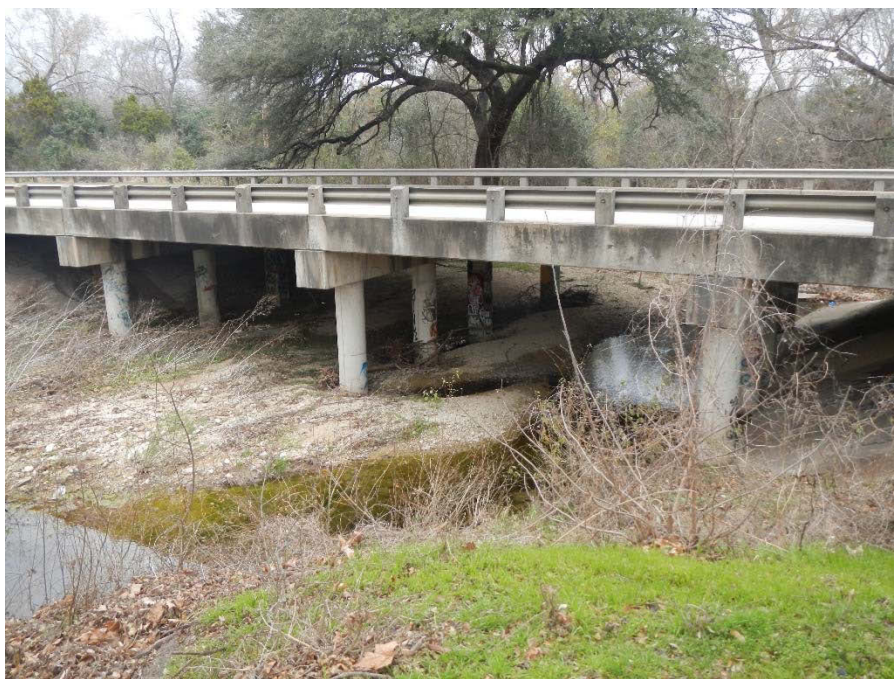
**Photograph 20:** Williamson Creek at SH 71 bridge; facing northeast.

Special habitat features within the proposed project area include water bodies and existing bridges with observed bird colonies. Water bodies within the proposed project area are associated with Wheeler Branch, Williamson Creek, Scenic Brook Tributary, Devil's Pen Creek, several unnamed tributaries to Williamson Creek, and a man-made water quality detention pond located on an adjacent property northwest of the US 290/SH 71/William Cannon interchange. Nesting swallows were observed within the concrete box culverts conveying Devils Pen Creek below US 290 at the western project terminus; no bats or evidence of bats (concrete staining or odor) were observed during visual surveys at any of the crossing structures during field investigation in January, May, or June 2016.
